Subject: Summary of Field Reconnaissance and Data Review
Evidence of Mining Activity in the Cajalco Mining Area
Riverside County, California
Terracon Project No. CB215076

Summary of Field Reconnaissance of Former Mining Areas

Cajalco Canyon Area ■ Riverside County, California

September 23, 2021 ■ Terracon Project No. CB215076

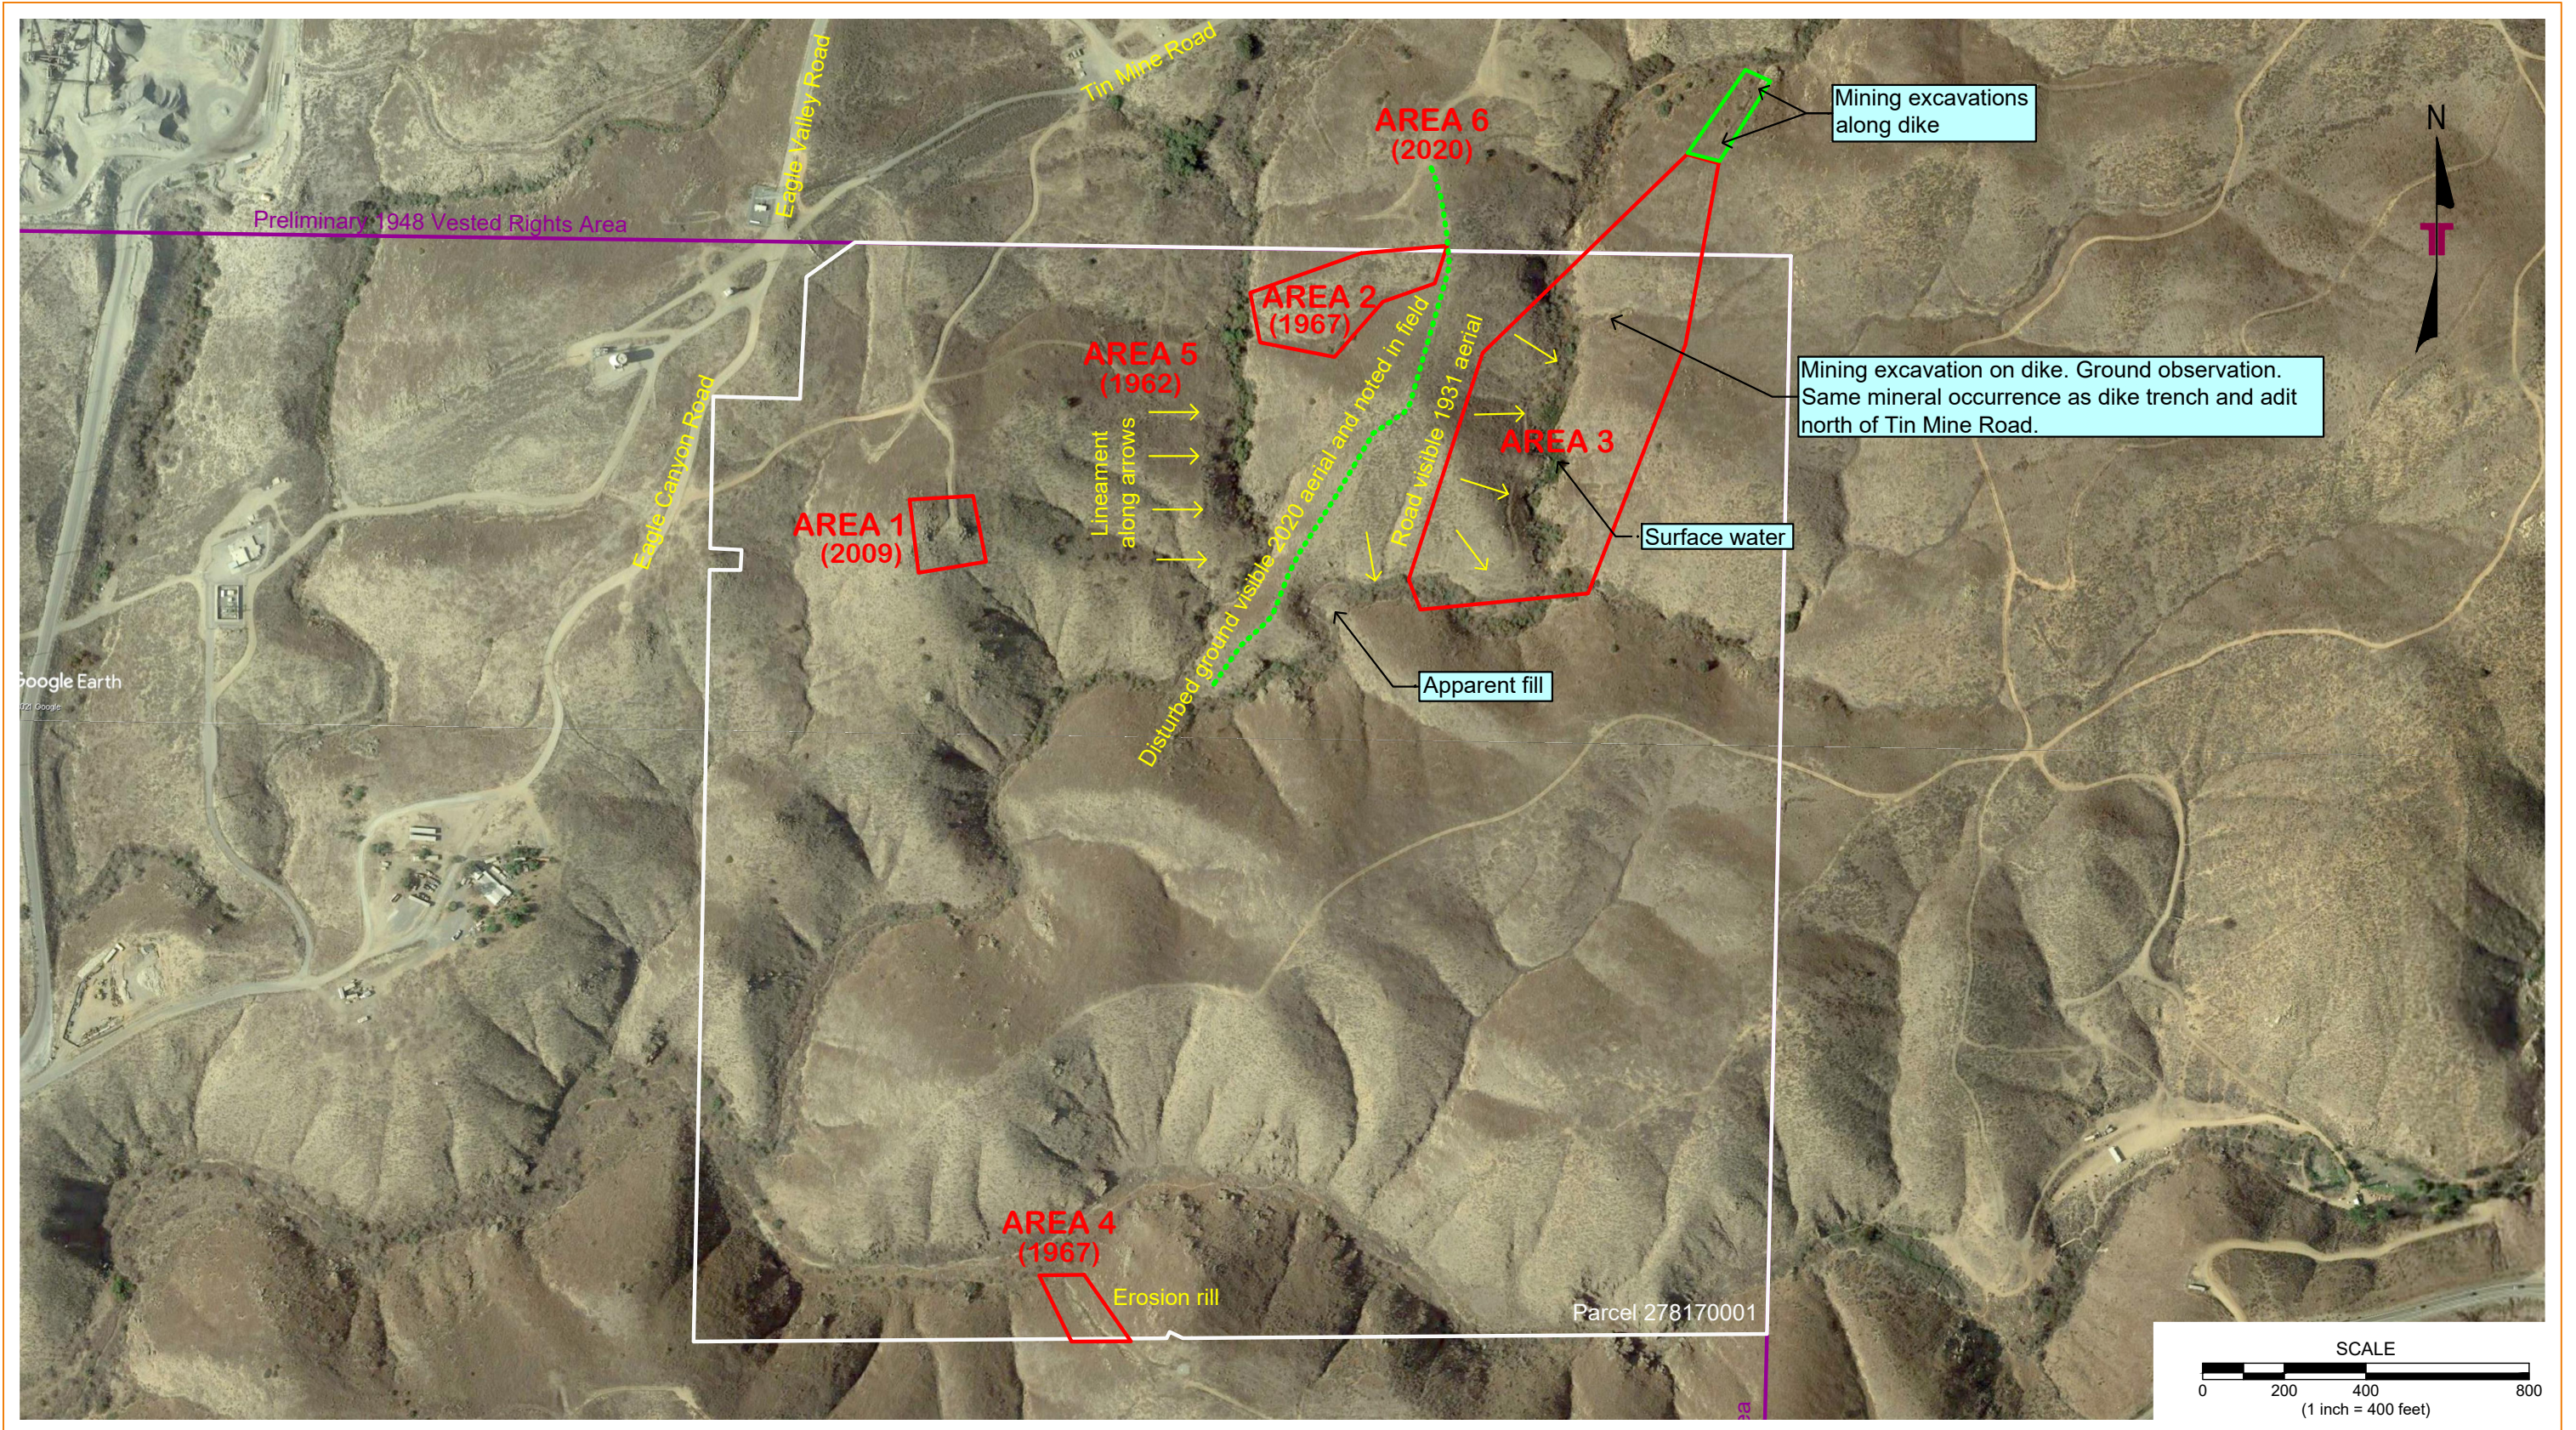
SITE MAP 1 - FIELD RECONNAISSANCE OF FORMER MINING AREAS

Area 1: Consists of a hill top with rock outcrop. An access road approaches a pad excavated into the hilltop outcrop from the north. No improvements are present here. The pad suggests a potential drill hole location that was not utilized. This feature is visible on LiDAR (color) imagery. Mining use is not evident for this feature.

Area 2: An area exhibiting surface disturbance of original soils and vegetation. The disturbance is visible as light-colored ground in aerial image dated 1967. Prominent rock outcrops not present in this area; however, surface is weathered portion of Estelle Mtn. bedrock unit. The timing, the 1960s during the Corona Quarries tenancy, suggests possible mineral exploration. LiDAR imagery reveals ground disturbance and several roads traversing this area that are consistent with clay mining/exploration. An apparent trench-like feature or soil windrows are within the northern portion of Area 2. Mining use of this area is possibly related to surface-level exploration, including exploration for clay deposits. The disturbance post-dates construction of the MWD lower feeder line; however, it may be related to the feeder line or road maintenance.

Area 3: A north-south trending canyon bisects hillside terrain. We noted surface water and dense vegetation along the canyon bottom. A road cut, visible in 1931 aerial imager and LiDAR imagery and verified in the field, traverses along the west side of the canyon slope and turns westward to a former fill area in the drainage. Based on overlay of mineral occurrences from the Tin Mine Disturbances map by Compass Land Group, a tourmaline vein (tin ore source) is located within the northeastern portion of Area 3. LiDAR imagery reveals a trench feature in the bedrock ridge within Area 3. Ground observations of the trench confirm excavations along a northeast-trending dike (mineralized zone). The dike consists of a dark gray, coarse-grained intrusive vein within lighter-colored Estelle Mountain Volcanics. The dike is exposed along the trench with raised ground along the downhill side indicating excavation to expose previously buried portions of the dike. Along the southwestward continuation of this dike, we observed an excavated area with similar vein mineralization. This feature lies within Area 3. Comparison of hand samples collected at each dike locality indicates that the mineral composition of this dike is identical to a dike located north of Tin Mine Road and documented as a former tin mining location. The dike north of Tin Mine Road includes underground excavation of the dike (an adit) and a mine spoils pile at the canyon bottom. These features coincide with mining/mineralization features on the 'TIN MINE MAP'. Mining use of a portion of Area 3 is clear based on our assessment of aerial imagery, maps, and field observations. The road cut (1931 aerial) described previously trends northward toward the vicinity of the dike excavation within Area 3 and is interpreted to be consistent with access to this mining area.

Area 4: A north-south trending linear feature suggesting a trench. This is determined to be a long-lived erosion rill associated with a tank pad visible in aerial imagery dated 1967. Area

4 is clearly defined in LiDAR (color and 315) imagery. Mining use is not indicated for this feature.

Area 5: A road cut providing access to a power pole. Visible in aerial imagery dated 1962. LiDAR (color and 315) imagery reveals both well-defined and subtle road-like features and ground disturbance east of this general area that are consistent with clay mining/exploration. In addition, a north-south trending lineament (LiDAR 315) formed along an apparent vegetational boundary suggests clearing/disturbance of the slopes west of the lineament. The lineament trends along the southward projection of a defined road. Based on location and timing, ground disturbance and roads may be associated with construction of the MWD lower feeder line or may be associated with small-scale exploration for surface clay resources. There are no clear spoils piles or other features indicative of intensive mining use.

Area 6: A road cut/dozer scrape path trending along a bedrock ridgeline. Visible in aerial imagery dated 2020 and LiDAR 315. Physically connects with the powerline access road network at its northern end. Extends southward to a drainage and area of apparent fill of Area 3. Clearly defined in LiDAR (color and 315) imagery. This feature is consistent with surface explorations for mining using a bulldozer to create shallow bedrock exposure along a transect and could be associated with a reported prior attempt to develop a quarry (Harlow Hill Development report (1984). Mining use/exploration is not determined, but is suggestive, for this area.

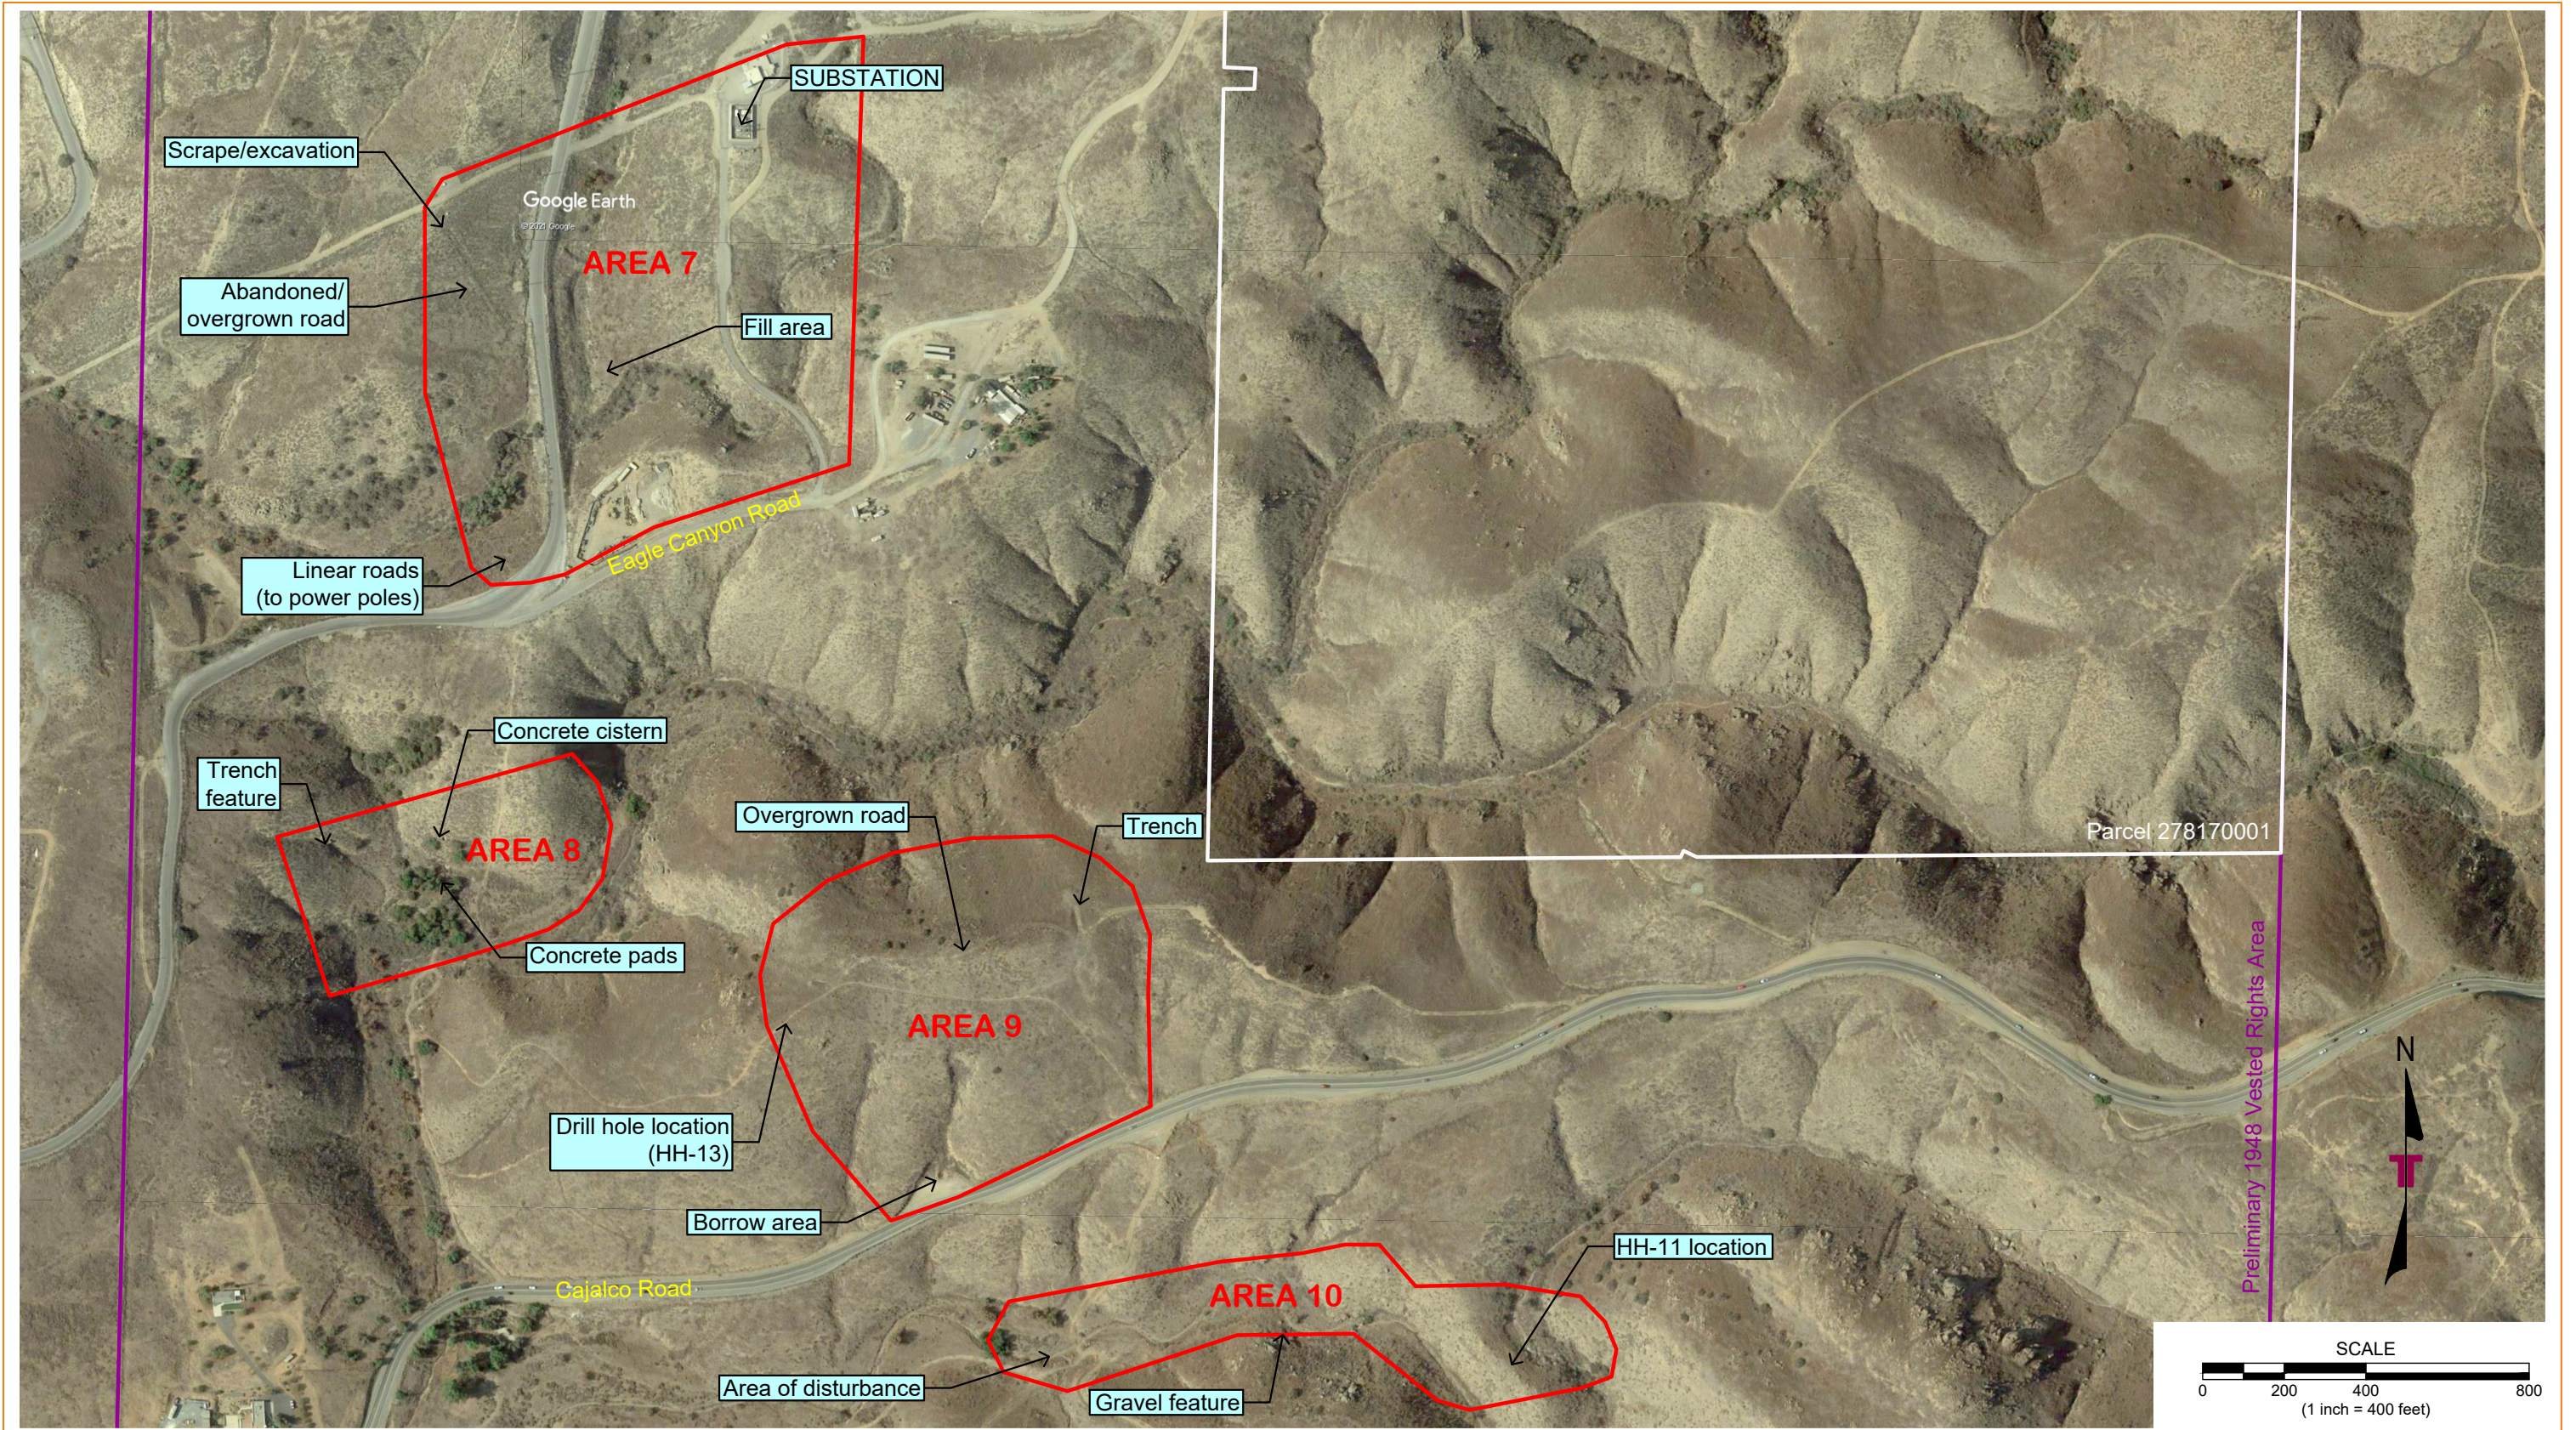
SITE MAP 2 - FIELD RECONNAISSANCE OF FORMER MINING AREAS

Area 7 (June 30 Area 1): This area is bisected by a modern mine access road and bounded along the south by Eagle Canyon Road. A substation/pump station occupies a ridgetop in the northeastern portion. Ground reconnaissance revealed a hilltop cut/scrape area, a likely fill area with 'two-track' road, and abandoned road within Area 7. The abandoned road was noted during ground reconnaissance and is overgrown but is visible as a lineament on aerial photos dated 1994. It is also visible on aeriels dated 1953 as a defined cut. The road appears to continue northward in 1953 imagery. This road is a possible side-hill prospect consistent with mining surface exploration - including known exploration for surface clay resources as described by Gray and others (1961) for the adjoining Section 16 of Township 4 South, Range 6 West - using a bulldozer to expose near-surface materials along a transect. The hilltop scrape and roadway are clearly defined in LiDAR (color and 315) imagery. In addition, two linear road-like features are visible in LiDAR (color and 315) imagery within the southwest portion of Area 7 and appear to be associated with power poles located near the terminus of each road. Outcrops within this area were described in the Harlow Hill Development Report (Locations 14a and 14b of map Harlow Hill report dated 1984) that states "rock apparently belonging to the Temescal Wash quartz latite porphyry and suitable for quarry operations crops out extensively". Based on the map included in the Harlow Hill Development report (1984), Area 7 is a documented mining exploration site. In addition, the

presence of disturbed ground and abandoned roads dating from at least 1953 suggests earlier mining exploration associated with near-surface clay resources.

Area 8 (June 30 Area 2): An area of former structures with a hillside cistern (circular concrete basin) accessed from Cajalco Road. This area is littered with modern household debris, landscape trimmings and other end-dumped trash. Several concrete pads indicating the locations of former structures, now partially obscured by mature trees, were observed during the ground reconnaissance. Structures are visible at the pad locations in 1938 aerial imagery. A road extending up canyon beyond the structures is also visible in 1938 imagery. This road is also visible in 1931 aerial imagery, but structures are not clear. A trench-like feature below a bedrock outcrop was observed on the hillside west of the former structure area. The cistern and trench features are visible in aerial and LiDAR imagery (315). A spoils pile or other feature indicating substantial exploration were not observed below the trench. Clearly defined indications of mining at this location are not identified; however, the location of the structure pads, the associated cistern and canyon road suggest a temporal association with near-site activities during the 1930s or earlier, and may be remnants of known historic housing for public works employees associated with the construction of Cajalco Road.

Area 9 (June 30 Area 3): This area consists of a road network extending along the south and north sides of an east-west trending ridgeline with areas of past disturbance visible in aerial and LiDAR (color and 315) imagery. An overgrown trench excavation, observed during the ground reconnaissance and clearly visible in LiDAR (color) imagery, is located on a topographic saddle in the eastern portion. This trench - and a cleared area to the south - is first visible in 1959 aerial imagery. A road segment along the north side of the ridgeline first appears in the 1959 imagery and is now overgrown with mature shrubs. An earlier and more extensive road is visible along the south side of the ridgetop in aerial imagery dated 1931. Terrace deposits with rounded cobbles (a likely gravel/aggregate source) occupy the higher portion of the Area 9 ridgeline. A road extends from the ridgetop downslope to Cajalco Road (visible in LiDAR (color) and aerial imagery). A borrow area adjacent to Cajalco Road is located south of this area. A drill hole location identified by surface spoils and a mud pit was observed west of this area and is likely associated with mining exploration related to the Harlow Hill Report location HH-13. Based on the features observed in Area 9, we conclude that past mineral/materials resource explorations/use are associated with this area. These uses may include supplying materials for the construction of Cajalco Road and Cajalco dam as well as gravel and aggregate mining.

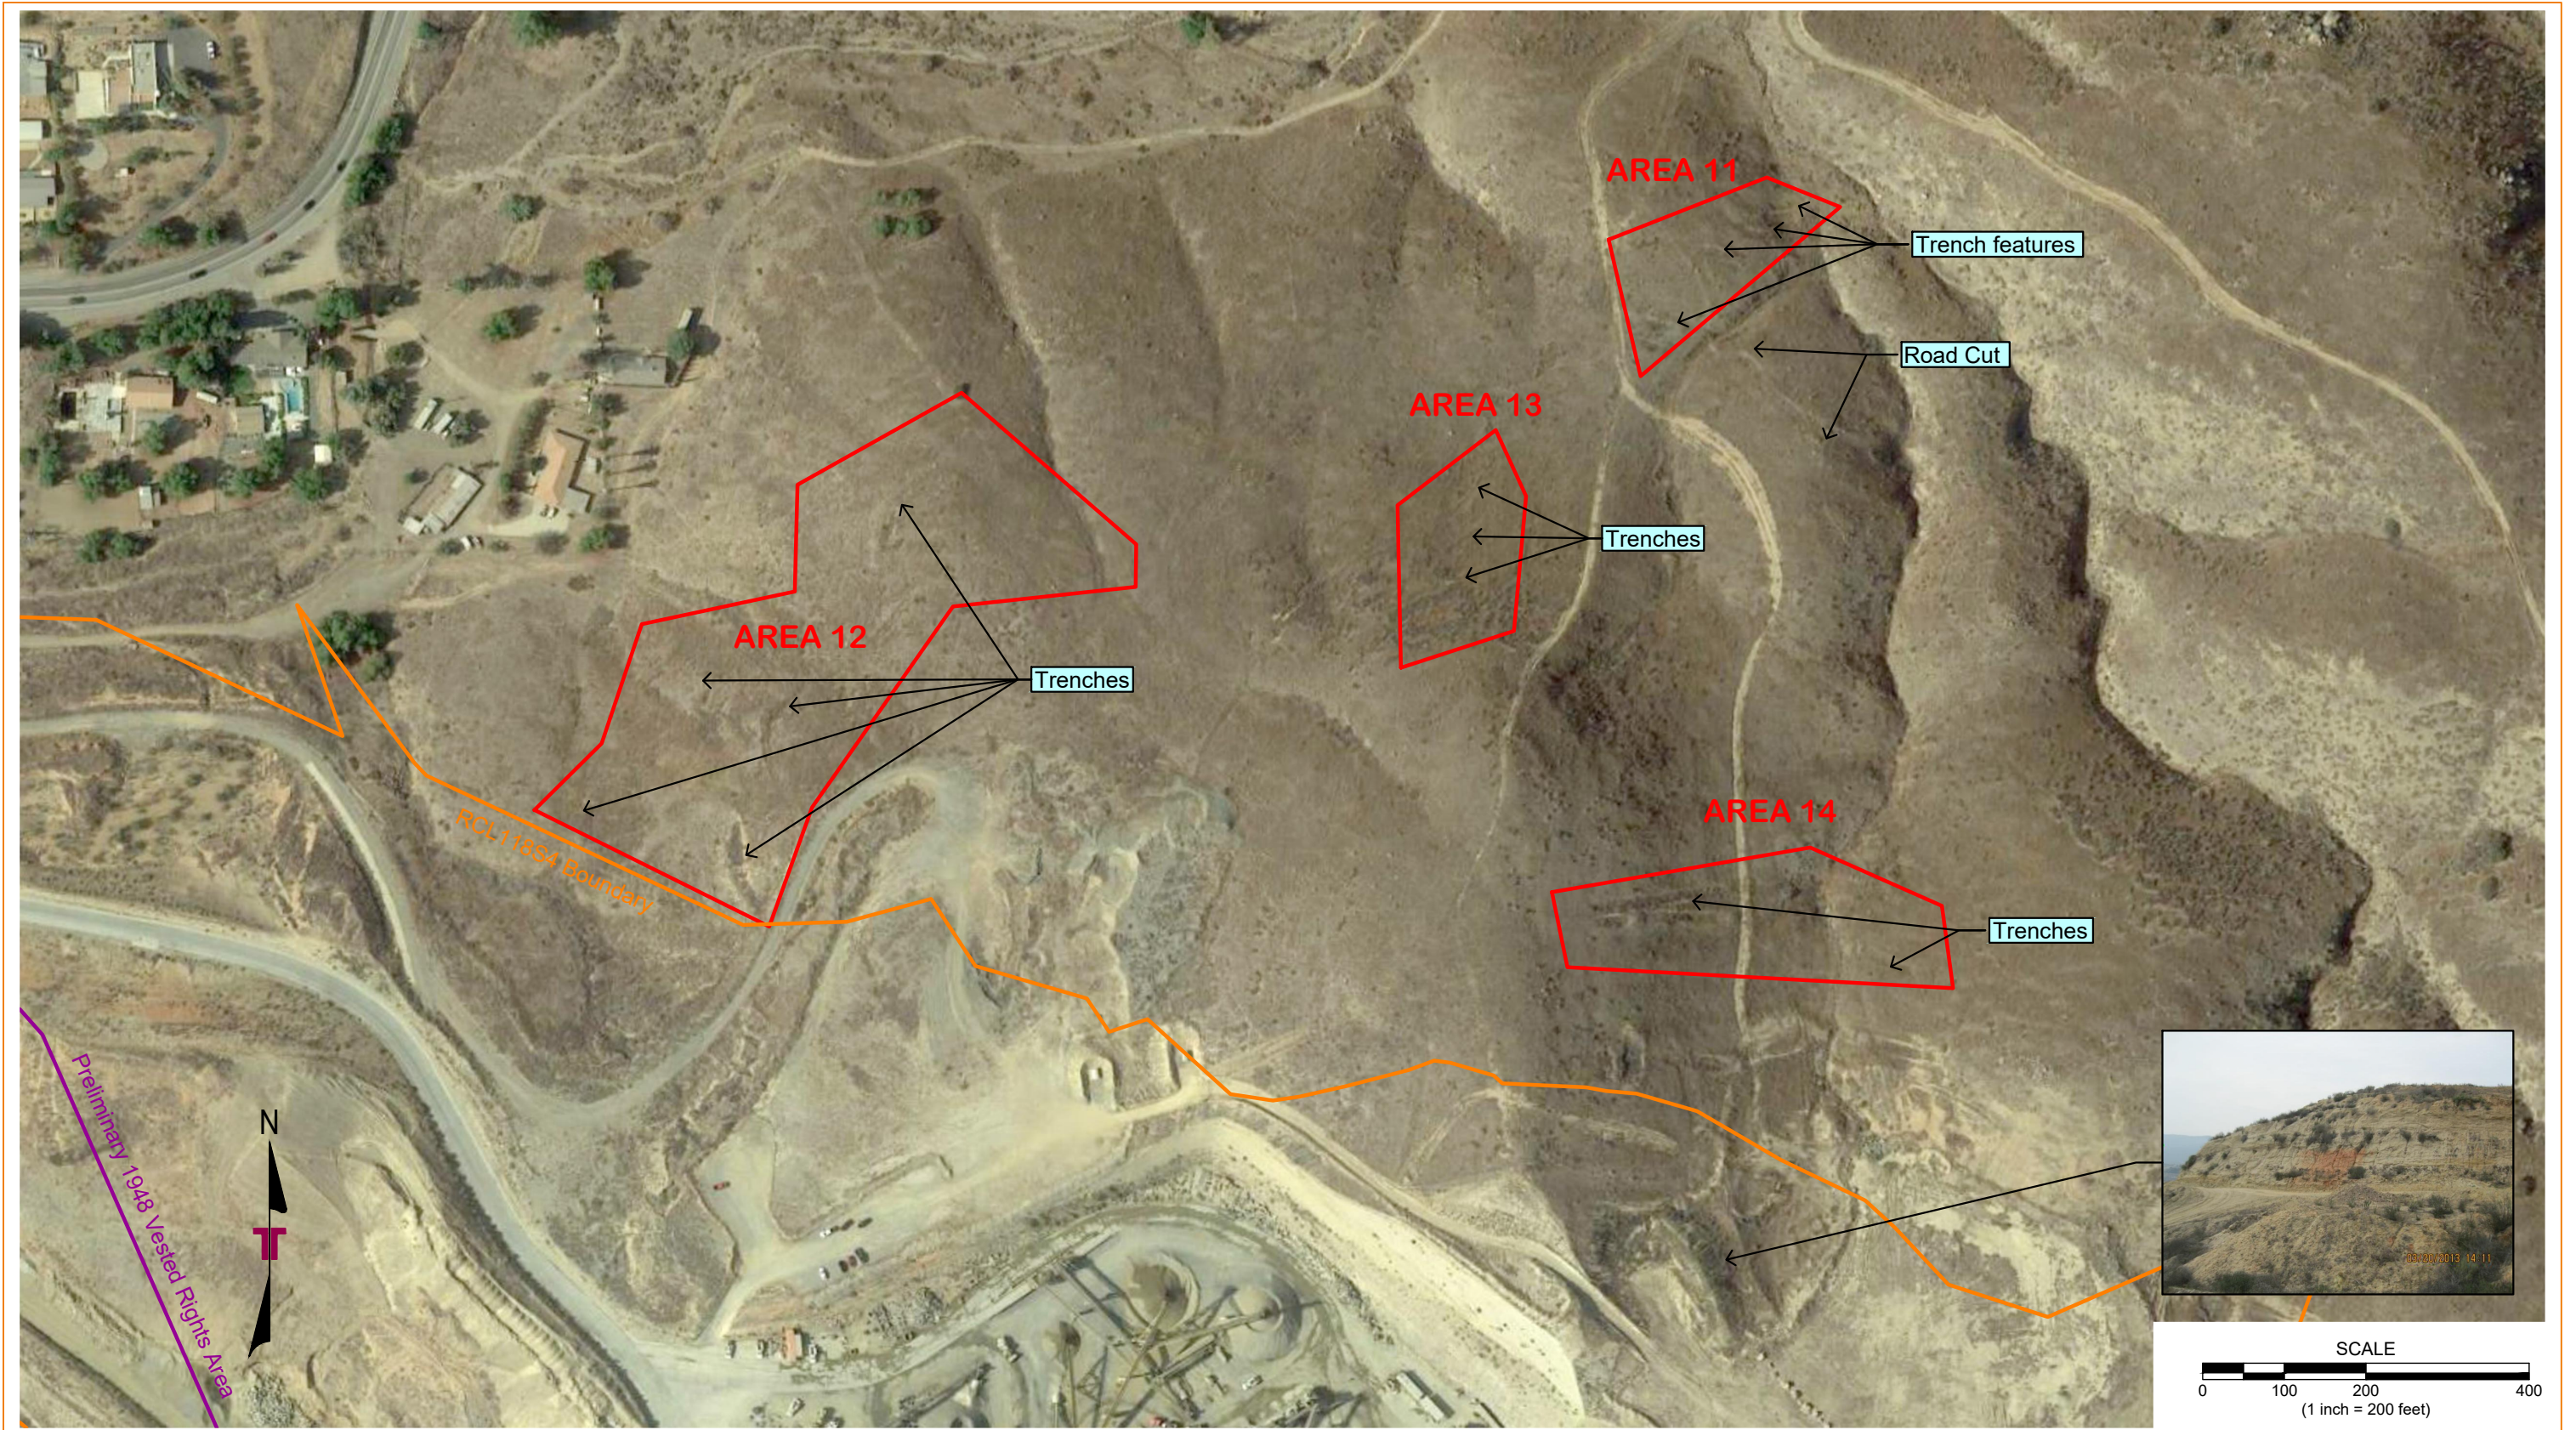
SITE MAP 3 - FIELD RECONNAISSANCE OF FORMER MINING AREAS

Area 10 (June 30 Area 4): This elongate area extends along hillsides flanking an east-west oriented drainage feature south of Cajalco Road. A roadcut extends along the south side of the drainage. An area of disturbance is located in the western portion (visible in LiDAR (color) imagery and aerial photographs). A subtle road/path-like feature on an isolated ridgeline observed during the ground reconnaissance is located at the eastern end of Area

10 is visible in LiDAR (315) imagery and corresponds with the mining exploration location HH-11 as shown on the Harlow Hill Report map (Harlow Hill report 1984). This road/path is consistent with mining exploration using a bulldozer to expose near-surface materials. A vertical exposure of cemented gravel (possible terrace deposits) suggestive of gravel mining was noted during ground reconnaissance near the drainage bottom in the east-central portion of this Area 10. Mining exploration is clearly documented for Area 10 in the Harlow Hill Development report (1984). Possible additional disturbances associated with Area 10 include supplying materials for the construction of Cajalco Road and Cajalco dam, gravel and aggregate mining, and possible use by Liston Brick Co. to supply their local plant located on Cajalco Road.

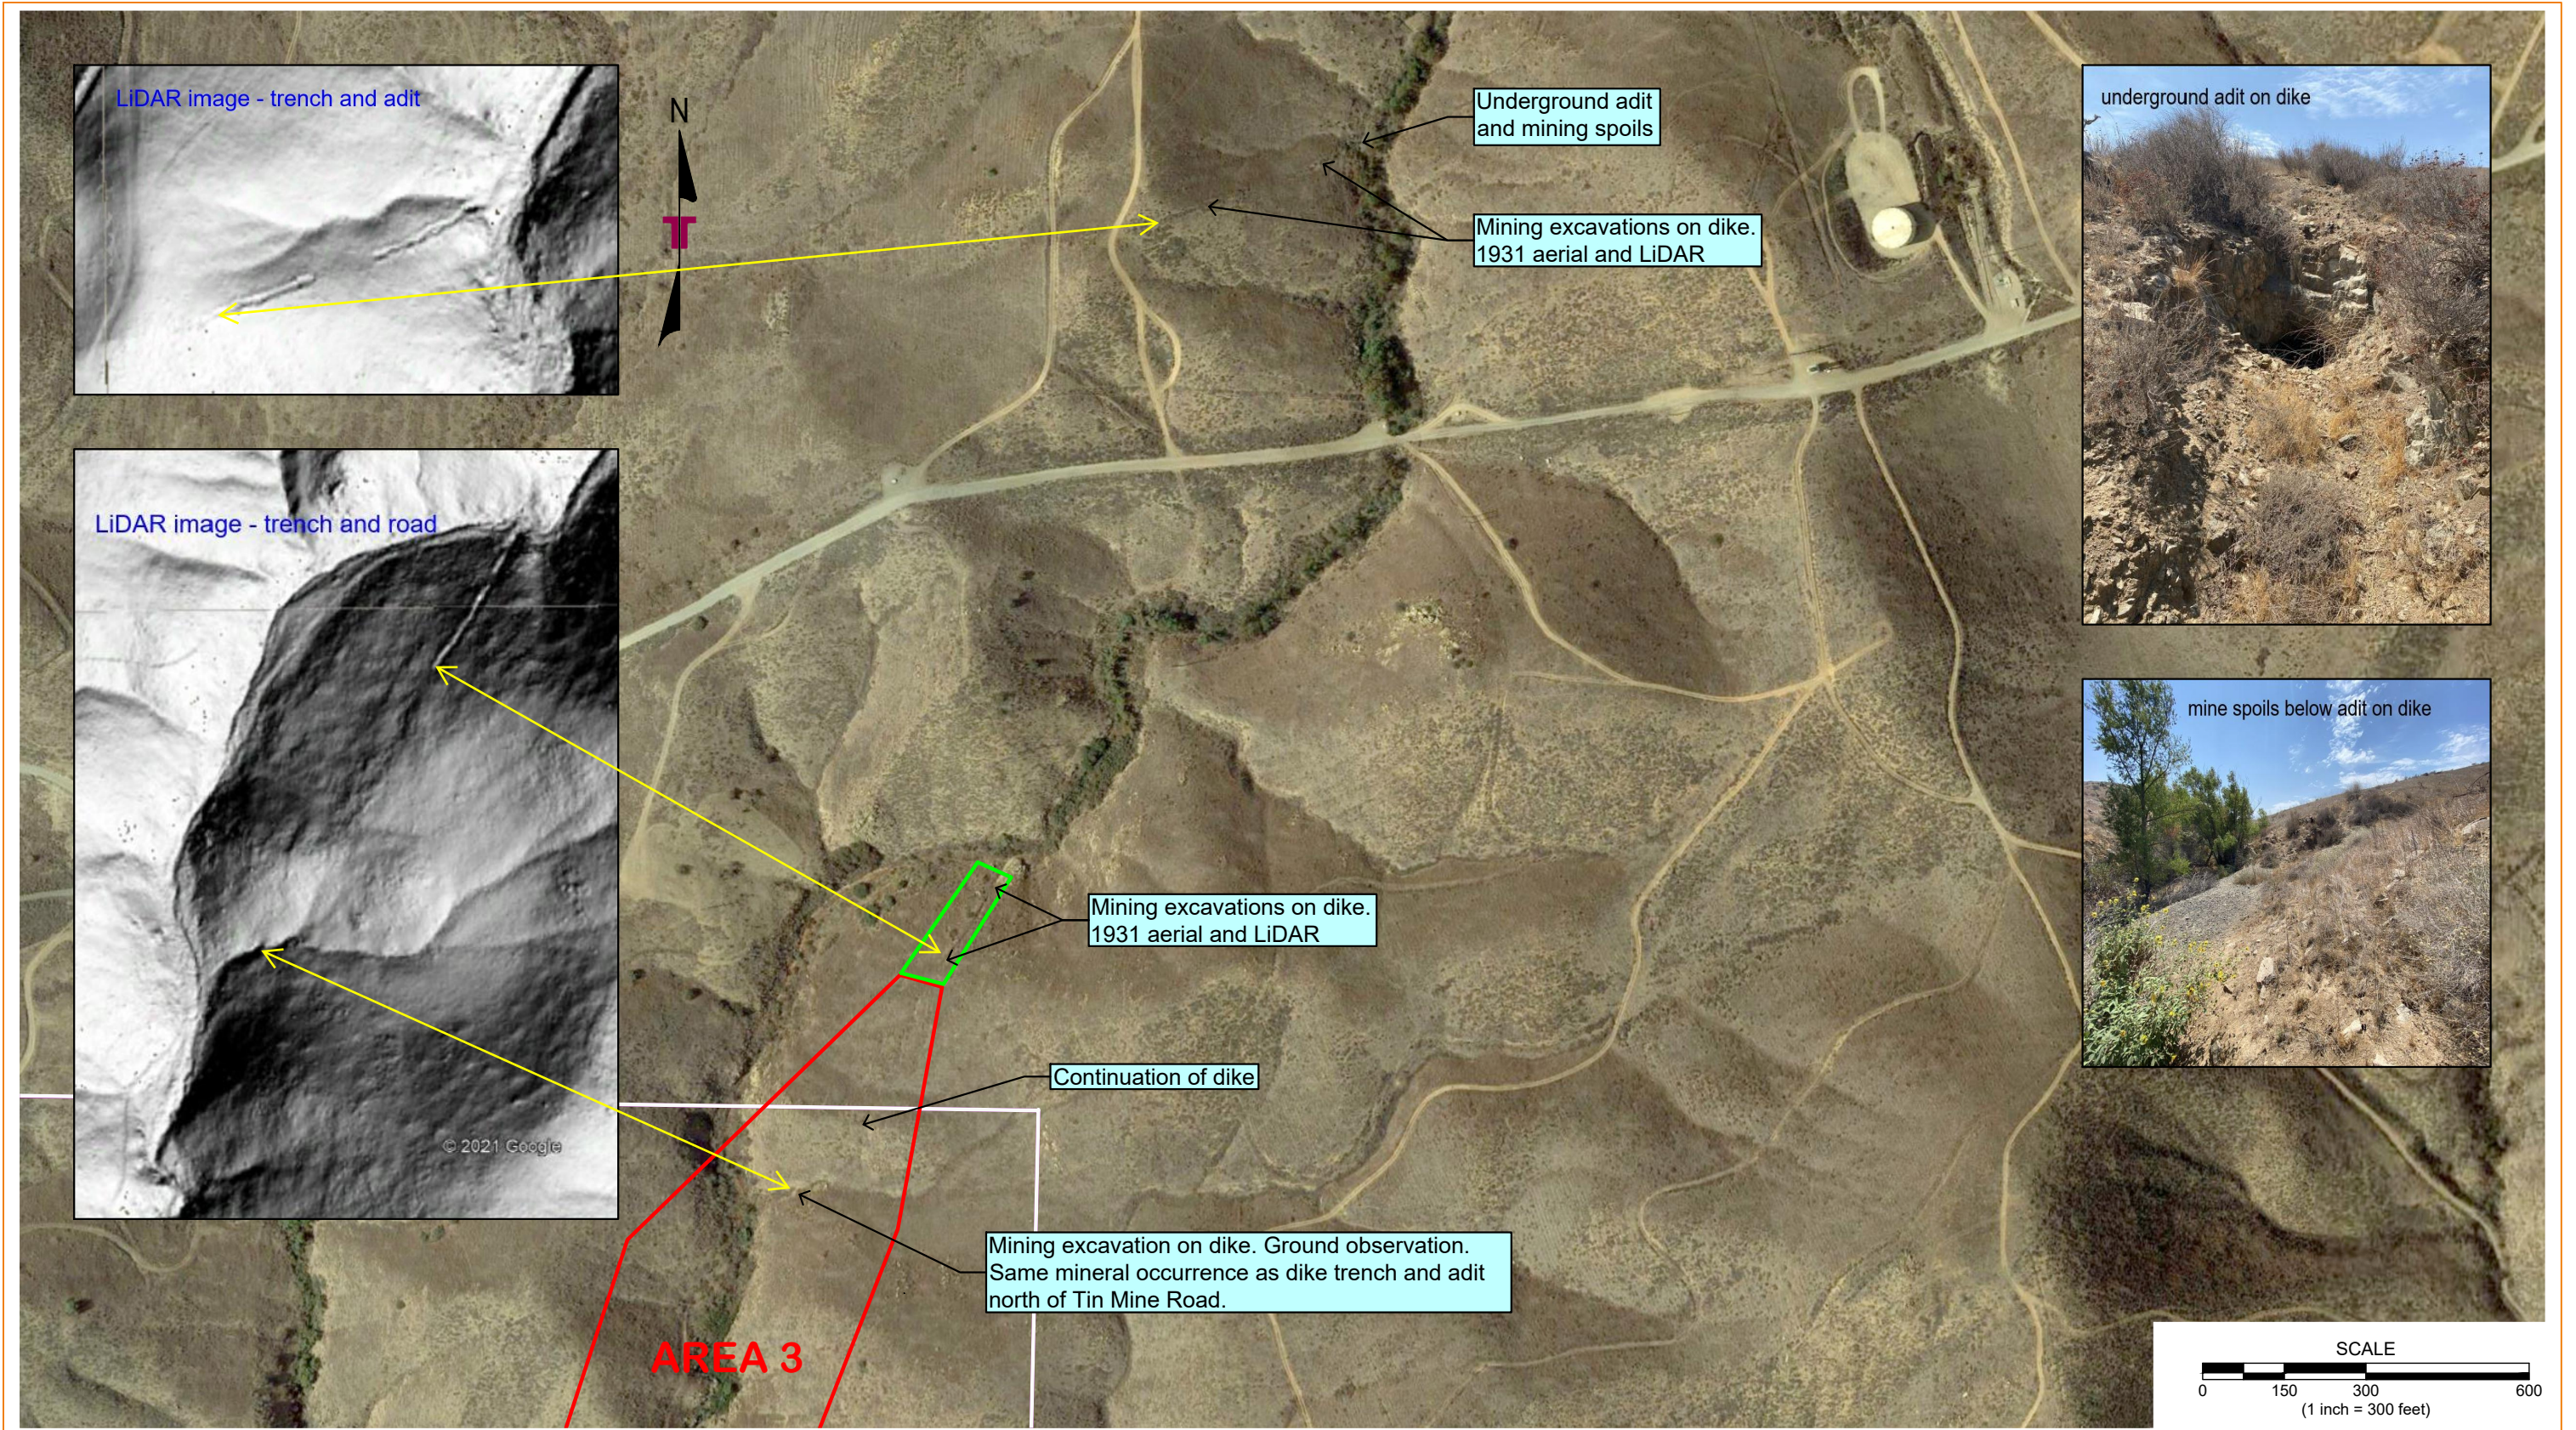
SITE MAP 4 - FIELD RECONNAISSANCE OF FORMER MINING AREAS

Area 11: This hillside area includes several trench features visible in aerial and LiDAR imagery. At least four (4) trenches are apparent. A subtle road feature trends northwesterly across Area 11 and is visible in aerial and LiDAR (315) imagery. These features are consistent with exploratory cuts and trenches created with a bulldozer and used in mining for exploration and/or resource extraction. This area is at the outer edge of the area of influence for either (i) the Cajalco Clay Pit or (ii) the existing Hubbs-Harlow Pit. Past mining uses of Area 11 are strongly indicated and are likely associated with known operations at the Hubbs-Harlow Quarry, Harlow Clay Pit, and-or Cajalco Clay Pit.

Area 12: This area includes several sinuous elongate trench excavations visible in aerial (1967) and LiDAR imagery. These excavations are consistent with mining explorations using a bulldozer. Area 12 is within the area of influence of the Hubbs-Harlow quarry. Reddish surface clay deposits are exposed in a modern roadcut approximately 600 feet west of this area suggesting a possible clay mining association. Alternatively, these trenches may be related to early phases of the ongoing aggregate/rip rap mining. In either case, mining use is clearly indicated for Area 12 and is likely associated with known operations at the Hubbs-Harlow Quarry, Harlow Clay Pit, and-or Cajalco Clay Pit.

Area 13: This area includes at least three trench excavations that are well-defined in aerial and LiDAR (315) imagery. The trenches trend subparallel to each other in a southwesterly direction. These trenches are consistent with mining surface explorations/excavations using a dozer. Area 13 is within the area of influence of the Hubbs-Harlow quarry. Mining use is strongly indicated for Area 13 and is likely associated with known operations at the Hubbs-Harlow Quarry, Harlow Clay Pit, and-or Cajalco Clay Pit.

Area 14: This area includes several east-west trending trench excavations that are well-defined in aerial and LiDAR (315) imagery. Area 14 is within the area of influence of the Hubbs-Harlow quarry. These trenches are consistent with mining surface explorations using

a bulldozer. Disturbances within approximately 100 feet south of the Area 14 features first appear in aerial imagery dated 1952 and are likely associated with known operations at the Hubbs-Harlow Quarry, Harlow Clay Pit, and/or Cajalco Clay Pit. A north-south trending road bisects Area 14. Reddish clay deposits were photographed in a prominent cut located south of the Area 14 trenches in March 2013. Mining use is strongly indicated for Area 14.
