# Western Riverside County Multiple Species Habitat Conservation Plan Section 6.1.2 Addendum Report

Plot Plan 180003

**PLOT PLAN 180003  
ASSESSOR'S PARCEL NUMBER 941-180-032**

**August 27, 2019**

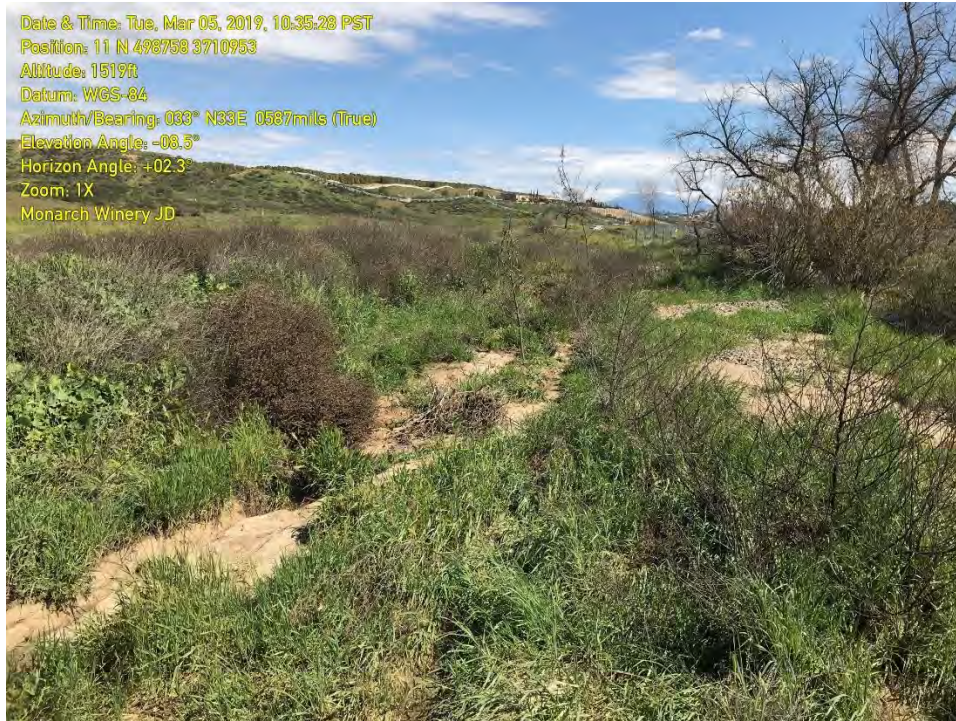
**PHOTOGRAPH 1:** Sediment transport and debris in the western end of the Property.

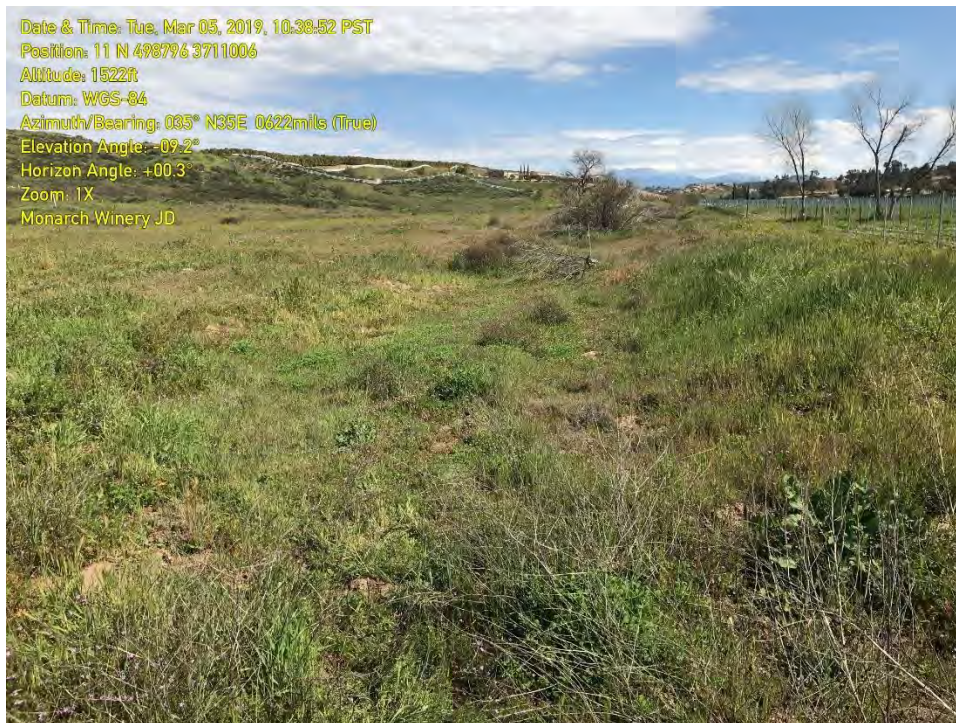
**PHOTOGRAPH 2:** No evidence of flow along the historic flow area of Long Valley Wash in the western portion of the Property.

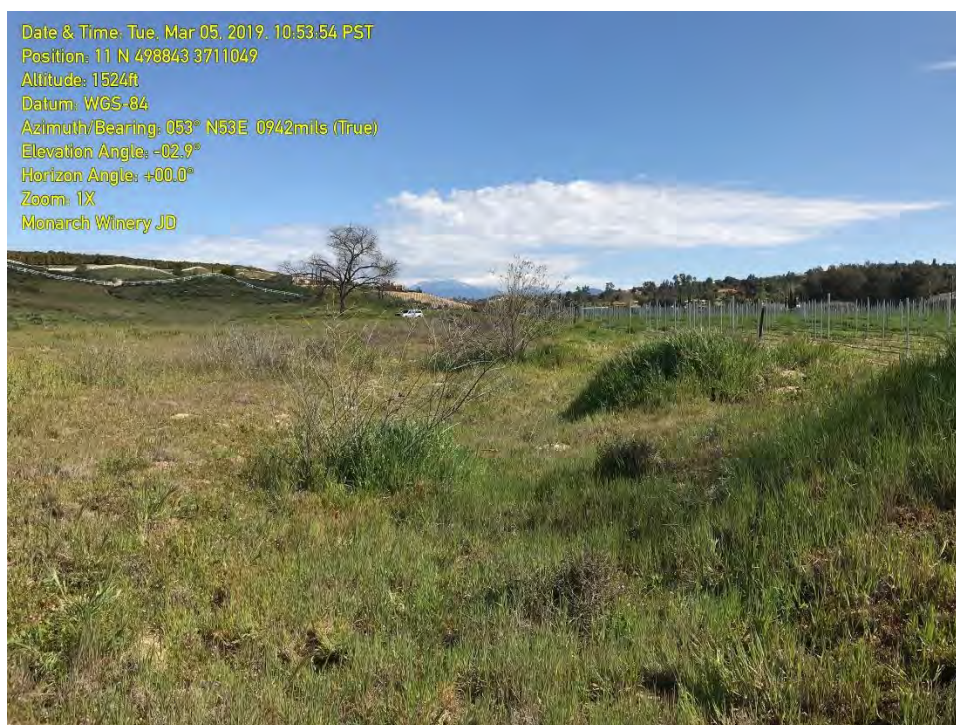
**PHOTOGRAPH 3:** No evidence of flow along the historic flow area of Long Valley Wash in the western portion of the Property.

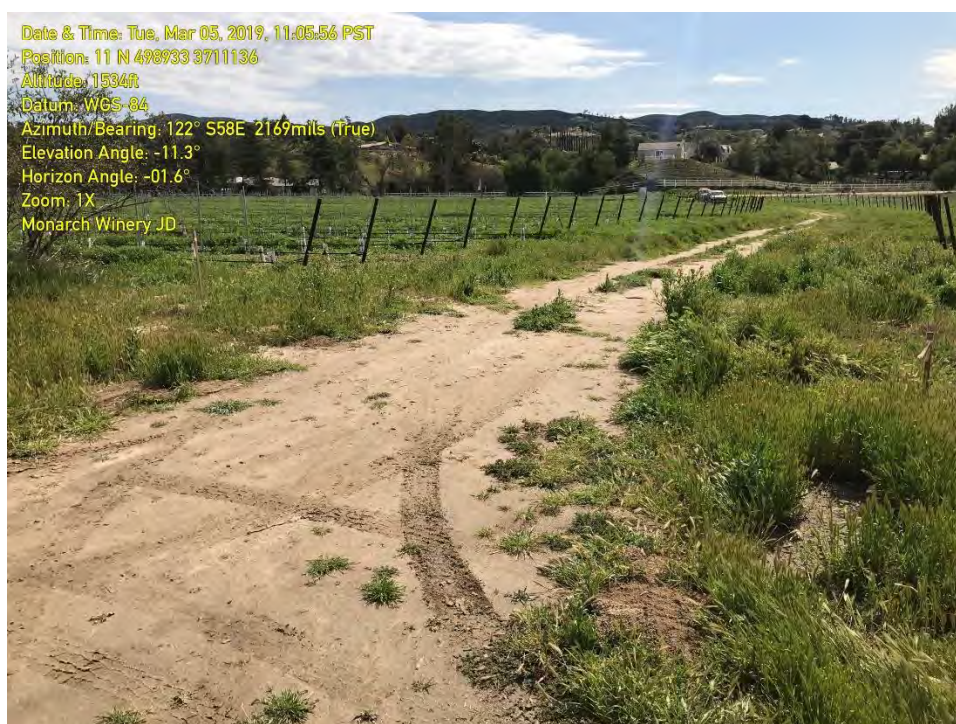
**PHOTOGRAPH 4:** No evidence of flow on the dirt access road.

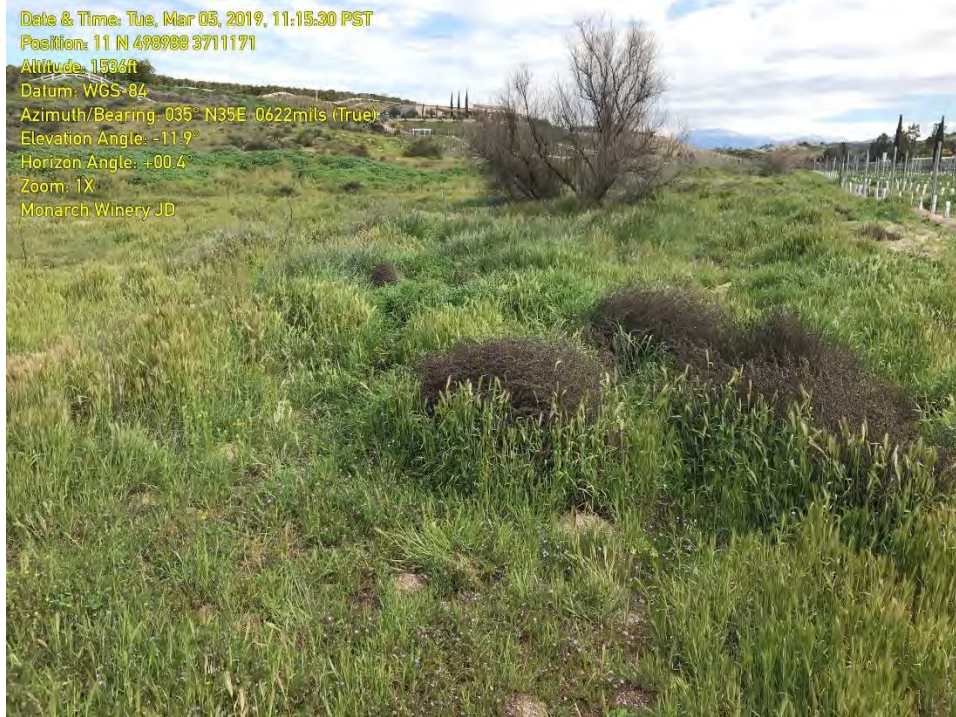
**PHOTOGRAPH 5:** No evidence of flow along the historic flow area of Long Valley Wash in the eastern portion of the Property. A salt cedar in the background.

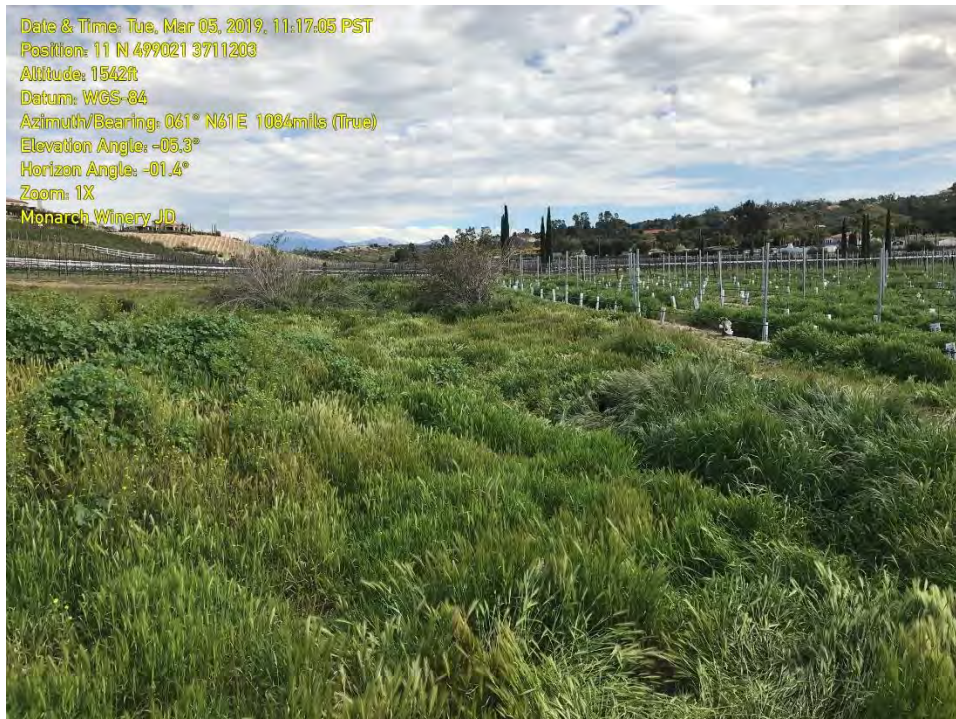
**PHOTOGRAPH 6:** No evidence of flow along the historic flow area of Long Valley Wash in the eastern portion of the Property. Remnant riparian scrub, consisting of mulefat, in the background.

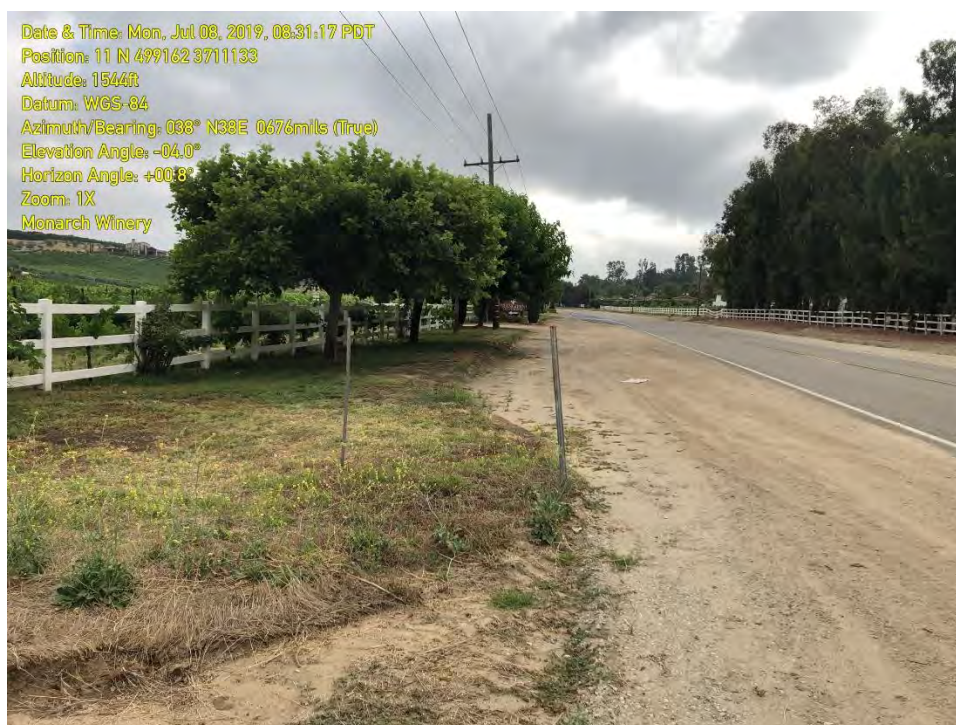
**PHOTOGRAPH 1:** No evidence of flow on the westside of De Portola Road near the northeast Property corner.

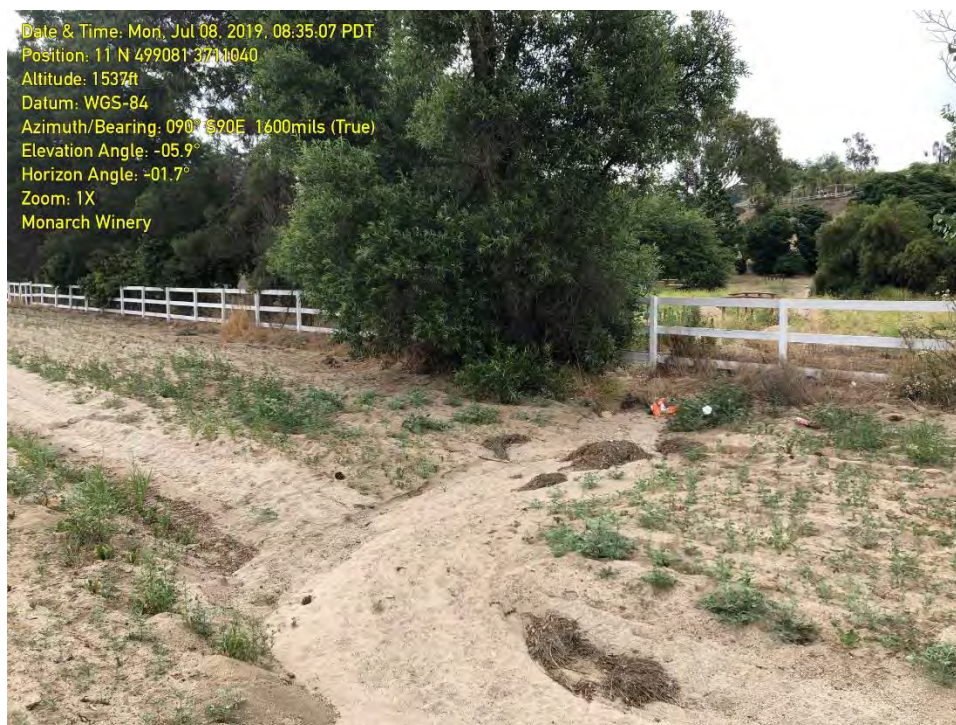
**PHOTOGRAPH 2:** A maintained, roadside drainage and sandy tributary from a nearby yard converge. Black willow in the background along the fence.

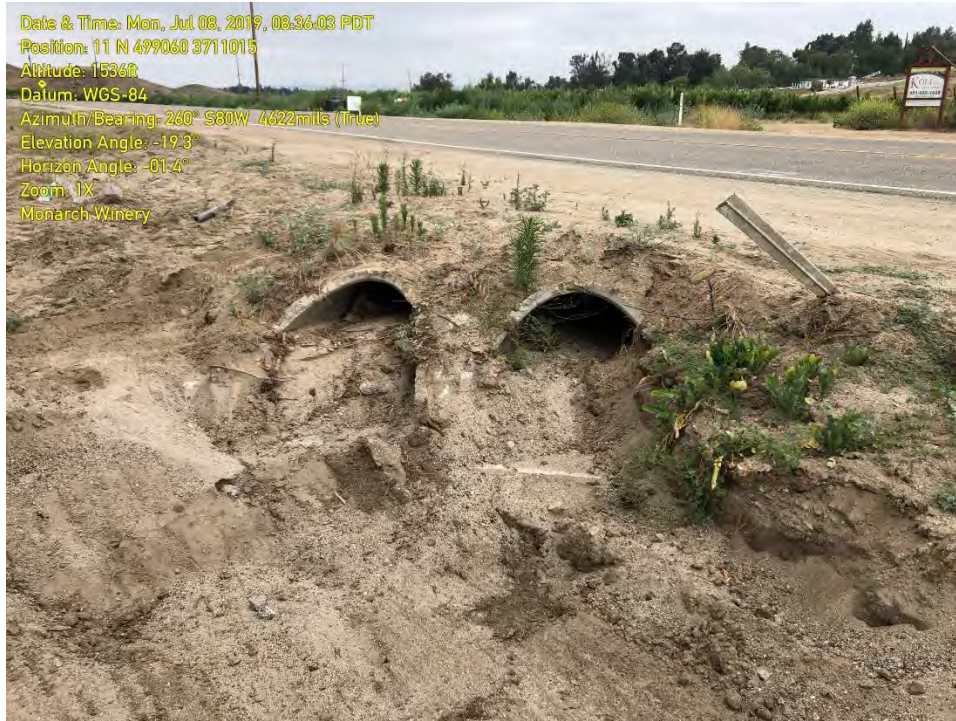
**PHOTOGRAPH 3:** Sediment has built-up within two 24-inch culverts where the roadside drainage enters.

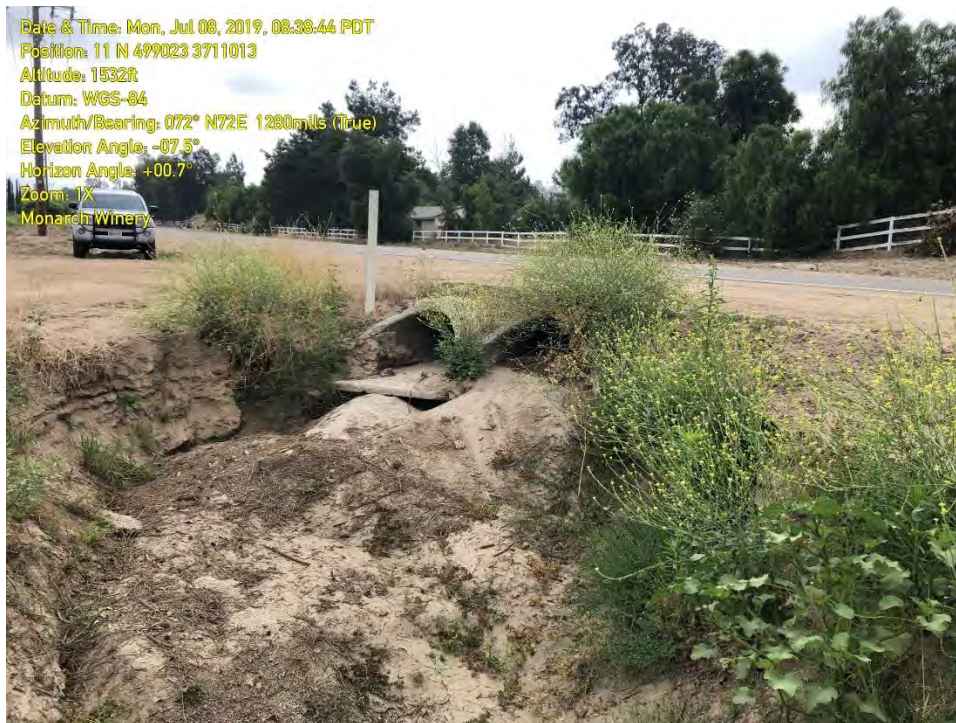
**PHOTOGRAPH 4:** The two 24-inch culverts convey flows into a small collection area near the Site's entrance.

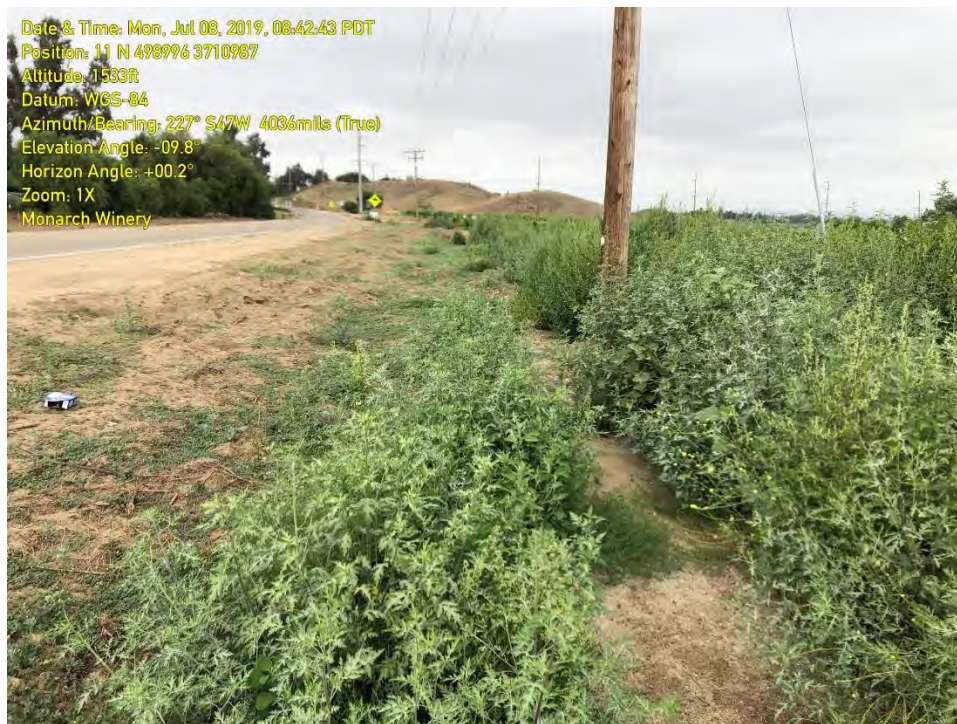
**PHOTOGRAPH 5:** No clear roadside drainage or Riverine feature was present downstream of the culvert conveyance area indicating flows dissipate to sheetflow.

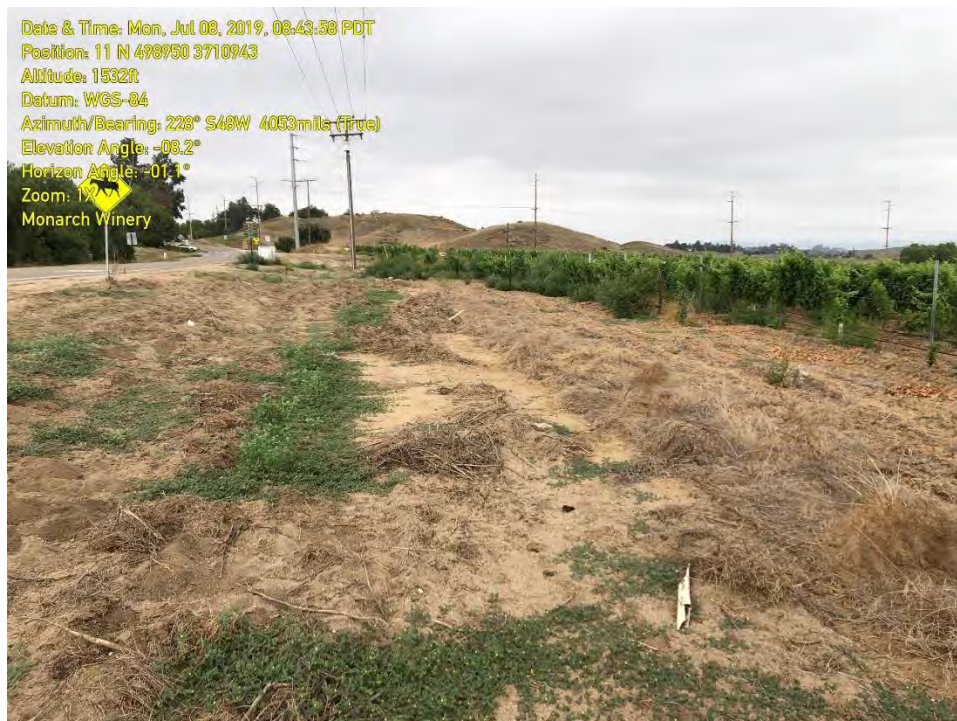
**PHOTOGRAPH 6:** No clear roadside drainage or Riverine feature was present downstream of the culvert conveyance area indicating flows dissipate to sheetflow.

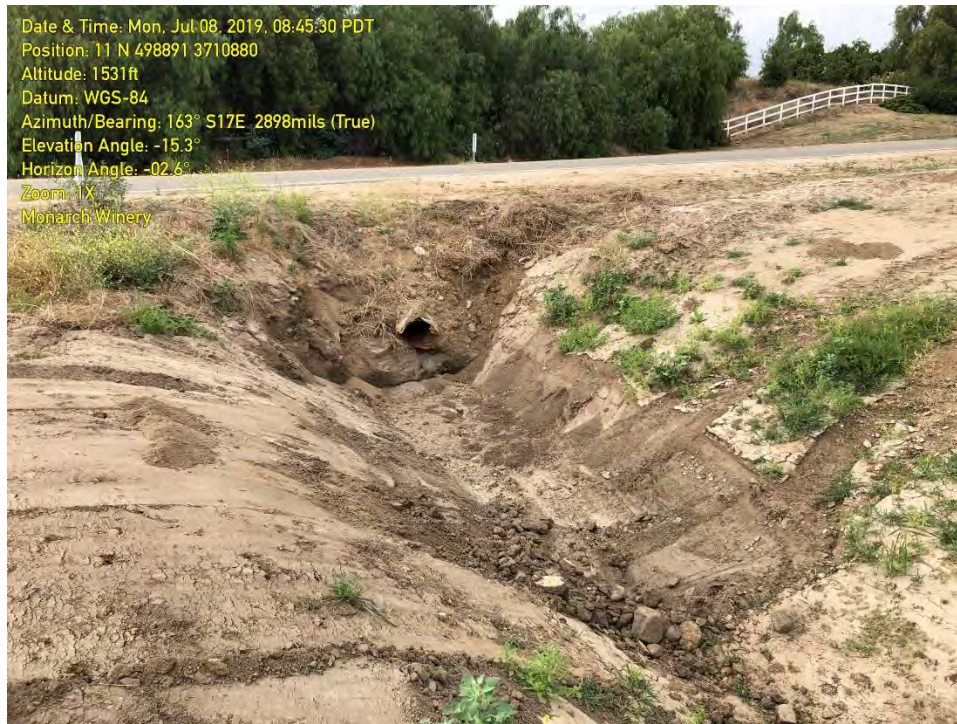
**PHOTOGRAPH 7:** A single 24-inch culvert conveys flows from the eastside of De Portola Road to this collection area.

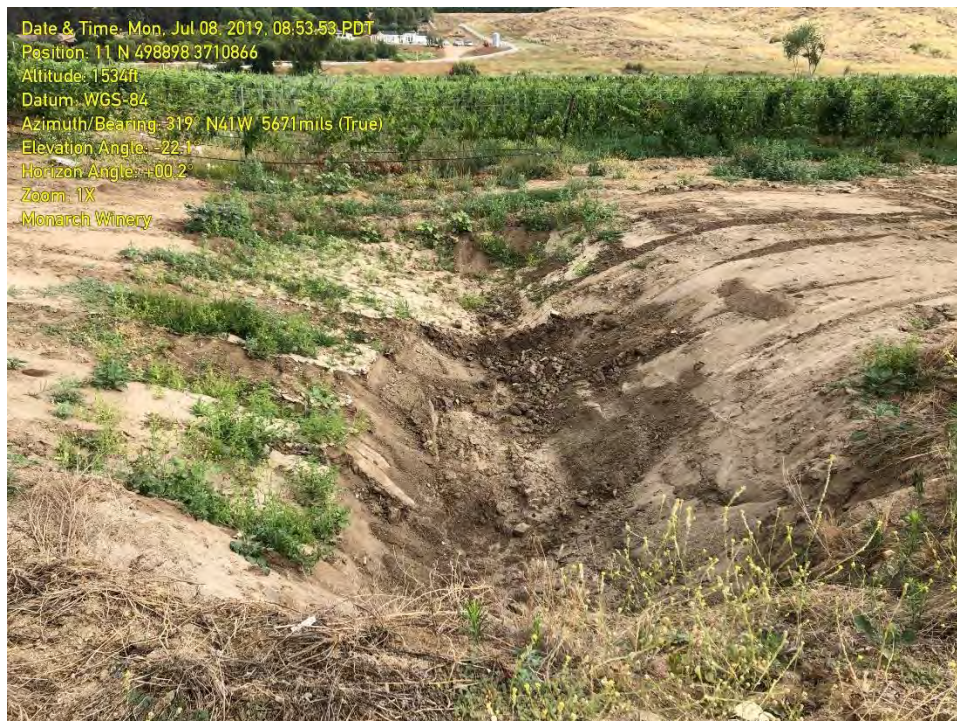
**PHOTOGRAPH 8:** A western view of the collection area. The agricultural swale is located within the vineyard in the background.

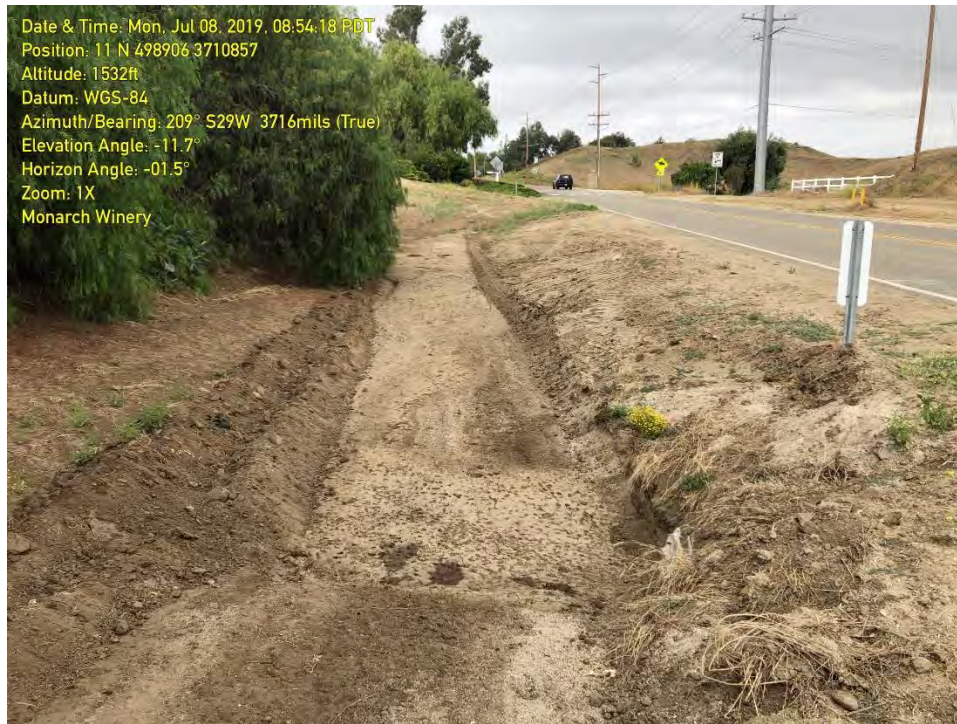
**PHOTOGRAPH 9:** Human-created channel leading into the single 24-inch culvert on the eastside of De Portola Road.

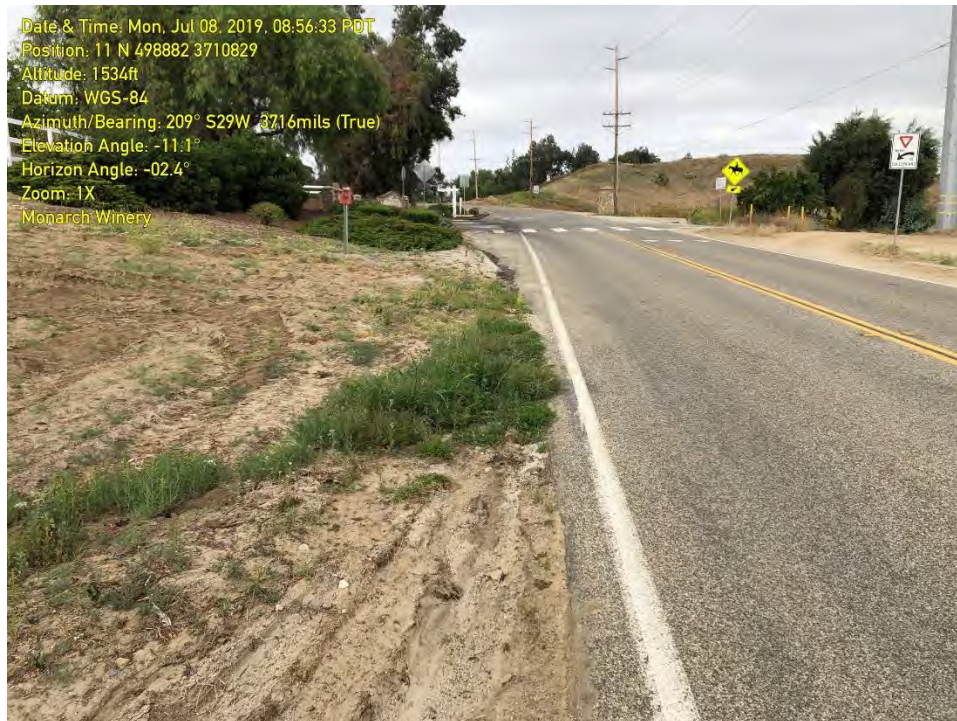
**PHOTOGRAPH 10:** The area where road runoff enters the human-created channel.

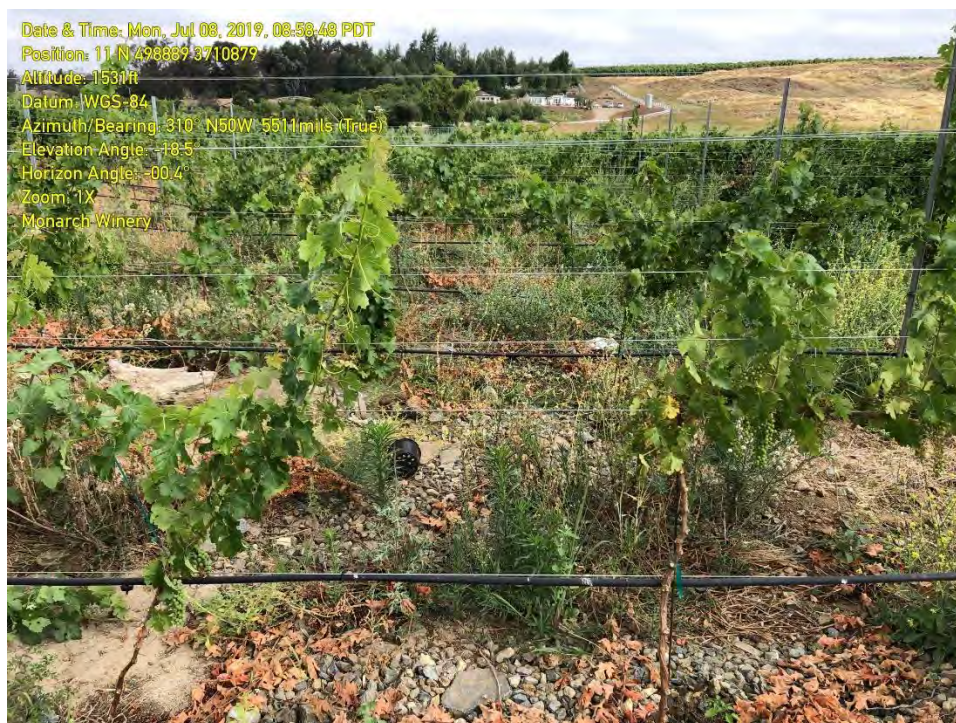
**PHOTOGRAPH 11:** The agricultural swale area within the vineyard.

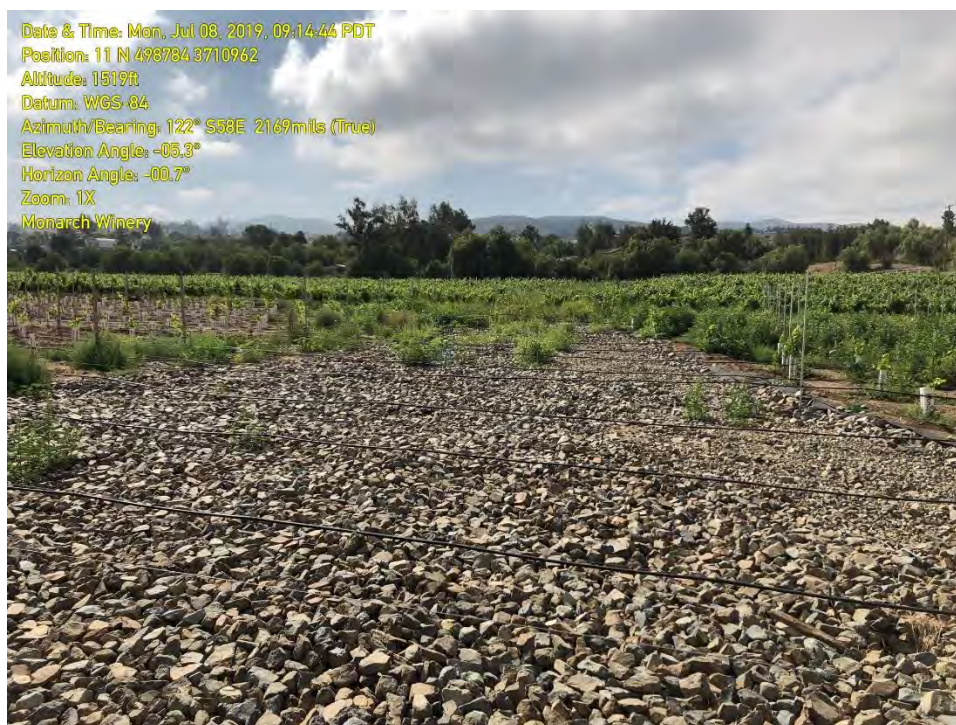
**PHOTOGRAPH 12:** An easterly view of the agricultural swale near its terminus.

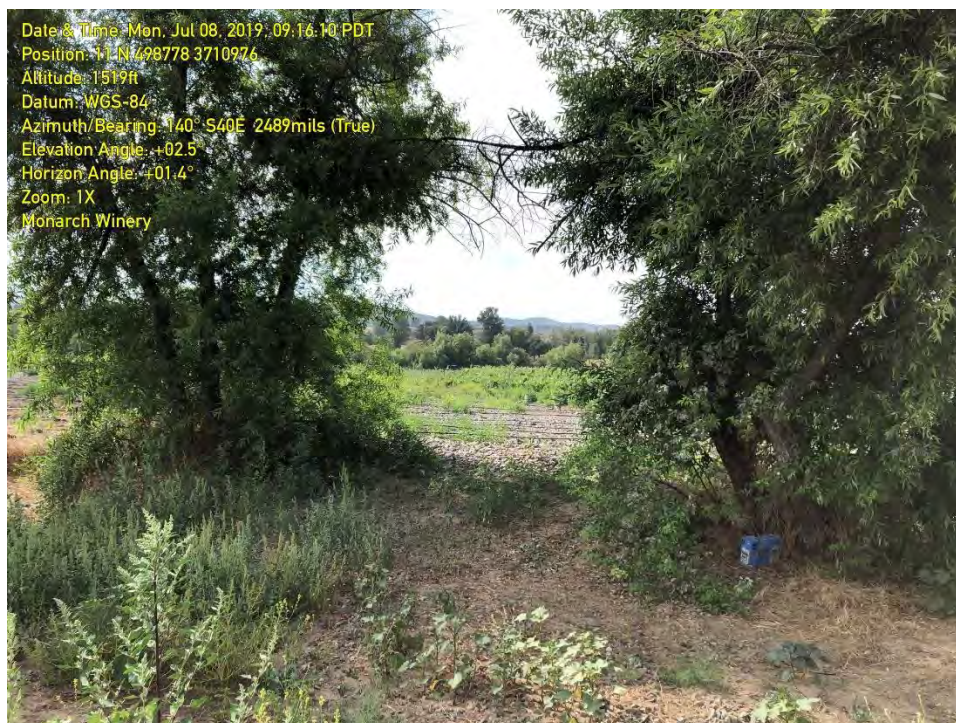
**PHOTOGRAPH 13:** The riparian area downstream of the agricultural swale.

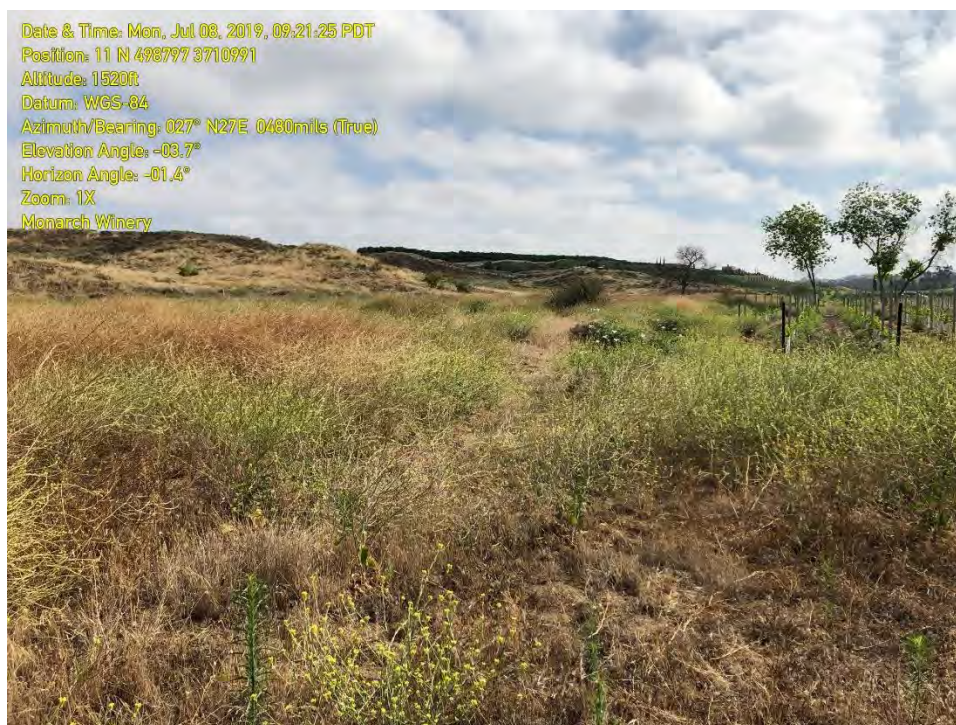
**PHOTOGRAPH 14:** No evidence was observed along the historic flow area of Long Valley Wash in the western portion of the Property.

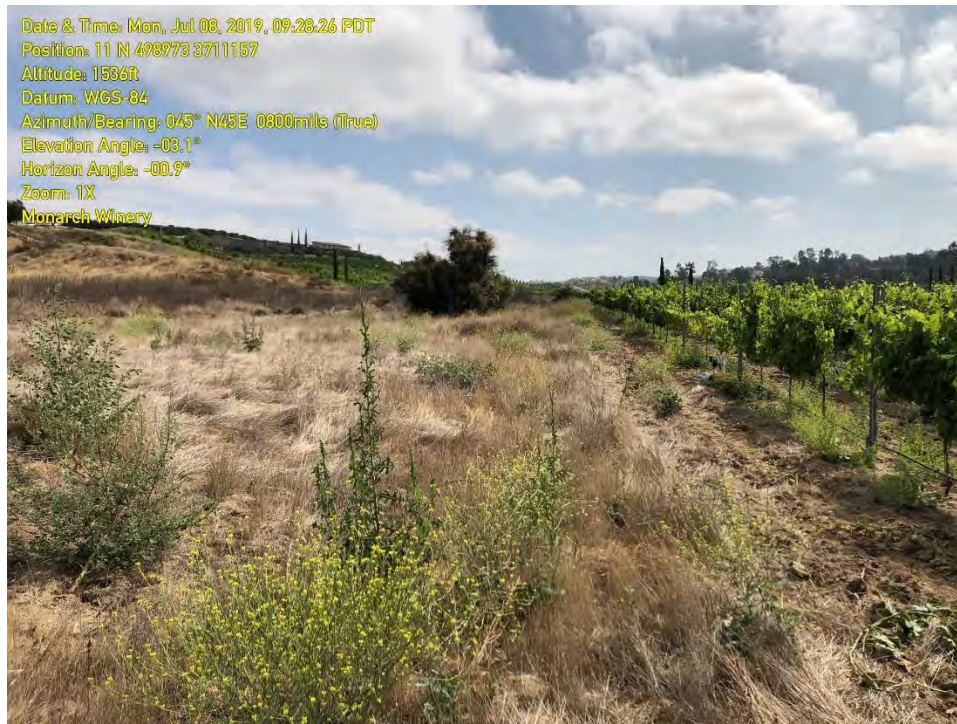
**PHOTOGRAPH 15:** No evidence was observed along the historic flow area of Long Valley Wash in the eastern portion of the Property.

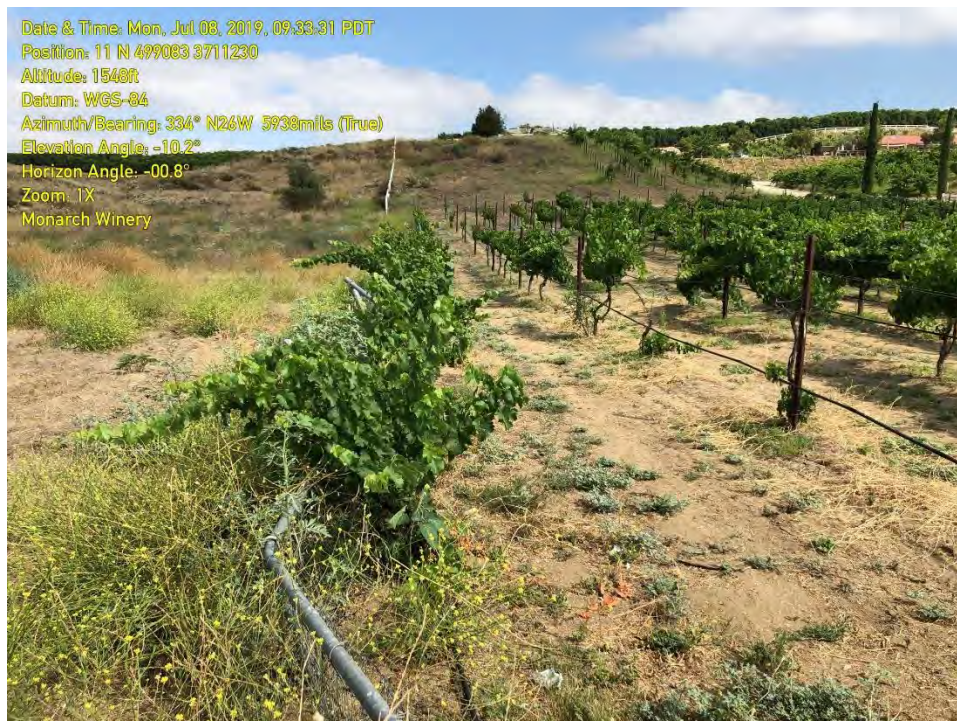
**PHOTOGRAPH 16:** No evidence of recent flow was present along the eastern Property boundary within the historic flow area of Long Valley Wash. It was uncertain if the fence was bent from historic flows or the weight of individual grape plants.

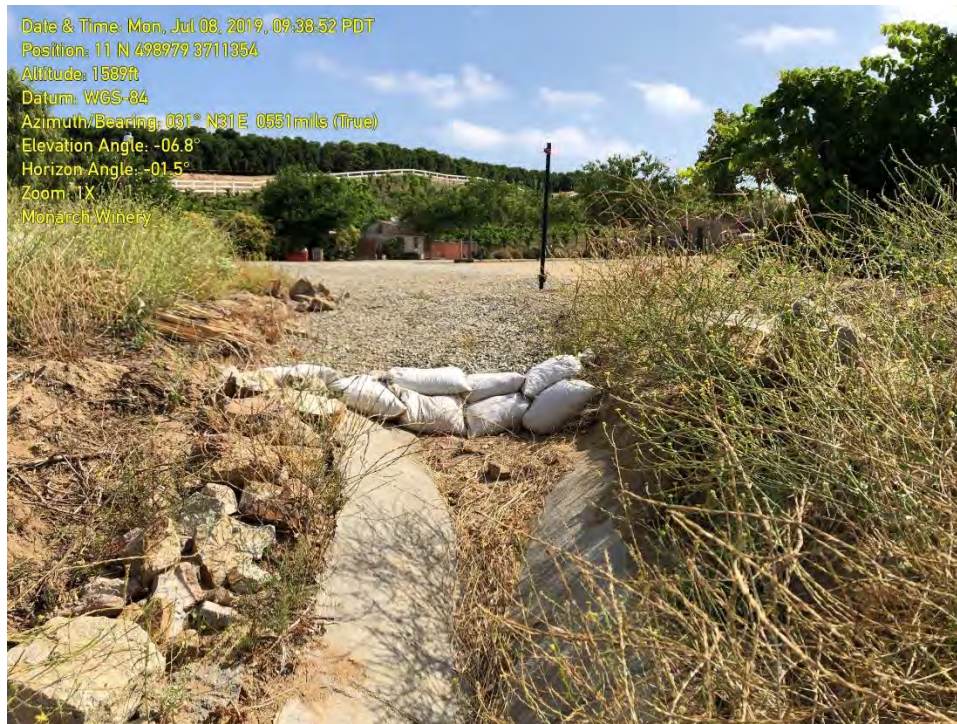
**PHOTOGRAPH 17:** A concrete V-channel and sandbags offsite above where the erosional gully originates.

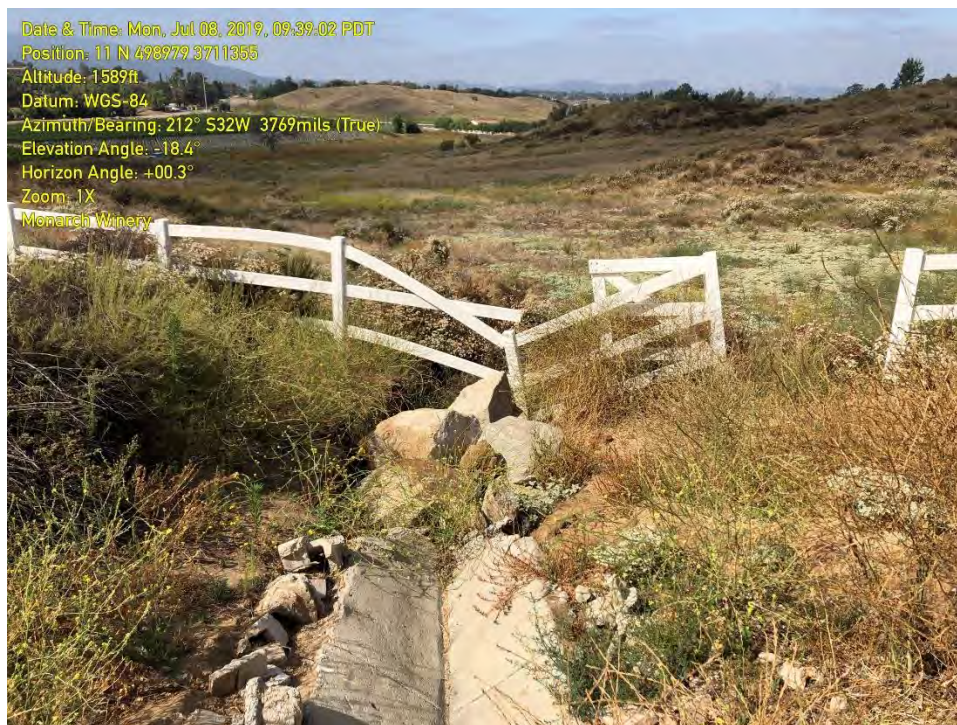
**PHOTOGRAPH 18:** A view of the same area looking downstream towards the Site. The boundary is at the fence.

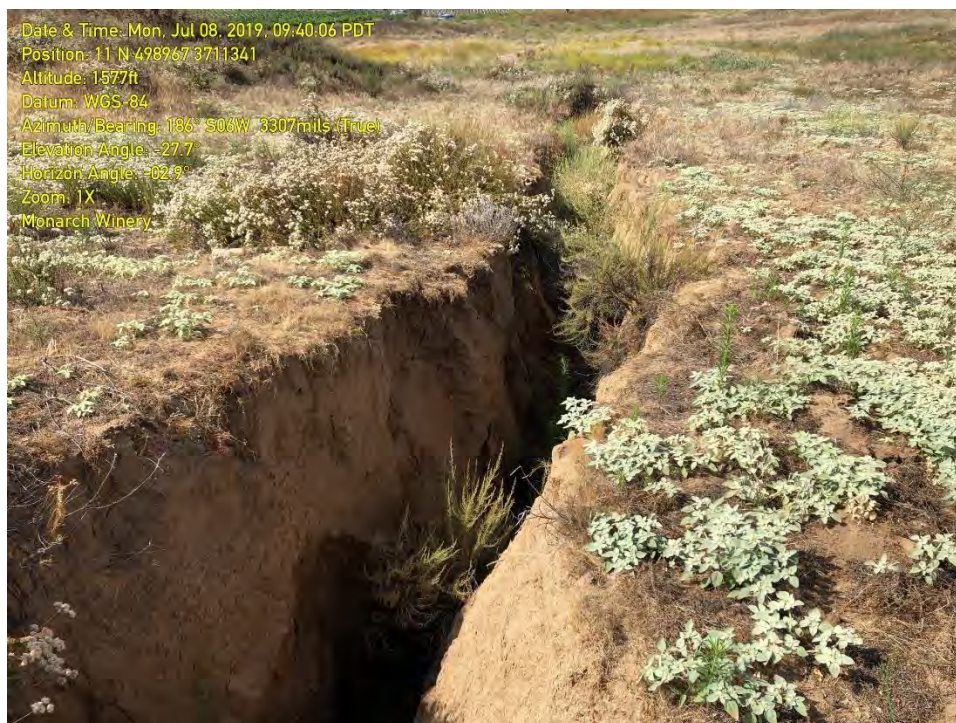
An erosional gully was present in the northeastern portion of the site. It was confined to a small ravine worn away by running water originating from the paved surfaces of the development located adjacent to the northeast corner of the site. The gully was evident for approximately 500-feet where it conveyed storm water runoff downslope before it dissipated on the surface as sheetflow. The gully did not connect to the historic low-flow area of Long Valley Wash and was not clearly evident on the Site in 1967, 1978, or 1996. It was present in 2009 subsequent to the construction of the development offsite.

**PHOTOGRAPH 19:** The erosional gully was deeply incised; typical of gullied lands.

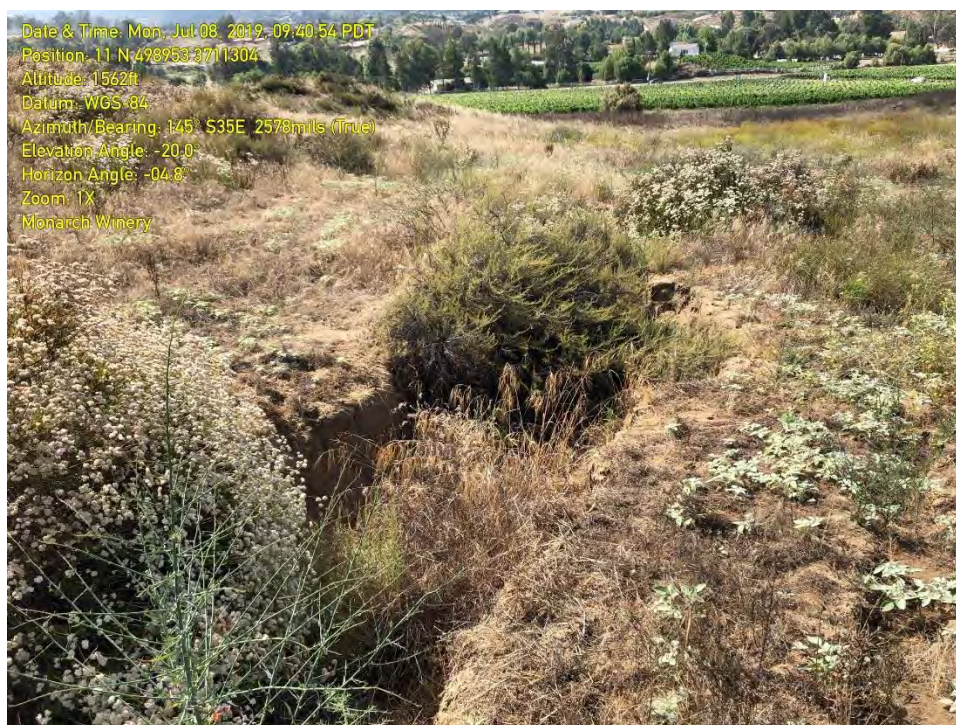
**PHOTOGRAPH 20:** A view of the erosional gully farther downstream.

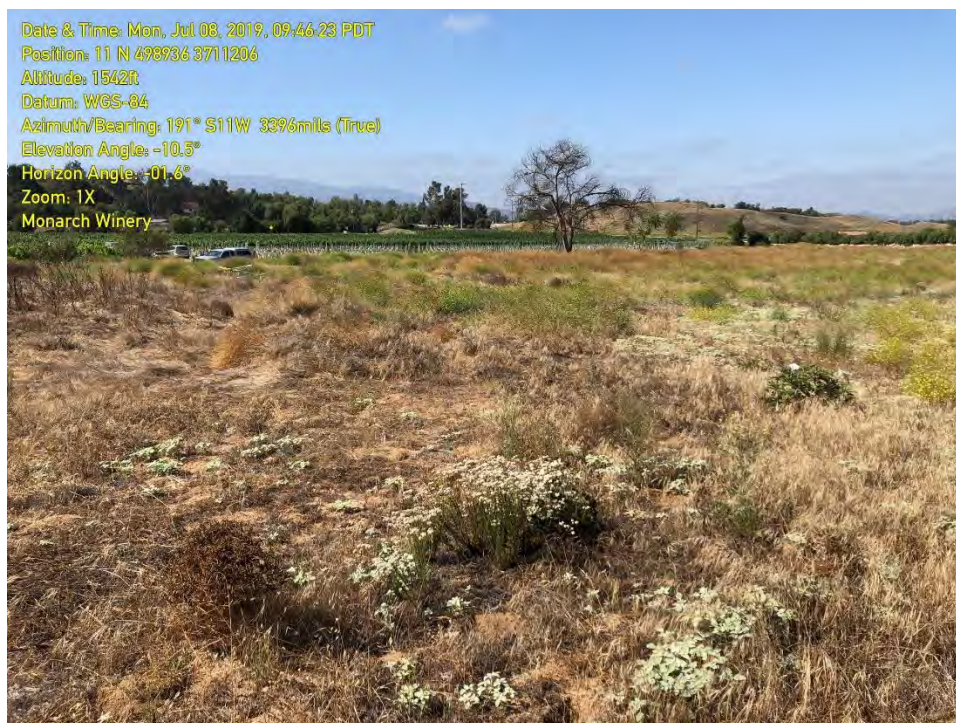
**PHOTOGRAPH 21:** Area downstream of the terminus of the erosional gully. No evidence of flow was present as the feature dissipates to sheetflow.

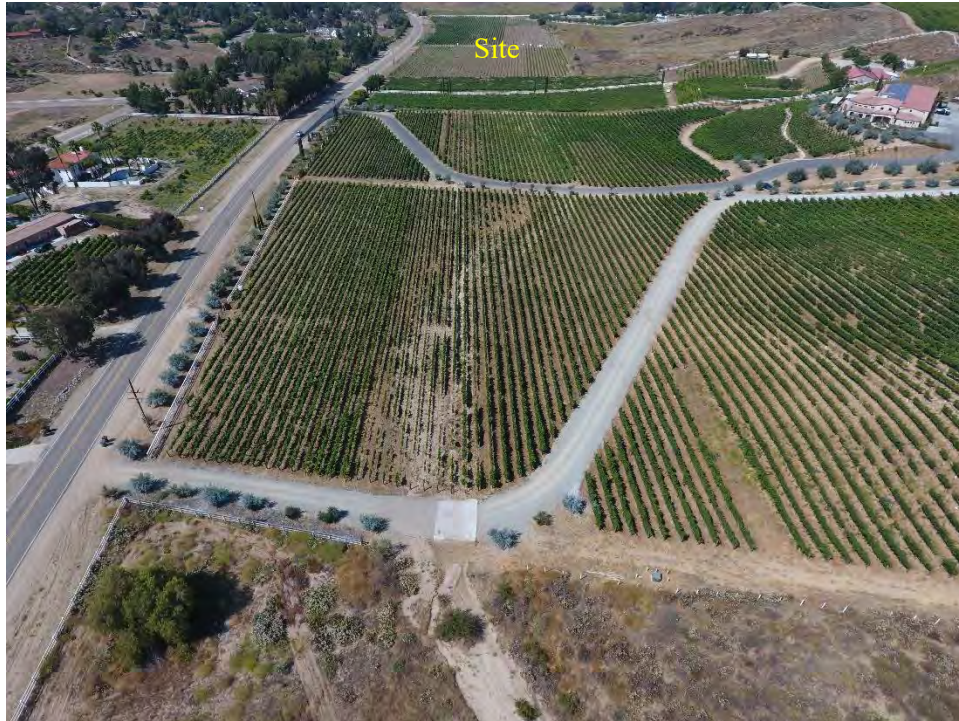
**PHOTOGRAPH 1:** A view of Long Valley Wash upstream of the Site. The “natural” wash enters a vineyard where flows still appear evident.

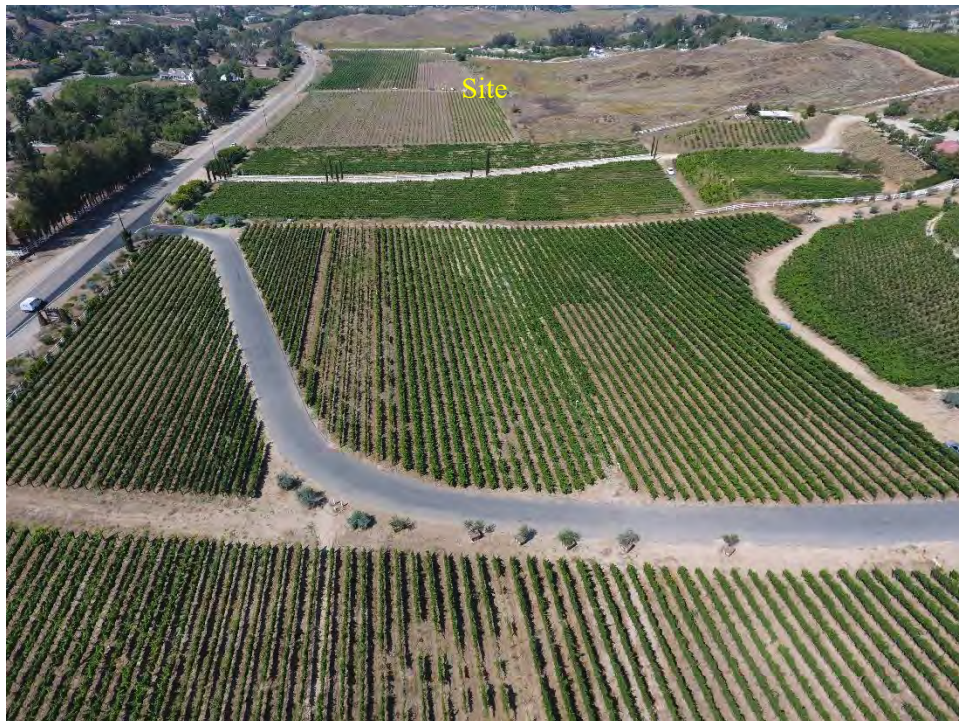
**PHOTOGRAPH 2:** A view of Long Valley Wash upstream of the Site. Evidence of flow begins to weaken.

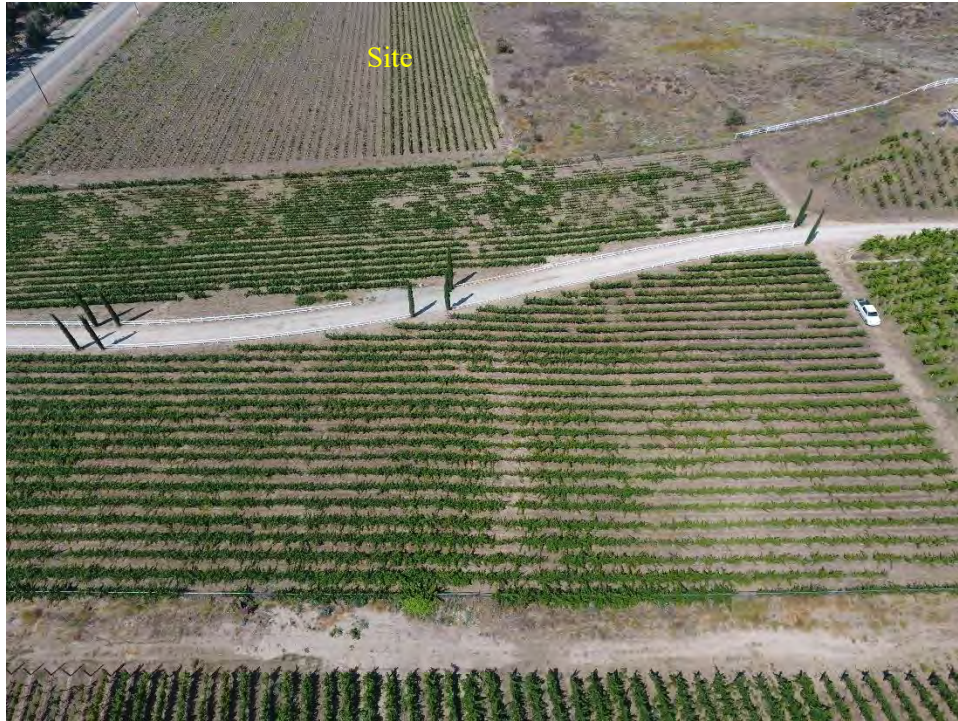
**PHOTOGRAPH 3:** A view of Long Valley Wash upstream of the Site. Flows appear to collect and dissipate east and west in the dirt area not planted with vineyard.

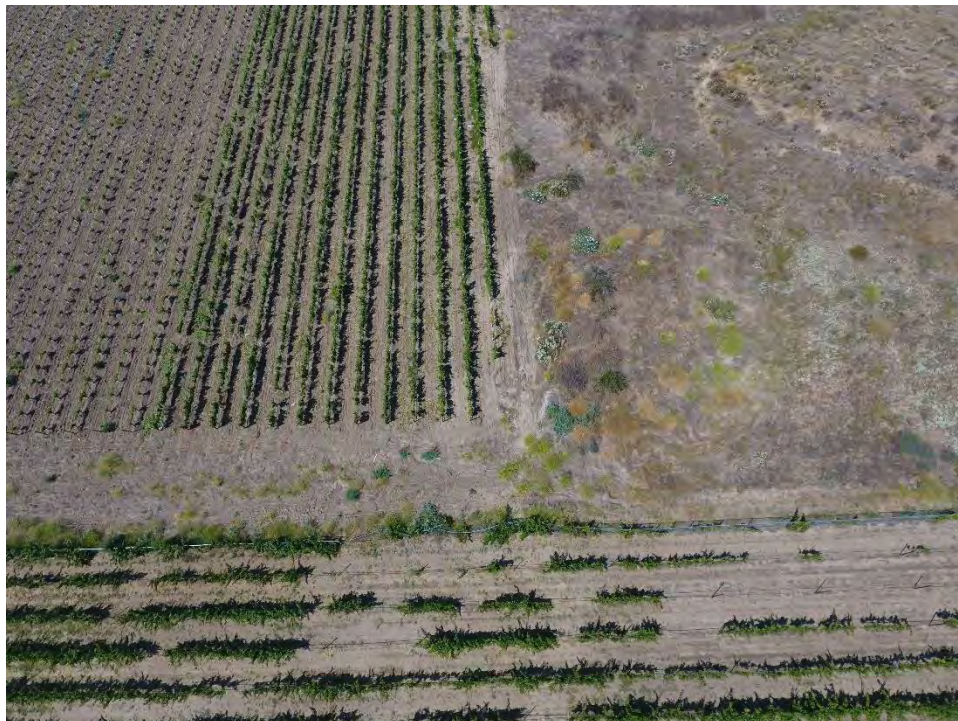
**PHOTOGRAPH 4:** The eastern Property boundary where flows historically entered the Site. No evidence of concentrated flow is present.
