# Western Riverside County Multiple Species Habitat Conservation Plan Section 6.1.2 Addendum Report

Plot Plan 180003

**PLOT PLAN 180003  
ASSESSOR'S PARCEL NUMBER 941-180-032**

**August 27, 2019**

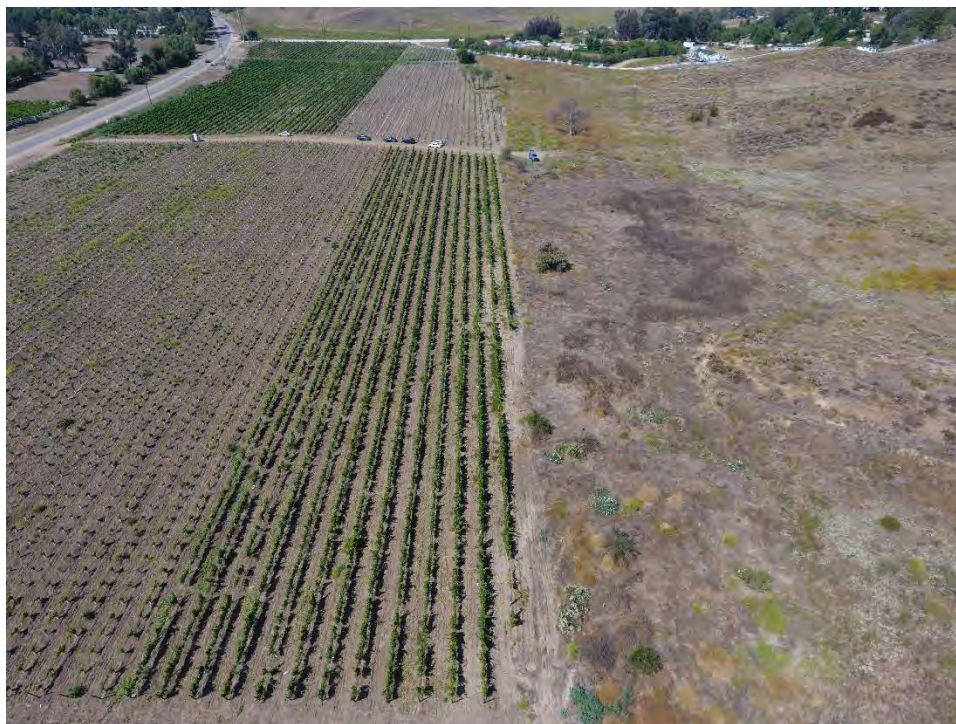
**PHOTOGRAPH 5:** A view of the entire historic flow-line of Long Valley Wash on the Property. No evidence of flow was present.

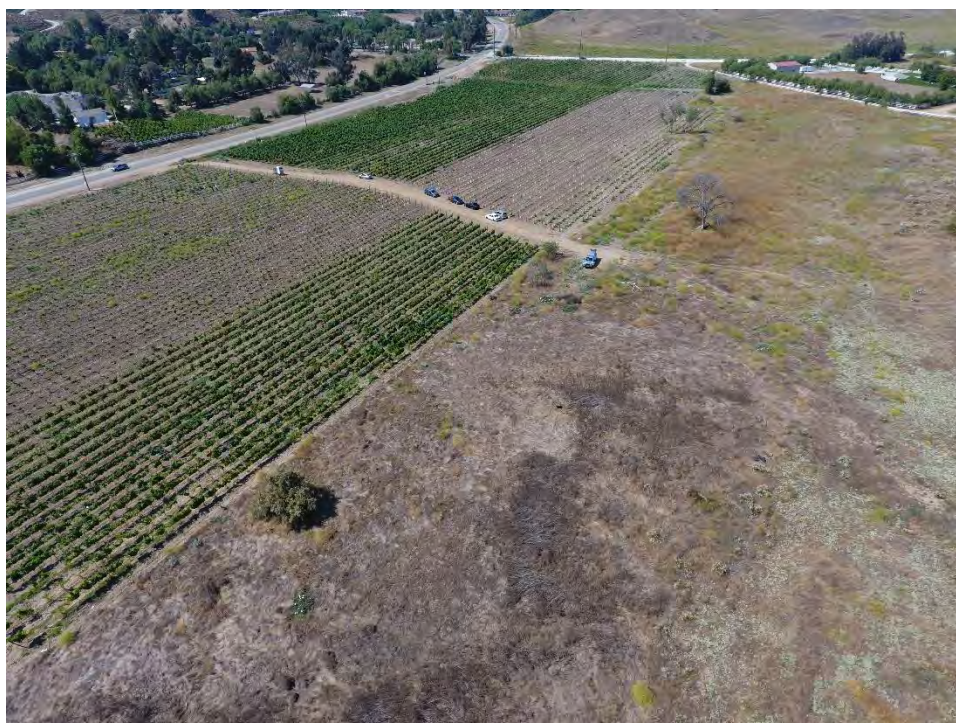
**PHOTOGRAPH 6:** An angled view of the historic flow-line of Long Valley Wash on the Property. No evidence of flow was present.

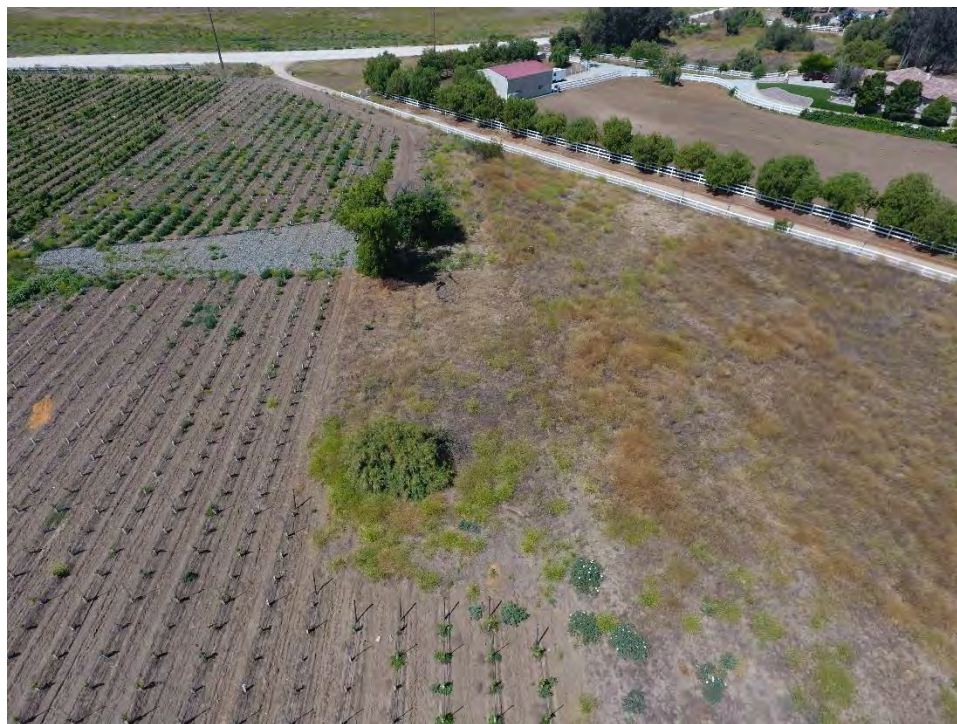
**PHOTOGRAPH 7:** The western portion of the Site where the rock-lined agricultural swale conveys flows to the Riparian/Riverine area.
