**COMBINED JURISDICTIONAL AND AQUATIC RESOURCES DELINEATION
FOR APN 470-070-043 (HAN190029), RIVERSIDE COUNTY, CALIFORNIA**

±9.2-Acre Parcel, ±9.2 Acres Surveyed

APN 470-070-043, HAN190029, St. Johns Canyon Area, Section 13, Township 6 South,
Range 1 West, USGS Hemet 7.5' Topographic Quadrangle Map
San Bernardino Base and Meridian

Report Date: April 22, 2020

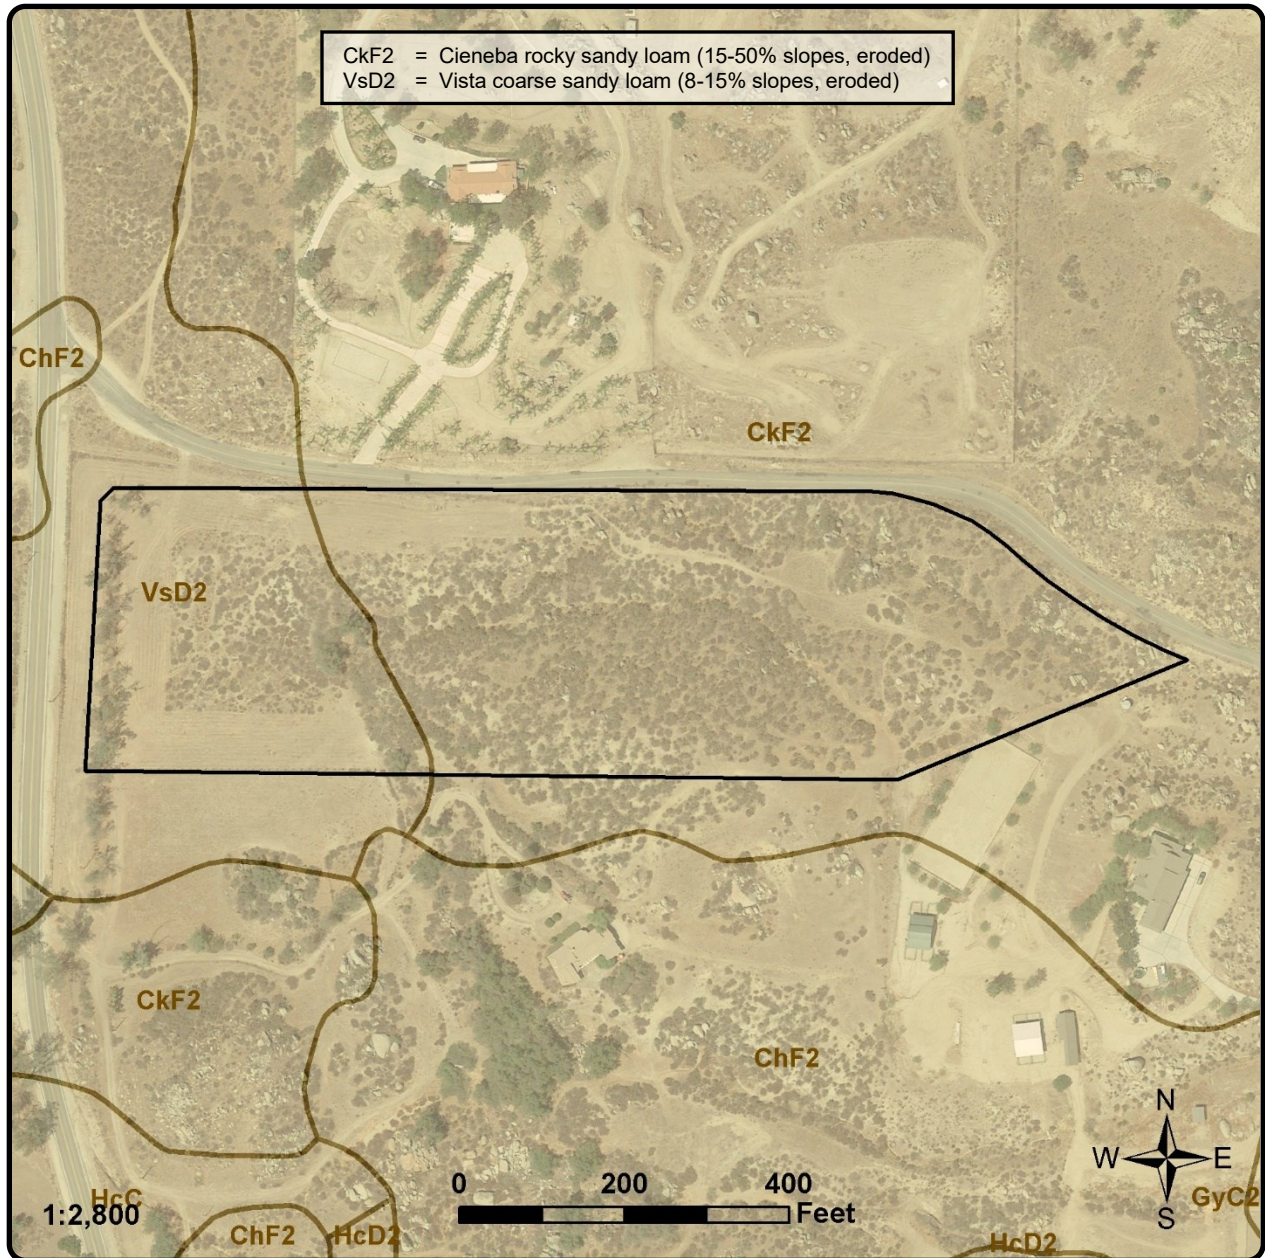
Figure 4
Soils Map
(Aerial obtained from Google Earth, August 2018,
USDA Nat. Res. Cons. Serv. SSURGO Data)

Soils onsite are mapped as Cieneba rocky sandy loam (15-50% slopes, eroded) and Vista coarse sandy loam (8-15% slopes, eroded, see Figure 4). Soils observed matched those mapped. More specifically, the elevation change within the parcel boundary is a total of 127 feet (2,047-1,920) between the eastern boundary corner and the southwestern boundary corner, a distance of 1,340 feet creating a ± 9.5 percent grade. Due to the coarse sand and rocky substrate, drainages are deeply incised and precipitation soaks into the ground within the sandy sloped area at the lowest point (southwest) without leaving the site. Areas outside the parcel that may be incorporated into the project design near the intersection of Sage and Minto and along Sage road are moderately sloped but without defined erosion or drainages.

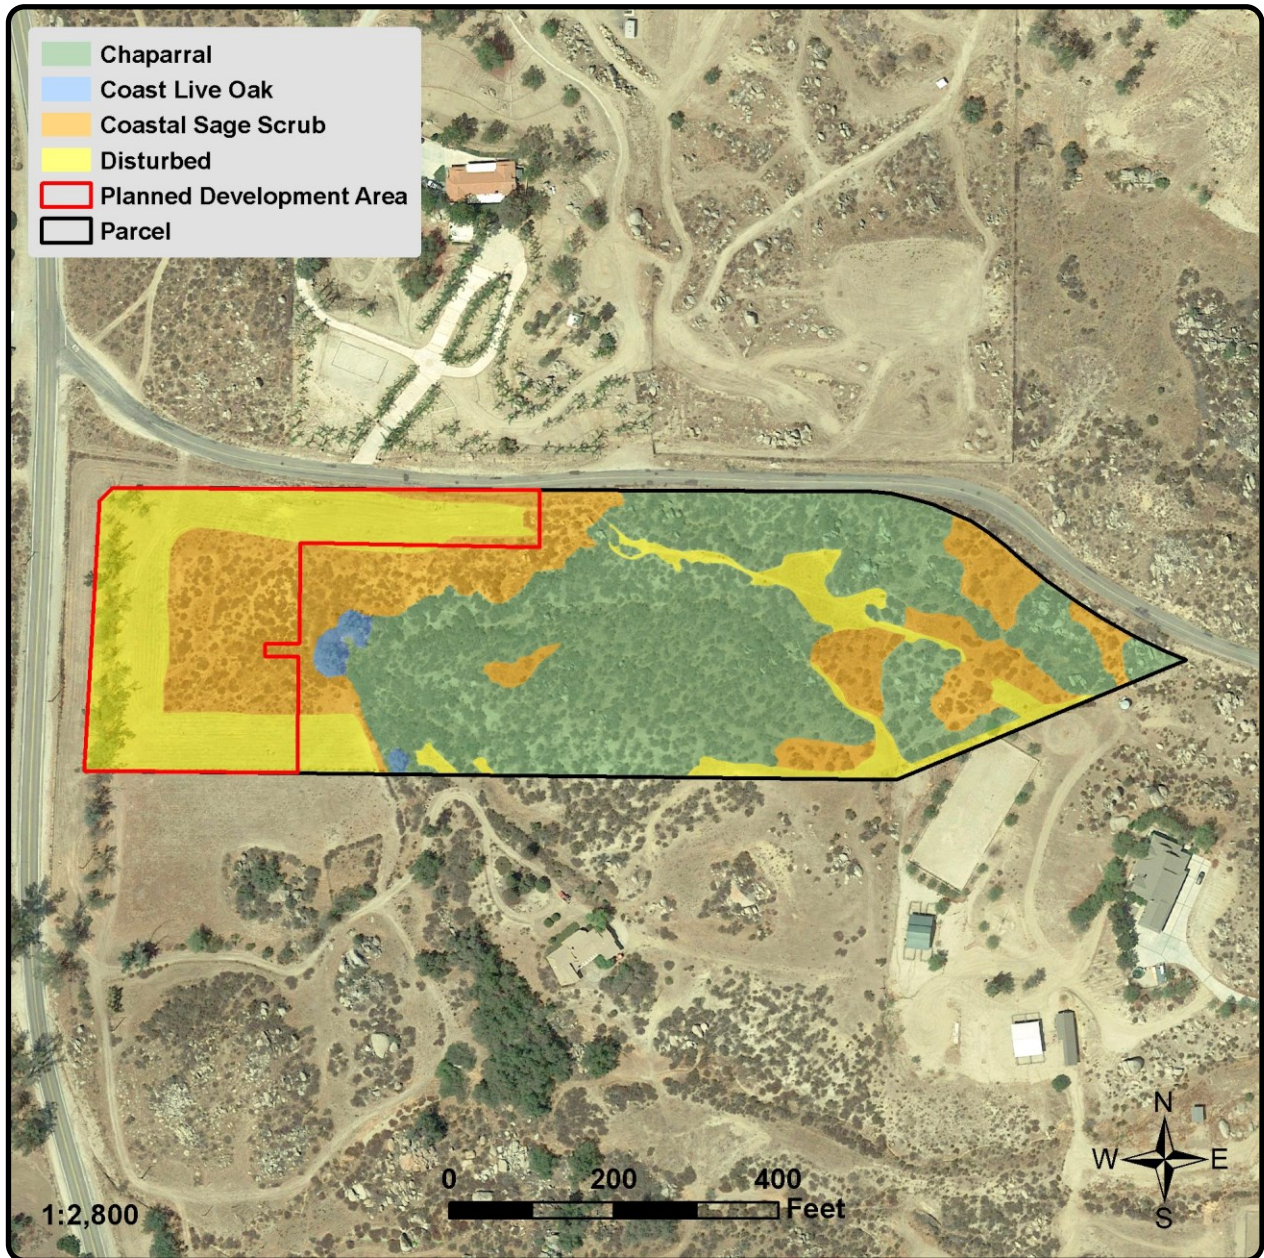
Habitat Map
(Aerial obtained from Google Earth, August 2018)

This habitat type is identified as “Chaparral” in Figure 5. Conspicuous perennials observed in mixed chaparral areas of the site include (but were not limited to) chamise (*Adenostoma fasciculatum*), scrub oak (*Quercus berberidifolia*), hollyleaf redberry (*Rhamnus ilicifolia*), valley cholla (*Cylindropuntia californica*), southern honeysuckle (*Lonicera subspicata*), yellow bush penstemon (*Keckiella antirrhinoides*), and coast figwort (*Scrophularia californica*). Annuals observed in these areas include (but are not limited to) wild cucumber (*Marah macrocarpus*), phacelia (*Phacelia* sp.), chia (*Salvia columbariae*), sapphire woolstar (*Eriastrum sapphirinum*), and fescue (*Festuca* sp.)

This habitat is identified as “Coastal Sage Scrub” in Figure 5. Plants observed include California buckwheat (*Eriogonum fasciculatum*), slender buckwheat (*Eriogonum gracile*), brittlebush (*Encelia farinosa*), blue elderberry (*Sambucus nigra* ssp. *caerulea*), deerweed (*Acmispon glaber*), slender tarweed (*Deinandra fasciculata*), dot-seed plantain (*Plantago erecta*), wreath plant (*Stephanomaria* sp.), and fiddleneck (*Amsinckia menziesii* var. *intermedia*). Various non-native grasses have invaded these areas.

This habitat type is identified as “Chaparral” in Figure 5. Conspicuous perennials observed in mixed chaparral areas of the site include (but were not limited to) chamise (*Adenostoma fasciculatum*), scrub oak (*Quercus berberidifolia*), hollyleaf redberry (*Rhamnus ilicifolia*), valley cholla (*Cylindropuntia californica*), southern honeysuckle (*Lonicera subspicata*), yellow bush penstemon (*Keckiella antirrhinoides*), and coast figwort (*Scrophularia californica*). Annuals observed in these areas include (but are not limited to) wild cucumber (*Marah macrocarpus*), phacelia (*Phacelia* sp.), chia (*Salvia columbariae*), sapphire woolstar (*Eriastrum sapphirinum*), and fescue (*Festuca* sp.)

This habitat is identified as “Coastal Sage Scrub” in Figure 5. Plants observed include California buckwheat (*Eriogonum fasciculatum*), slender buckwheat (*Eriogonum gracile*), brittlebush (*Encelia farinosa*), blue elderberry (*Sambucus nigra* ssp. *caerulea*), deerweed (*Acmispon glaber*), slender tarweed (*Deinandra fasciculata*), dot-seed plantain (*Plantago erecta*), wreath plant

Areas of disturbance are associated primarily with the western, northwestern, and southwestern edge of the parcel where weed abatement occurs (Figure 5). The western edge of the parcel also contains mature Eucalyptus trees along Sage Road. Many weedy non-native plant species have invaded this area, including non-native grasses (*Bromus* spp., *Avena barbata*), mustards (*Hirschfeldia* and *Sisymbrium*), Russian thistle (*Salsola tragus*), tumble pigweed (*Amaranthus albus*), tocolate (*Centaurea melitensis*), and prickly-lettuce (*Lactuca serriola*). Other plants observed in more open and disturbed areas of the site include jimsonweed (*Datura wrightii*), horseweed (*Erigeron canadensis*), and telegraph weed (*Heterotheca grandiflora*).

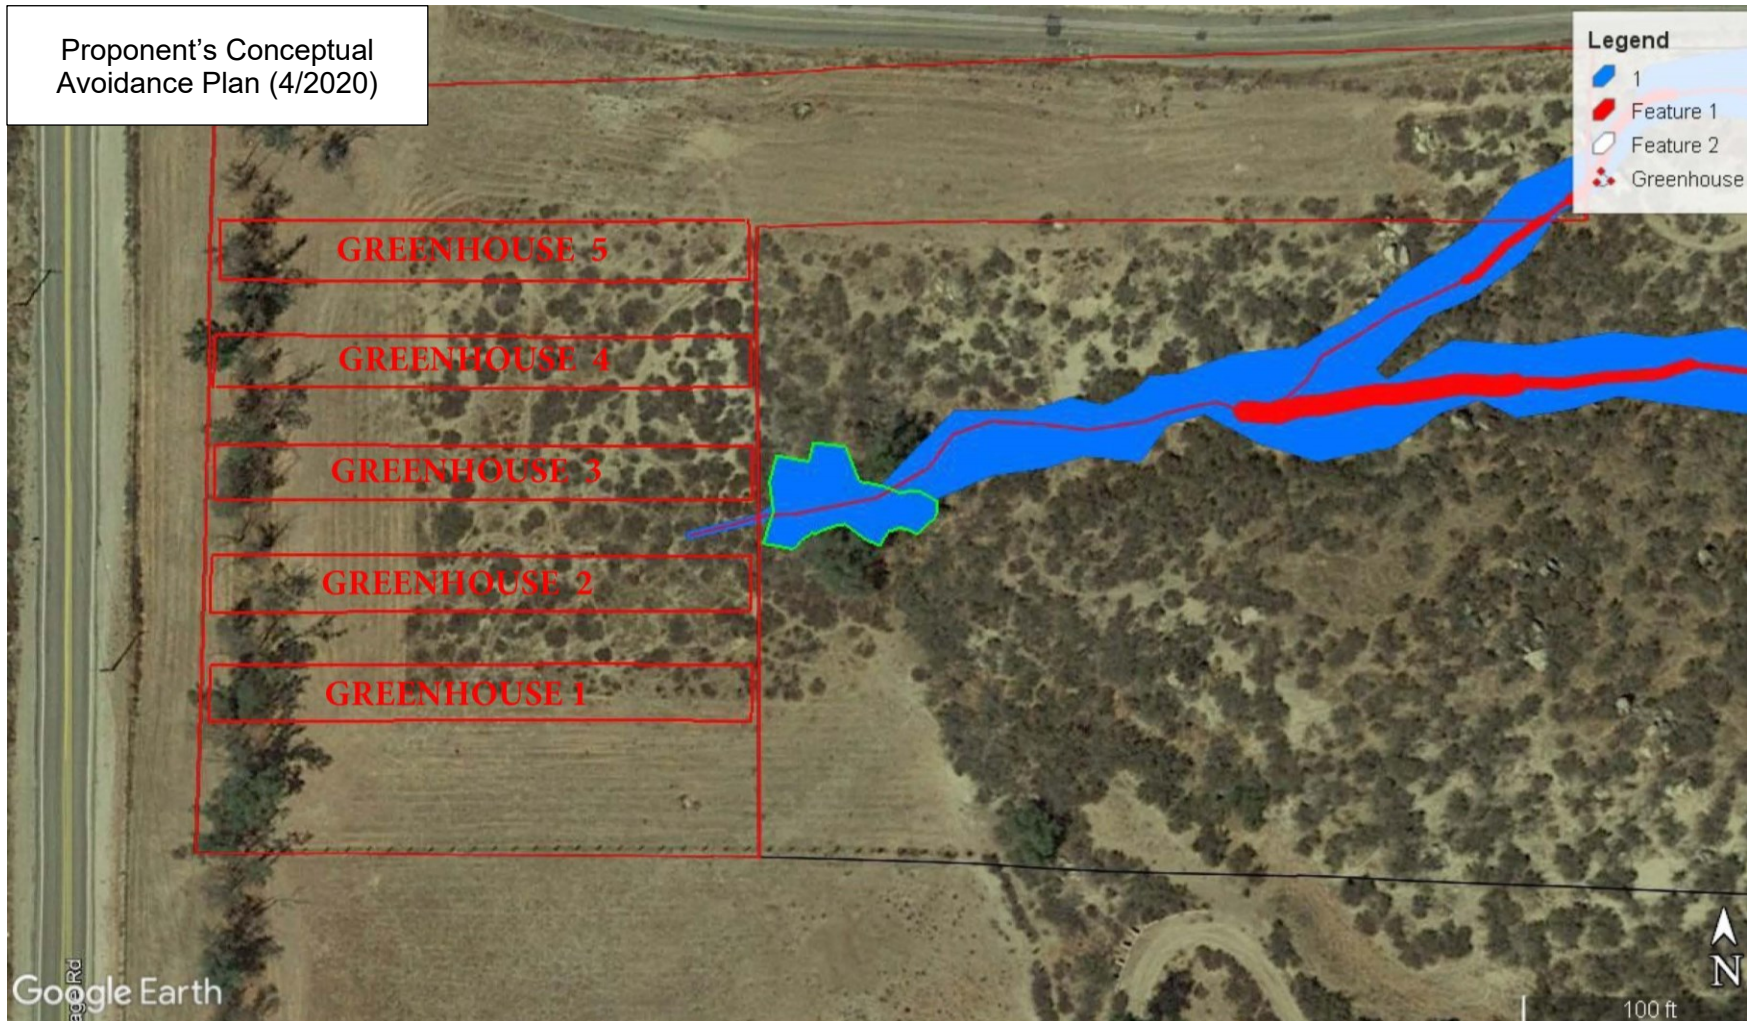
Figure 6. Development Plan

Jurisdictional drainage features are present on the parcel and are planned for avoidance. The owner plans to develop ±2.42 acres and to place ±6.78 acres into conservation. Nearly all of the jurisdictional drainage features are within the 6.7 acres planned for conservation. Aquatic and Streambed Resources present on the parcel include 1,839 lf (0.12 acre) of non-wetland "waters of the U. S." (NWW) and 52,535 sf (1.20 acre) of combined California Streambed and California Wetland. The proponent has redesigned the project to allow for 100% avoidance and conservation of the majority of the drainages within the 6.7 acres. Based on the level of conservation this project alternative is the LEDPA and offers long-term conservation value to Riverside County.

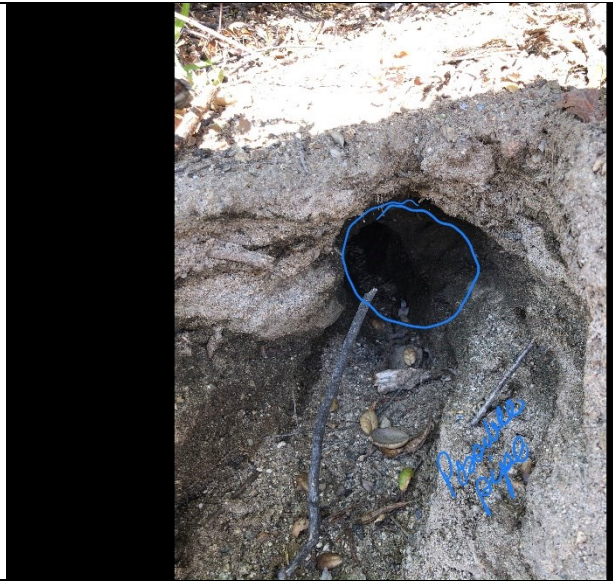
PP 1 Apparent pipe near wetland/riparian area

Flows west of the wetland extend from a 6-8-inch pipe that is present underground at a level ranging in depth between three (3) feet on the upstream end and one (1) foot on the downstream end. Flanking the wetland in the tree layer are two (2) mature oaks located north and south of a single old growth (trunk size exceeding 12 inches in diameter) fallen (prostrate) willow that is partially decayed and separated into two (2) living sections visible on photos. An additional section of the willow (possibly a section of the original willow tree trunk) is located parallel to and overlaying the drainage on the uphill side of the wetland.

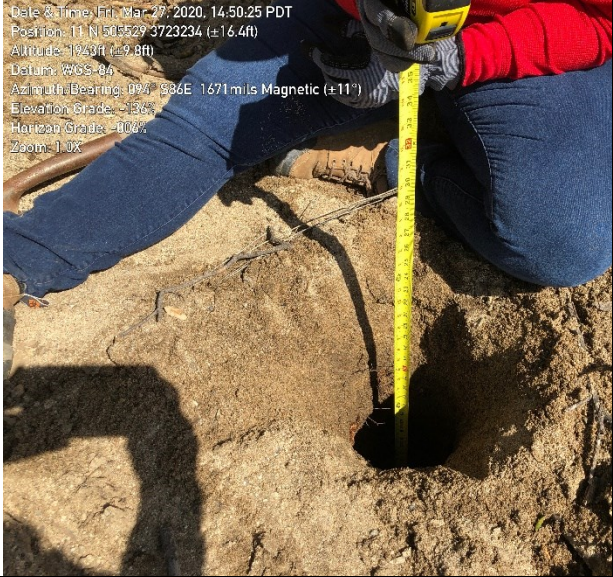
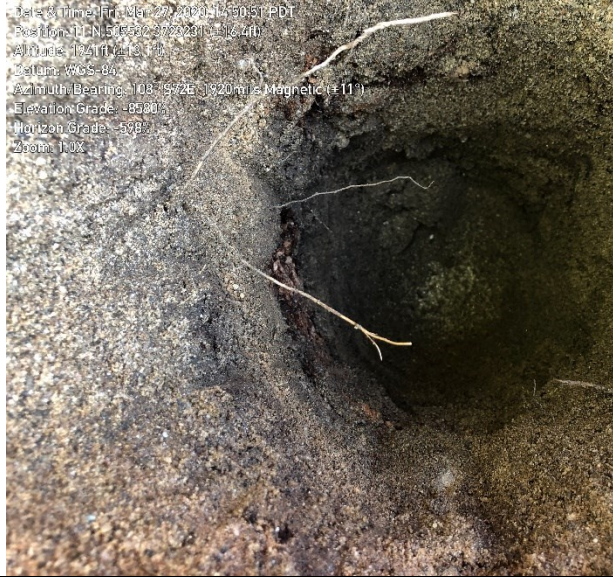
DP #1 Test Pit

Test Pit #1 was excavated to a depth of 20 inches and revealed course sandy soils throughout, with a small area of buried and rotting wood located at about 4 inches below the surface. Soils excavated and in the sidewalls of the pit were well drained with little organic component. Moisture levels were uniform throughout and did not increase with depth. Color ranged from sandy white at the surface to gray and finally brown near to the bottom of the pit.

Test Pit #1 was excavated to a depth of 20 inches and revealed course sandy soils throughout, with a small area of buried and rotting wood located at about 4 inches below the surface. Soils excavated and in the sidewalls of the pit were well drained with little organic component. Moisture levels were uniform throughout and did not increase with depth. Color ranged from sandy white at the surface to gray and finally brown near to the bottom of the pit.

Test Pit #1 was excavated to a depth of 20 inches and revealed course sandy soils throughout, with a small area of buried and rotting wood located at about four (4) inches below the surface. Soils excavated and in the sidewalls of the pit were well drained, with little organic component. Moisture levels were uniform throughout and did not increase with depth. Color ranged from sandy white at the surface to gray and finally brown near to the bottom of the pit.

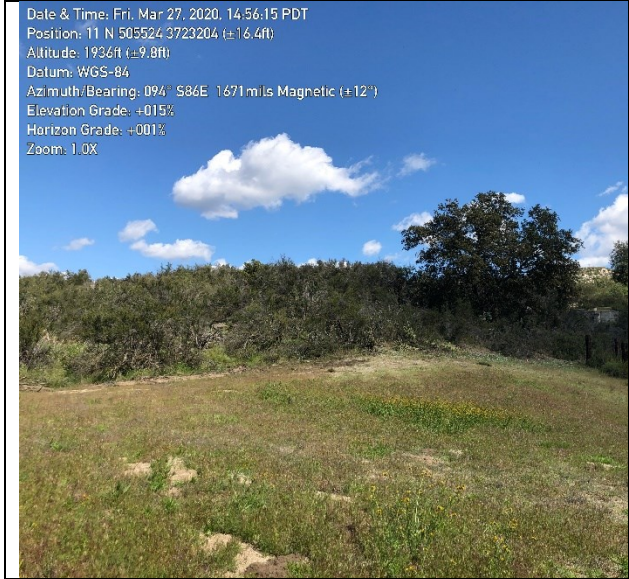
PP 1

DP #1 View looking northeast.

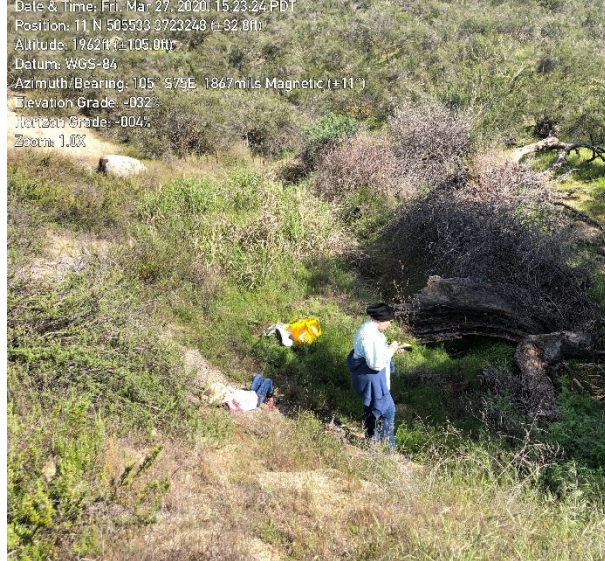
<p>PP 3 looking east (Drainage 1)</p>	<p>PP4 looking east (Drainage 1)</p>
<p>Date & Time: Fri, Mar 27, 2020, 16:57:40 PDT Position: 11 N 505767 3723280 (+32.0ft) Altitude: 2000ft (+52.5ft) Datum: WGS-84 Azimuth/Bearing: 295° N65W 5266mils Magnetic (+14°) Elevation Grade: +027% Horizon Grade: +003% Zoom: 1.0X</p>

Feature 1 ranges in width between 1-5 feet with cut vertical sidewalls that range in height from 3 inches at trail crossing to as deep as 4 feet within the steeper walled portions. The deepest cuts are within loamy soils with annual grass cover and the shallowest cutting occurs near granite rock boulders that range in size from 3-10 feet in diameter.

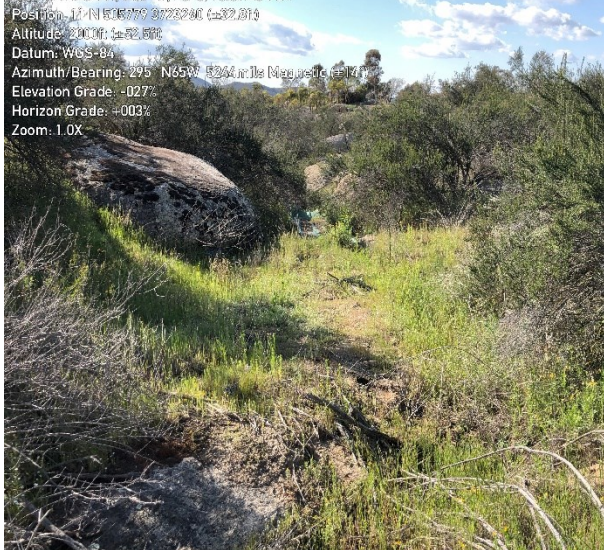
<p>Date & Time: Fri, Mar 27, 2020, 16:01:12 PDT Position: 11 N 505736 3723209 (+16.4ft) Altitude: 2008ft (+9.8ft) Datum: WGS-84 Azimuth/Bearing: 146° S34E 2596mils Magnetic (+12°) Elevation Grade: +005% Horizon Grade: +001% Zoom: 1.0X</p>

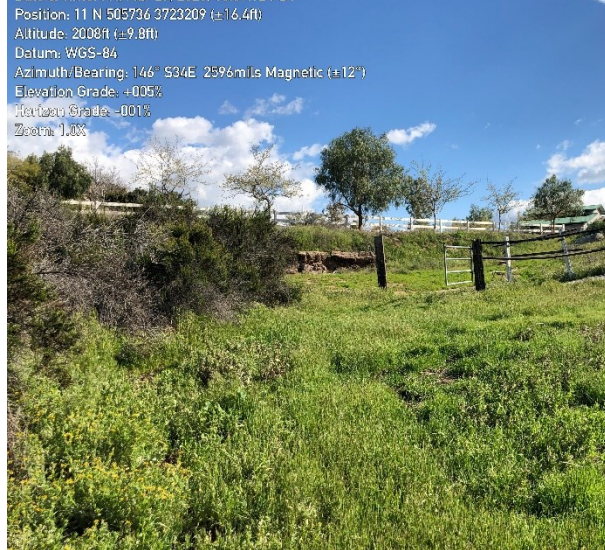
<p>PP 5 looking west (Drainage 1a)</p>	<p>PP 6 looking southwest (top of D 1a)</p>

Riverine Feature #1a begins at a graded and disturbed area along the southeastern parcel boundary, just downhill from an adjacent ranch. Riverine Feature #1a flows west and then curves north to connect with Riverine Feature #1, just upstream of the riparian area.

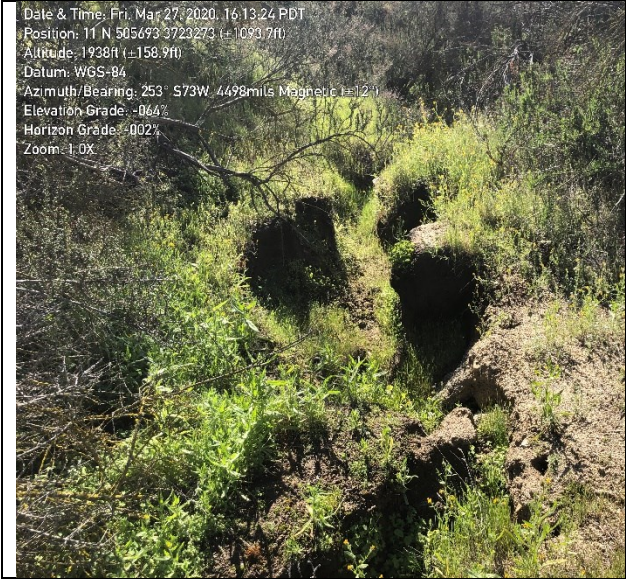
PP 7 looking west (D 1a)

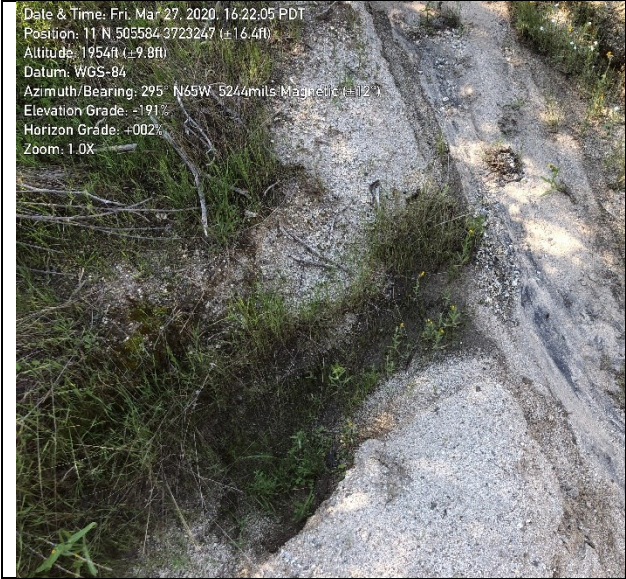
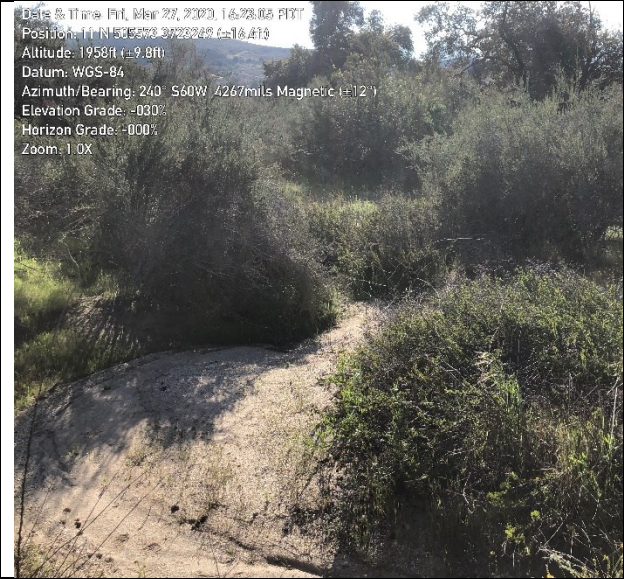
PP 11 Merge Point of D1 and D1a

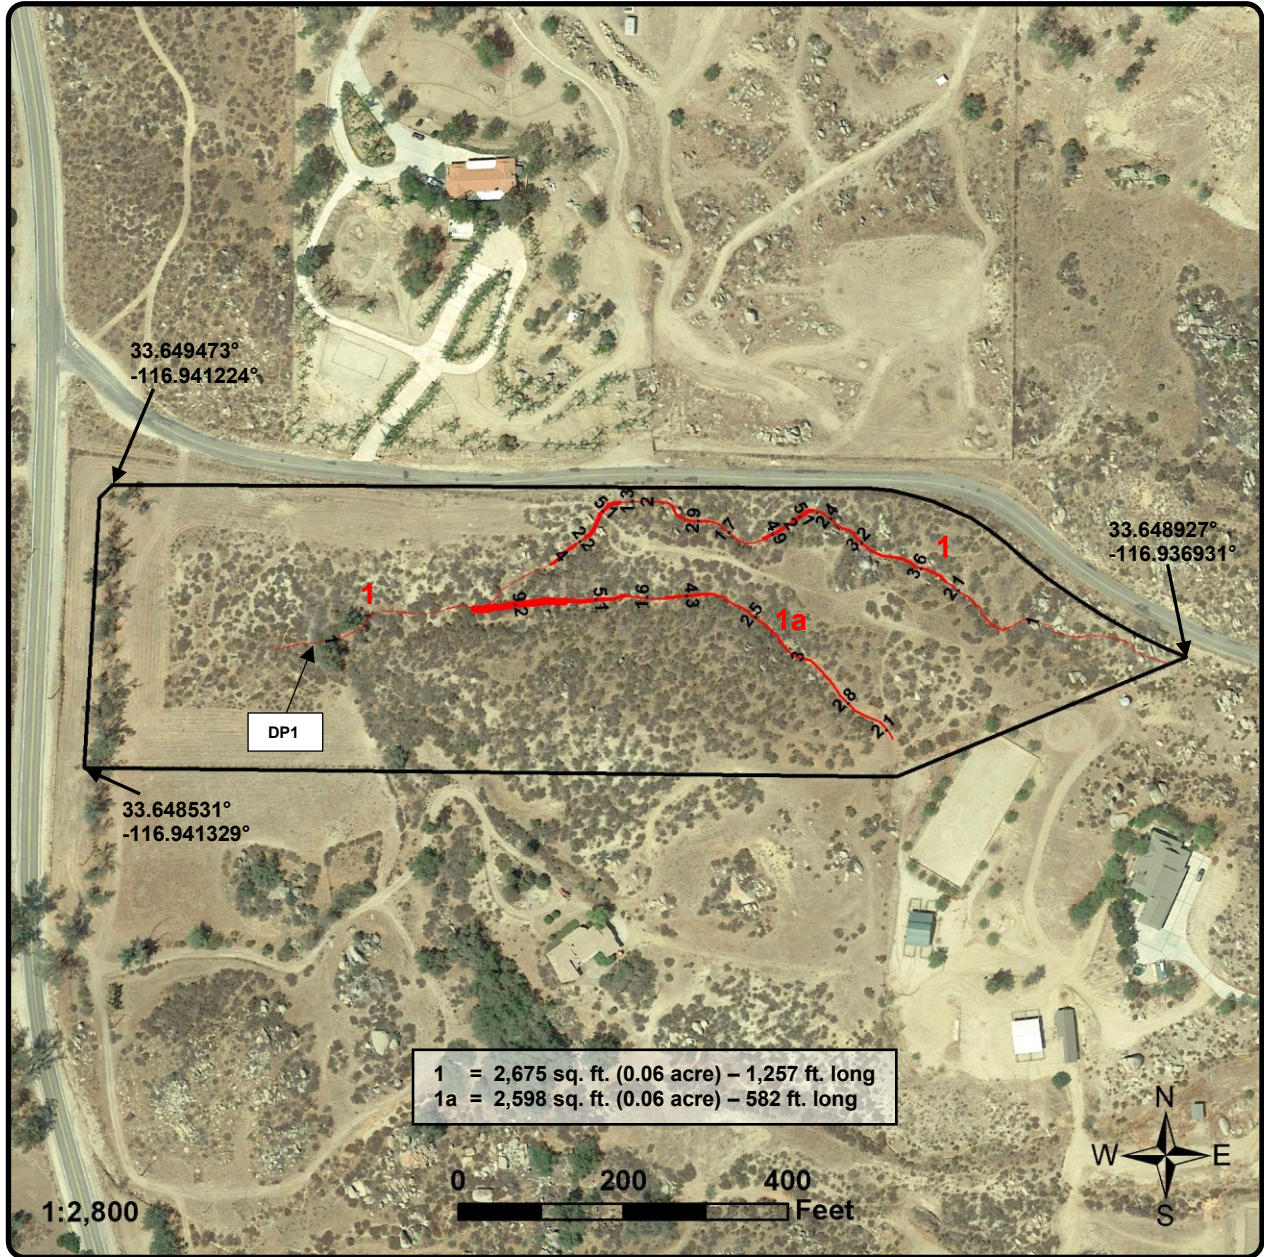
At the terminal end of the erosional feature, just uphill and generally west of the planned impacts, a small area of state wetland is present (Figure 7). Vegetation in this area consists of a single prostrate willow flanked on the toe of slope to the north and south by mature oaks. The understory contains poison oak and wild cucumber, *Amsinckia*, giant wild rye, and non-native annual grasses. A branch of the willow has re-sprouted, forming two (2) living sections. The remaining portions of the tree, including the trunk, are scattered around the wetland and are well rotted and decomposing. The area of this wetland has been combined into the overall jurisdiction for CDFW.

L&L found 52,535 sf (1.20 acre) of combined California Streambed and California Wetland present within onsite. Included within the limits of the California State Streambed are federal Aquatic Resources of 1,839 lf (5273 sf/0.12 acre) of non-wetland waters of the U. S. (NWW).
