# Jurisdictional Delineation Report

# **JURISDICTIONAL DELINEATION REPORT**

**MONARCH WINERY  
RIVERSIDE COUNTY, CA  
ASSESSOR'S PARCEL NUMBER 941-180-032**

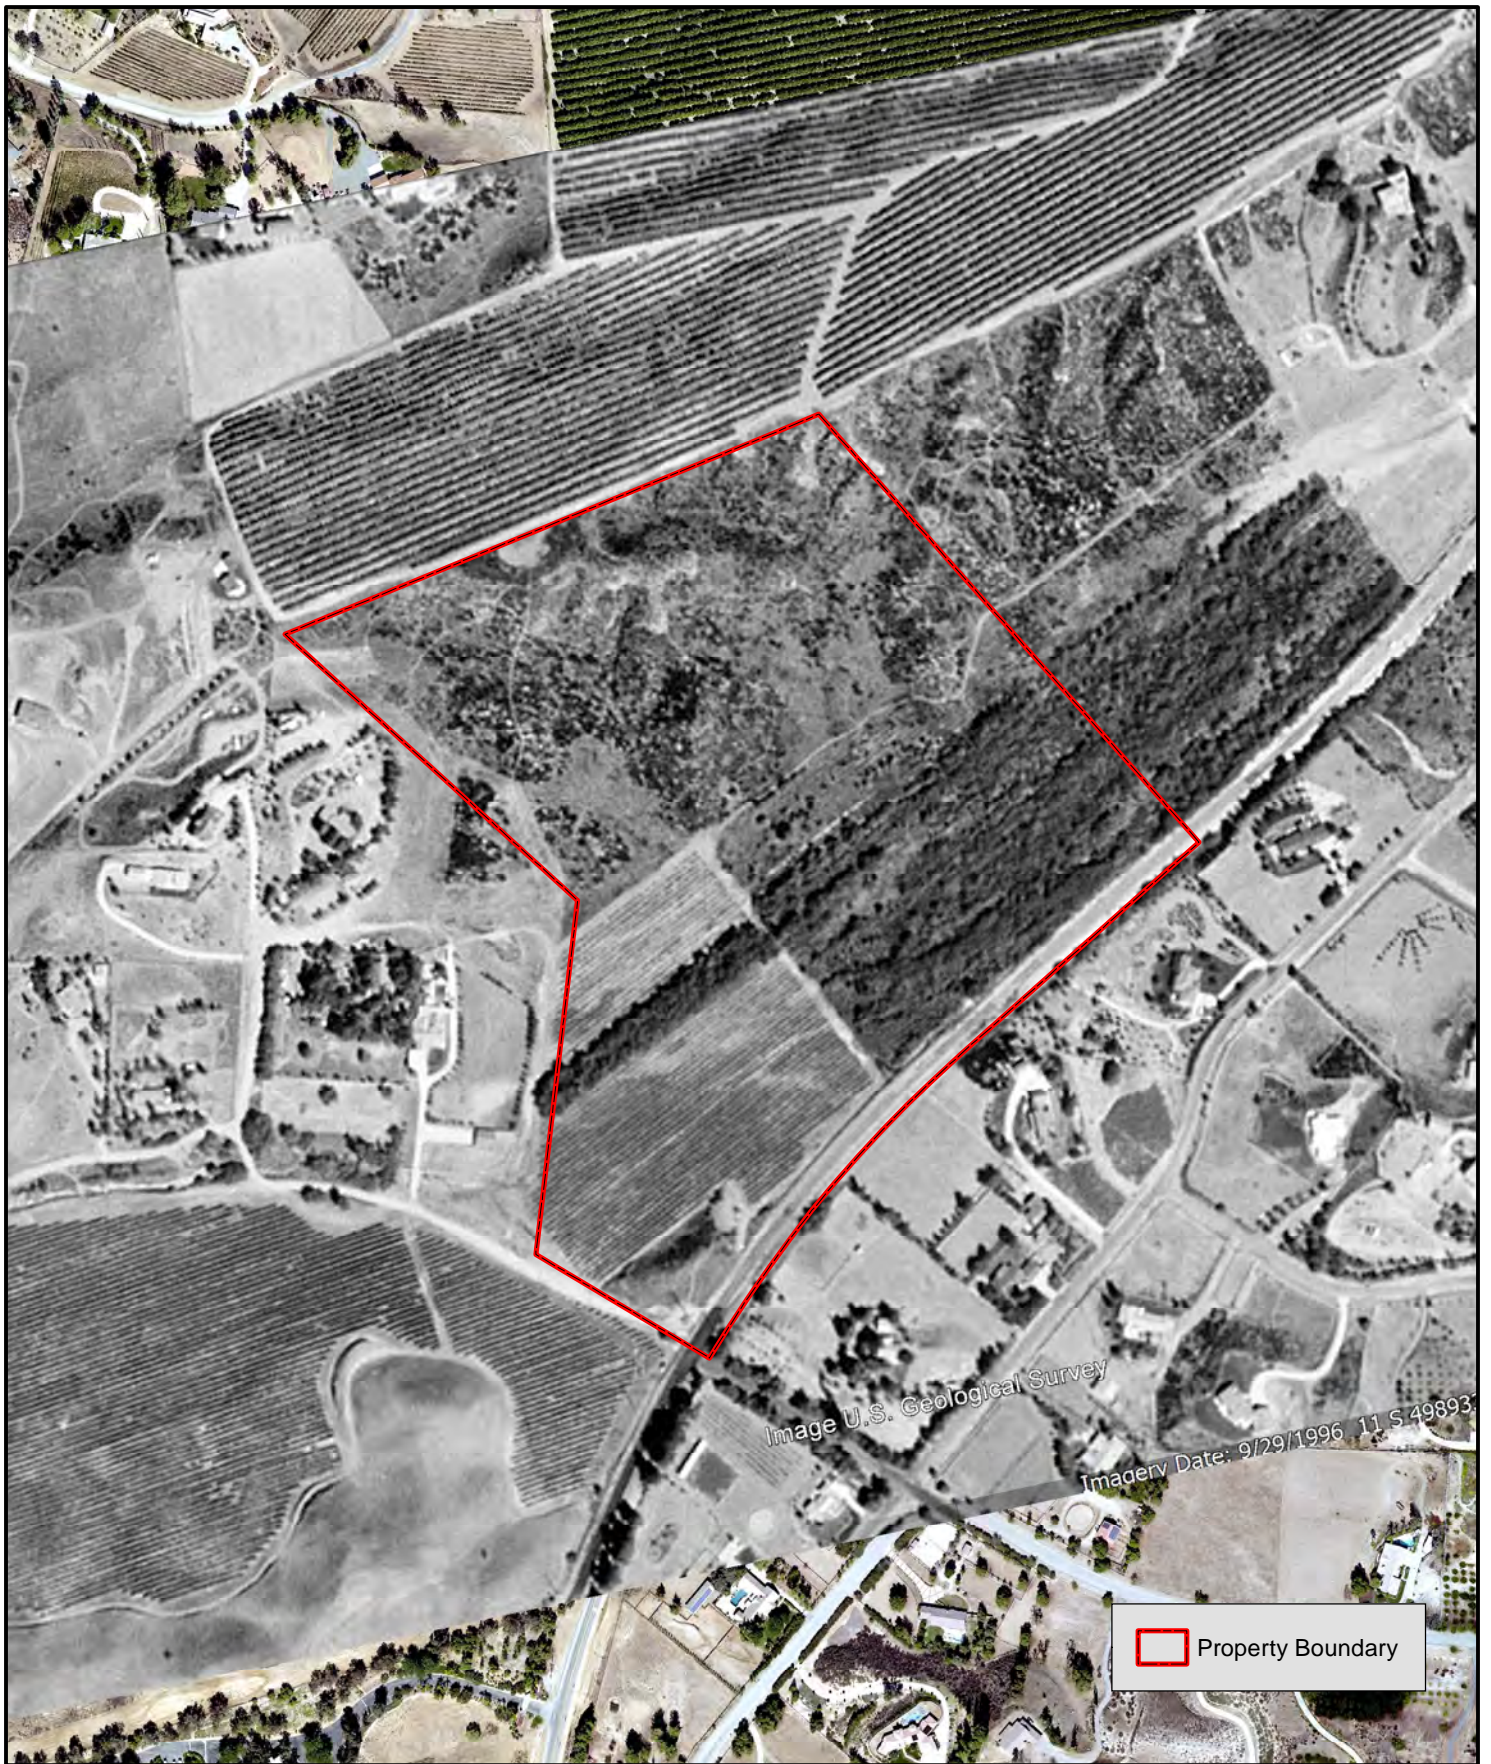
**FIGURE 10**  
**1996 Aerial Photograph**

In 1996, the southwestern portion of the Property was in active agricultural use with what appears to be vineyard. A densely vegetated, linear area is evident within the agricultural area near the current alignment of the estimated low flow area of Long Valley Wash. This may have been an agricultural ditch. The southeastern portion of the Site was densely vegetated, along with the adjoining area to the east, and did not appear to be in active agricultural use. Single-family homes had been constructed west of the Site. *Figure 10 – 1996 Aerial Photograph* (Page 19) depicts the conditions described above.

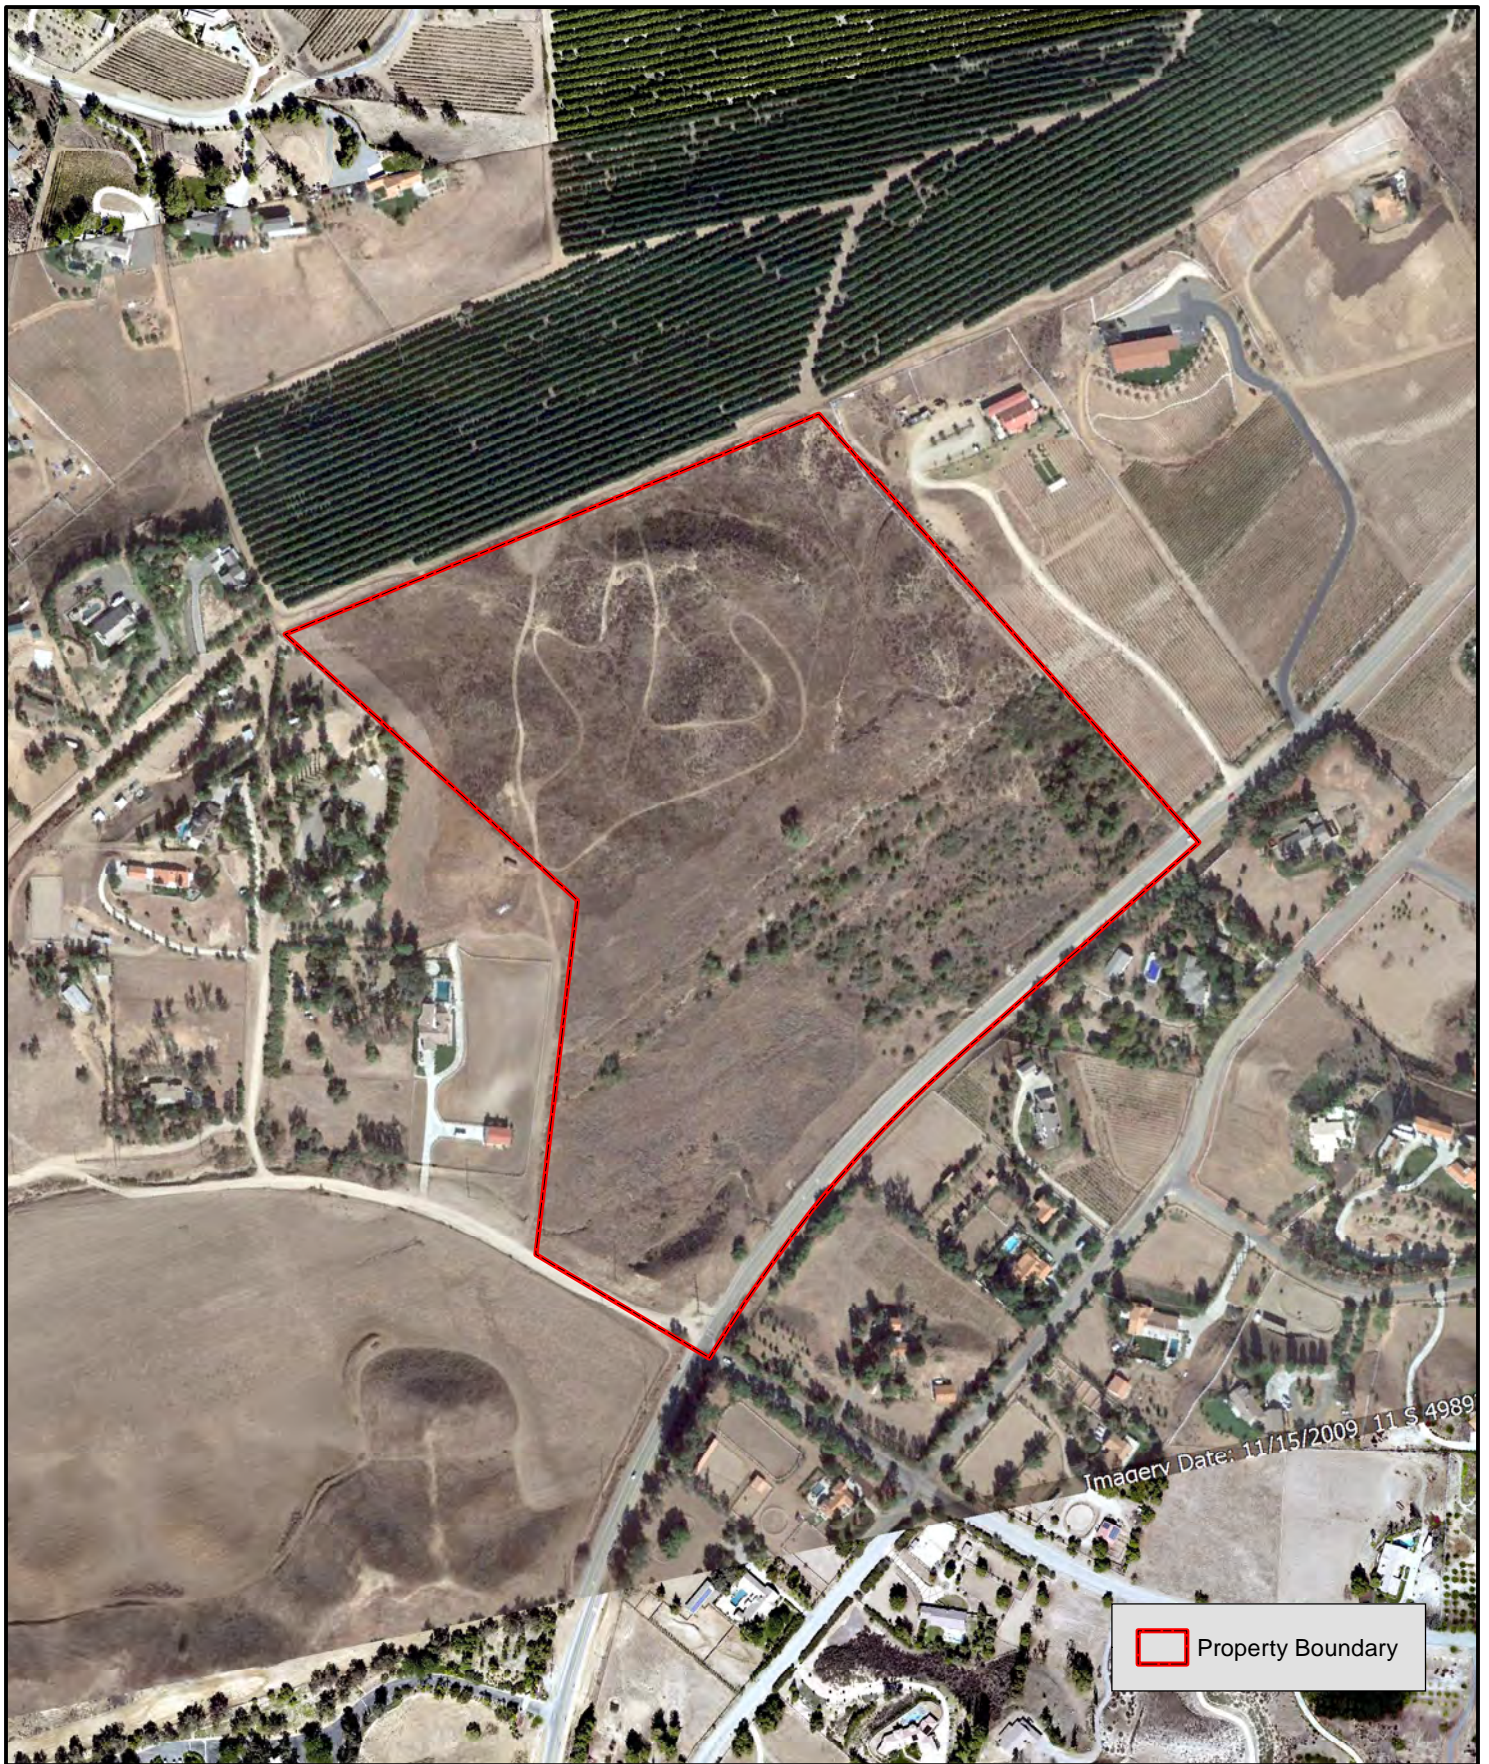
**FIGURE 11**  
**2009 Aerial Photograph**

The Property did not appear to be planted and appeared vacant in 2009. Conversely, the properties to the east/upstream were back in agricultural use and planted with vineyard. This includes the Long Valley Wash area. Hydrologic flow was evident upstream of the Site based on soil color and entered the Property near the current alignment of the estimated low flow area of Long Valley Wash. Flow exits the Property in the west and eventually enters a ditch along Monte de Oro Road. *Figure 11 – 2009 Aerial Photograph* (Page 20) depicts the conditions described above.

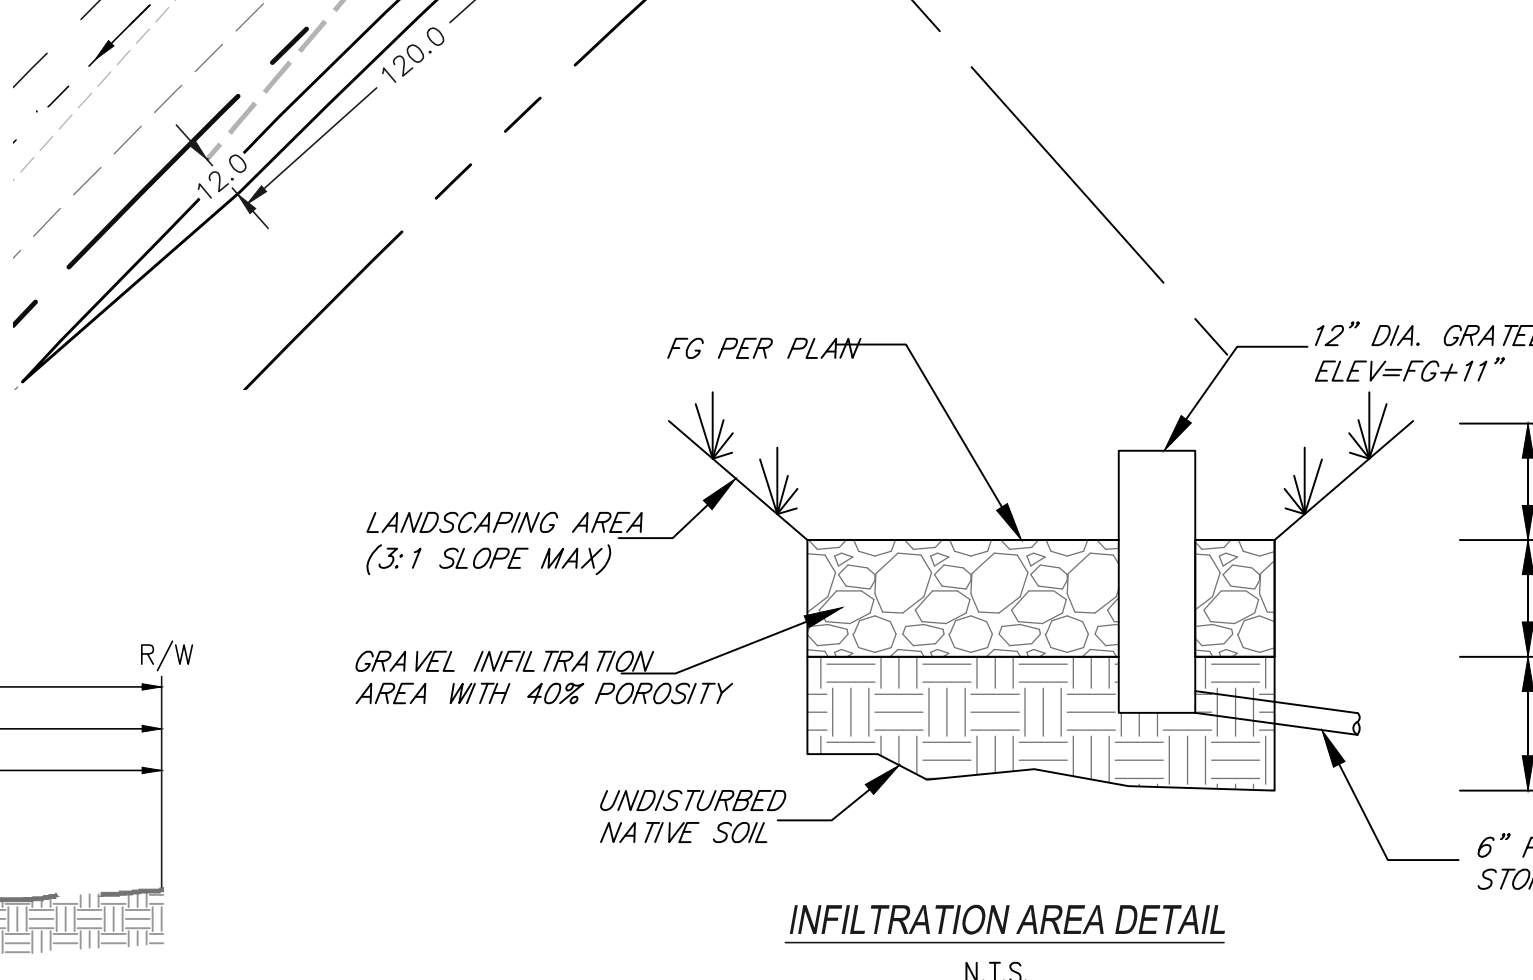
INFILTRATION AREA DETAIL  
 N.T.S.

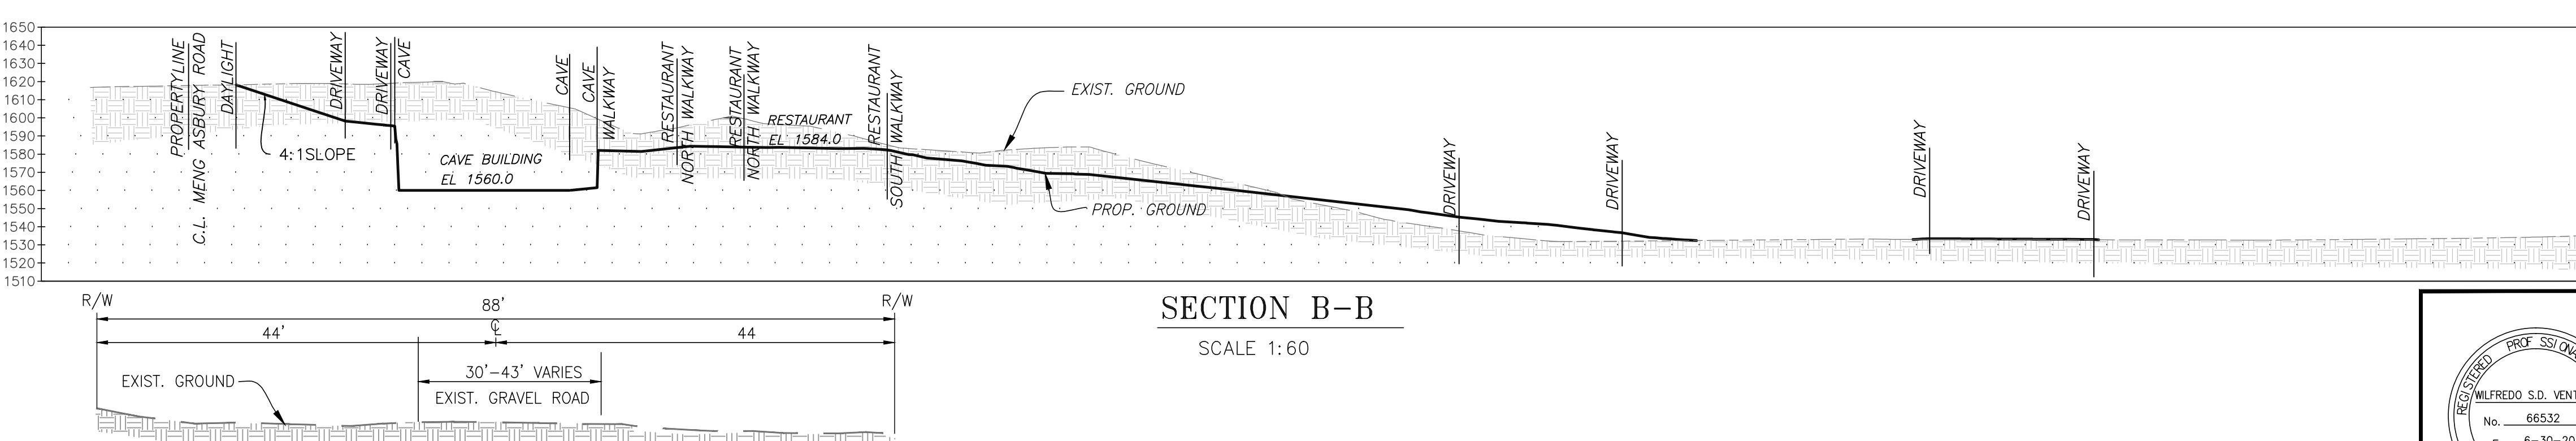
SECTION B-B  
 SCALE 1:60

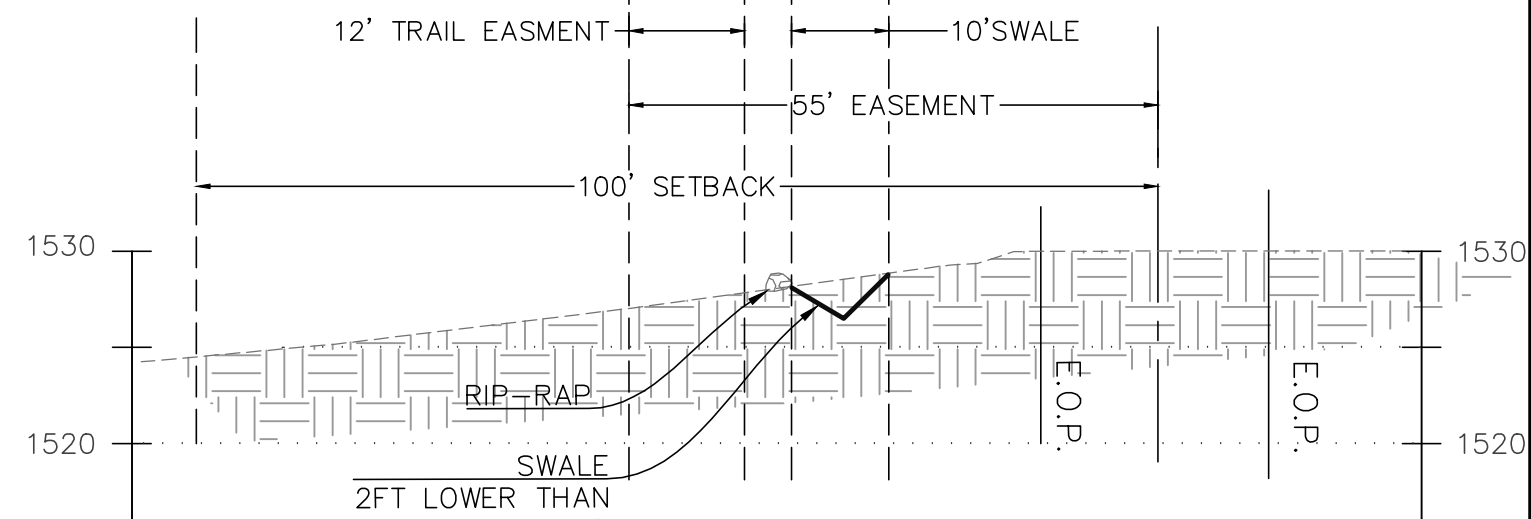
SECTION C-C  
 SCALE H 1:20 V 1:10

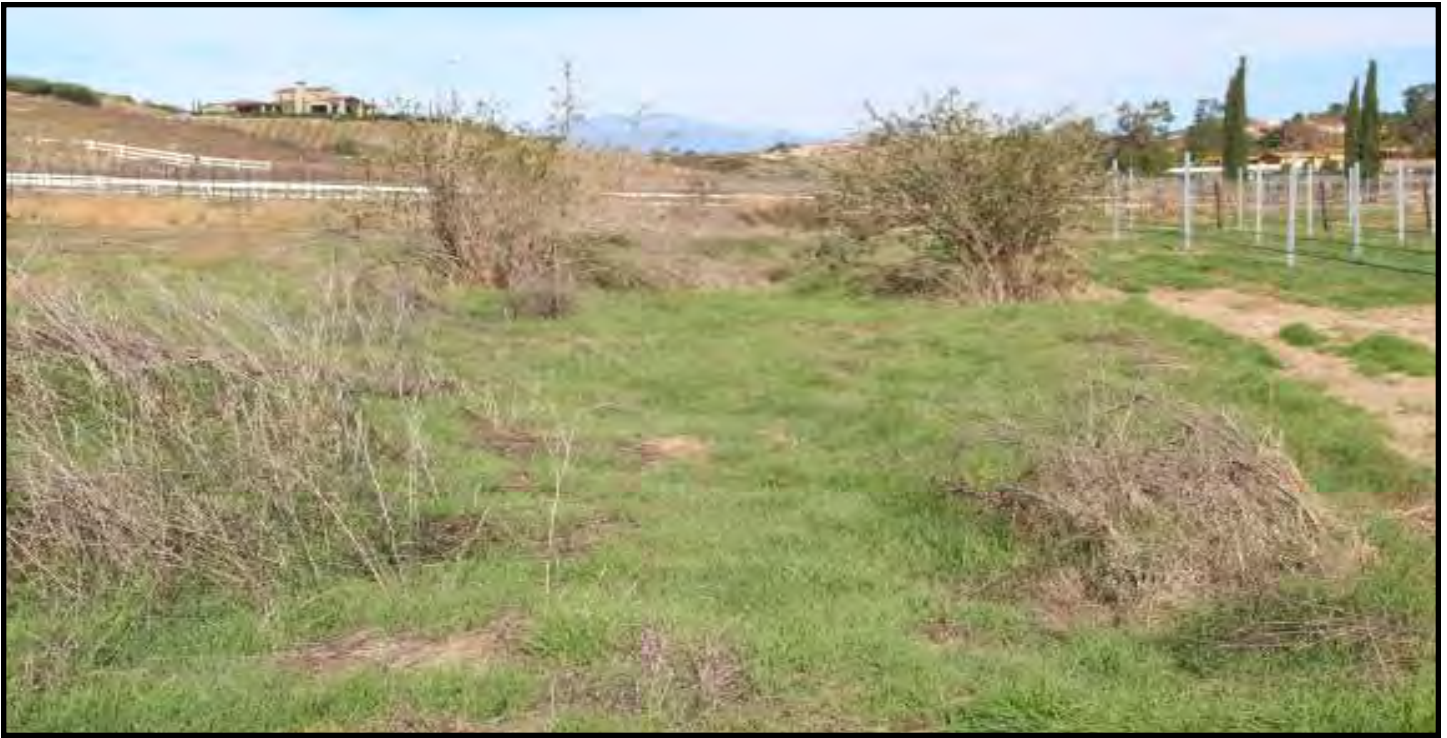
LONG VALLEY WASH IS NOT INCISED IN THE EASTERN PORTION OF THE SITE

The channel of this wash is difficult to detect in the eastern and central portions of the site. There are reaches that are not incised into the terrain. Mule fat (*Baccharis salicifolia*) is the only riparian species growing in these areas. Annual burweed (*Ambrosia acanthicarpa*), a common species found along sandy washes in lowlands, was also growing there. The other species are all upland types, and include \*shortpod mustard, interior California buckwheat, \*brome grasses, and jimsonweed (*Datura wrightii*). Mule fat is on the National Wetland Plant List (USDA 2012).

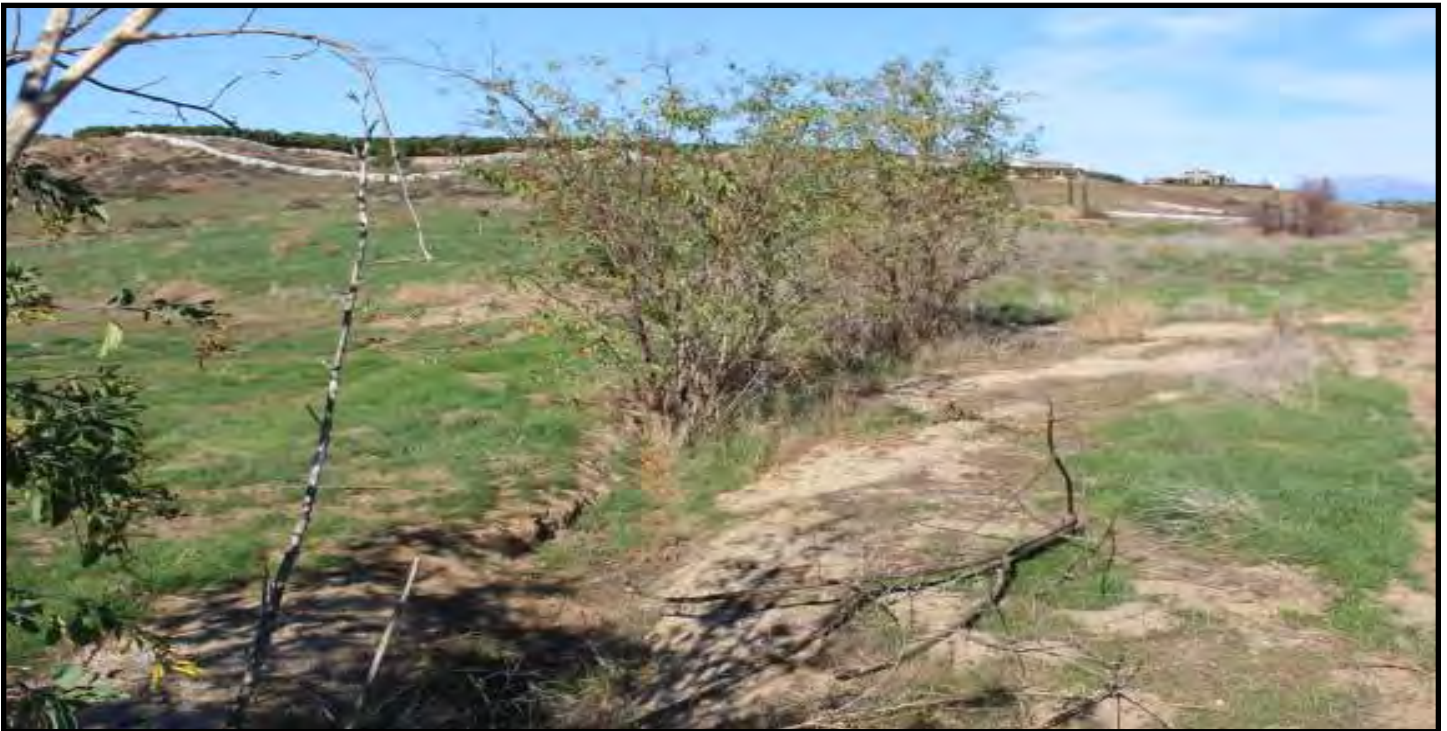
ITS CHANNEL IS INCISED IN THE CENTRAL PORTION OF THE SITE

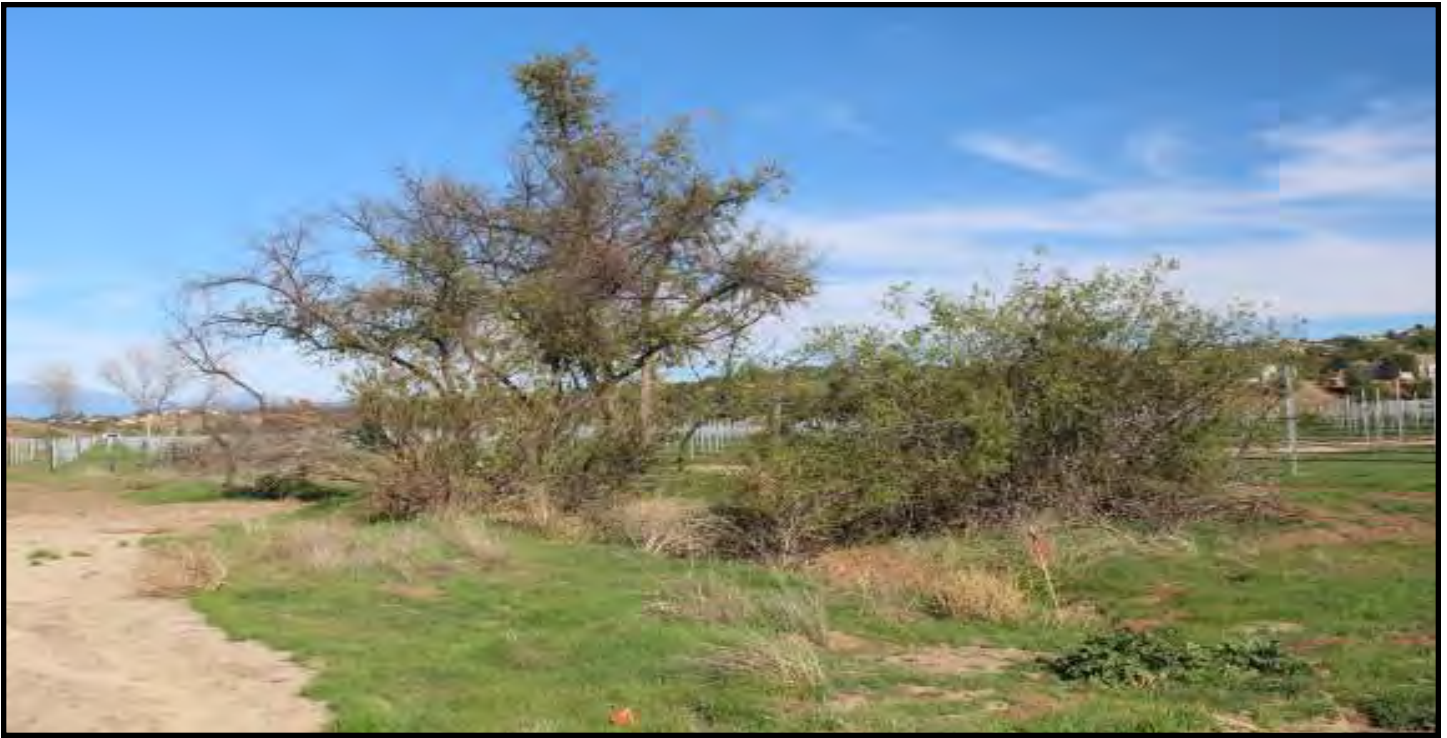
VIEW OF RIPARIAN SCRUB IN WESTERN PORTION OF THE SITE

The channel is incised in the western portion of the site, where it varies from less than one-foot to about three feet into the terrain. *The best examples of Riparian Scrub are present in this portion of the site, but note that the trees are sparse, the canopy is open and intermittent, and the condition and vigor of the trees is poor.* Typical riparian species found growing in this area are western cottonwood (*Populus fremontii* subsp. *fremontii*), black willow (*Salix gooddingii*), red willow (*Salix laevigata*), and arroyo willow (*Salix lasiolepis* var. *lasiolepis*). Black, red and arroyo willows are on the National Wetland Plant List (USDA 2012), western cottonwood is not.

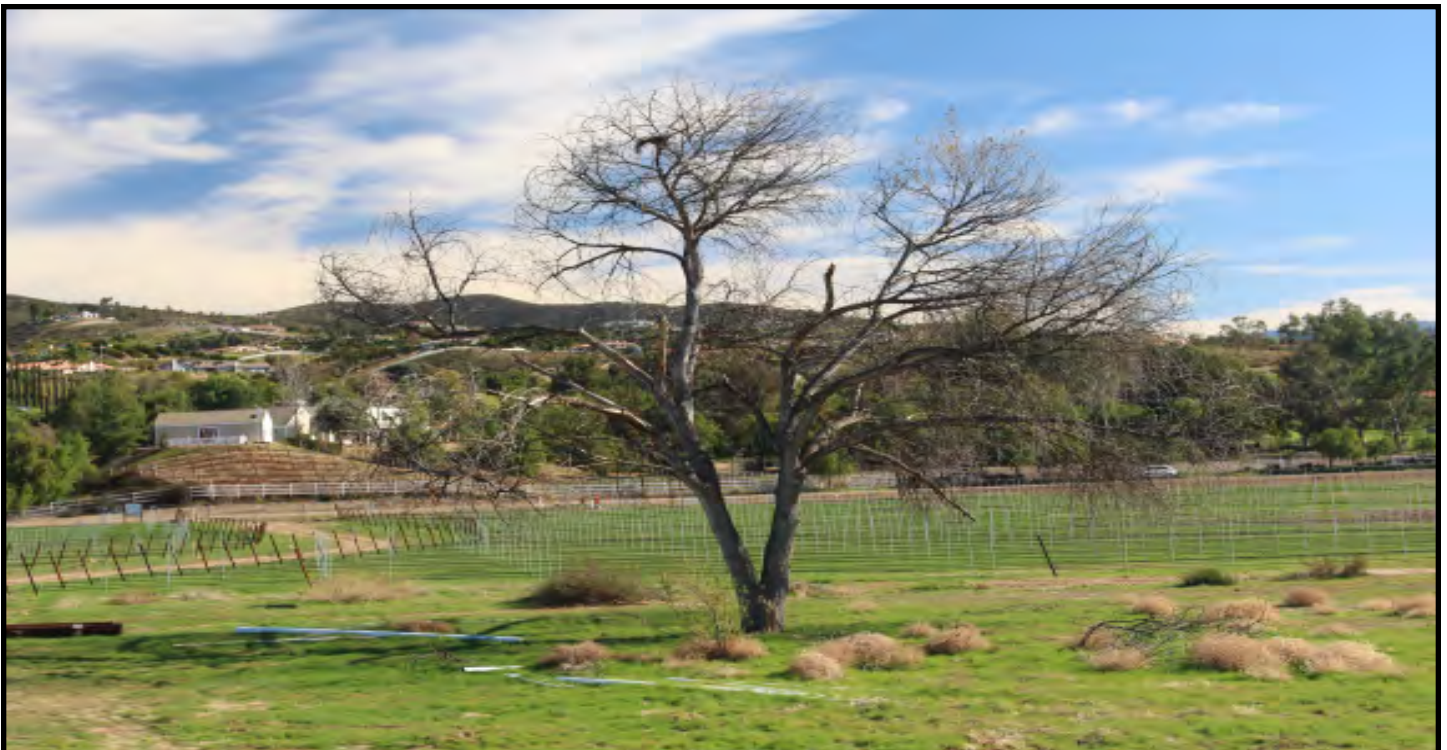
SITE PHOTOGRAPH 5  
PRINCIPE AND ASSOCIATES

VIEW OF WESTERN COTTONWOOD IN CENTER OF THE SITE WITH OLD NEST

There is a remnant of a raptor nest in the largest western cottonwood tree present on the site. During the four nesting season surveys conducted on the site for the burrowing owl, it was not being used by any bird species. Additional surveys were conducted at the site on September 29, October 4 and 17, 2017 and January 5 and February 9, 2018 which coincided with the nesting season for raptors (September 1 to January 14) and for songbirds (September 1 to February 14). There were no nesting activities observed during those survey dates.

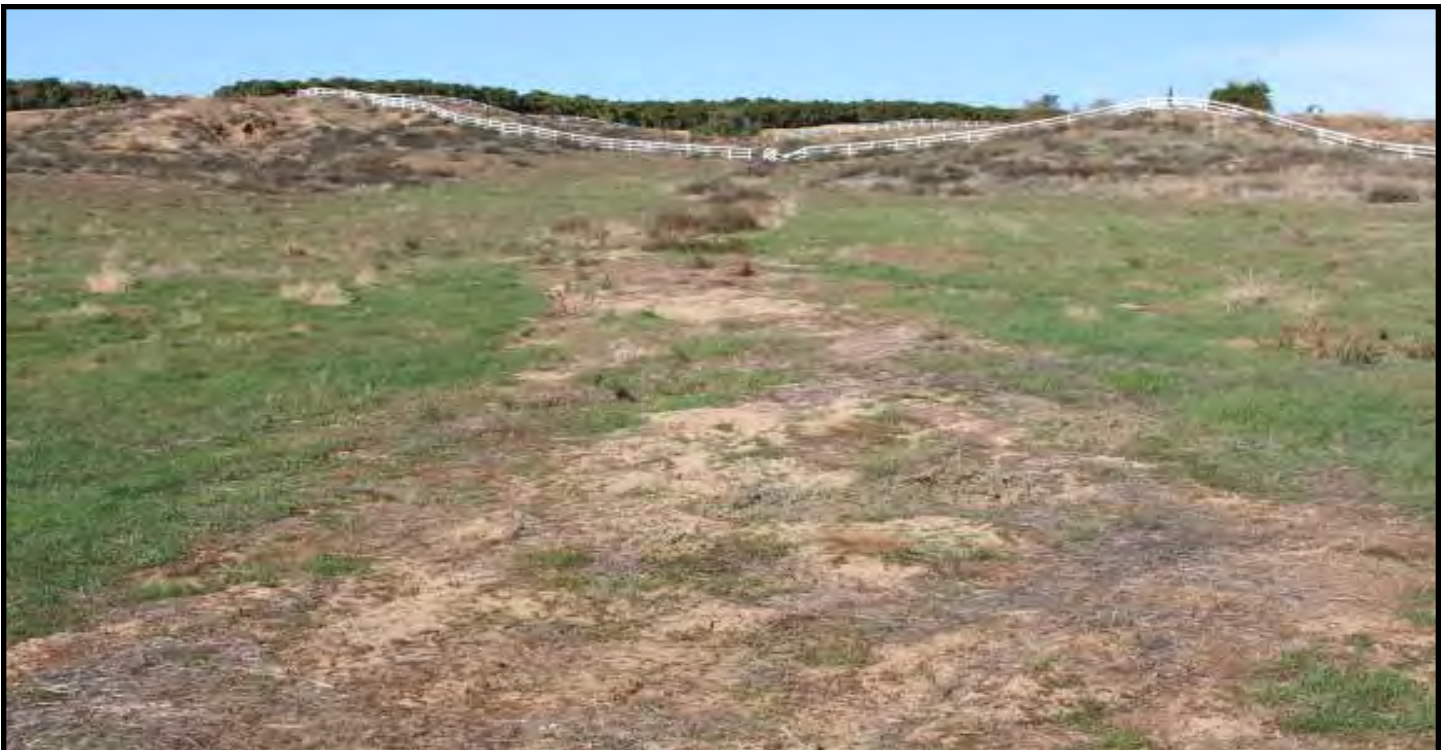
SITE PHOTOGRAPH 6  
PRINCIPE AND ASSOCIATES

VIEW OF THE GULLY PRESENT IN THE NORTHEAST PORTION OF THE SITE

An erosional gully was present in the northeastern portion of the site. It was confined to a small ravine worn away by running water originating from the paved surfaces of the development located adjacent to the northeast corner of the site. The gully was evident for approximately 400 feet where it conveyed storm water runoff downslope before it dissipated on the surface as sheetflow. The gully did not connect to the estimated low flow area of Long Valley Wash and was not clearly evident on the Site in 1967, 1978, or 1996. It was present in 2009 subsequent to the construction of the development offsite.

There is a gully present in the northern portion of the site. It is confined to a small valley or ravine originally worn away by running water originating from the paved surfaces on the single-family residence located adjacent to the northeast corner of the site. The two main processes that result in the formation of gullies are downcutting and headcutting, which are forms of longitudinal (incising) erosion. These actions ordinarily result in erosional cuts that are often deeper than they are wide, with very steep banks and small beds. Gullies are younger than streams in geologic age, and typically lack an ordinary highwater mark (OHWM). They are commonly found in areas with low density vegetative cover and soils that are highly erodible.

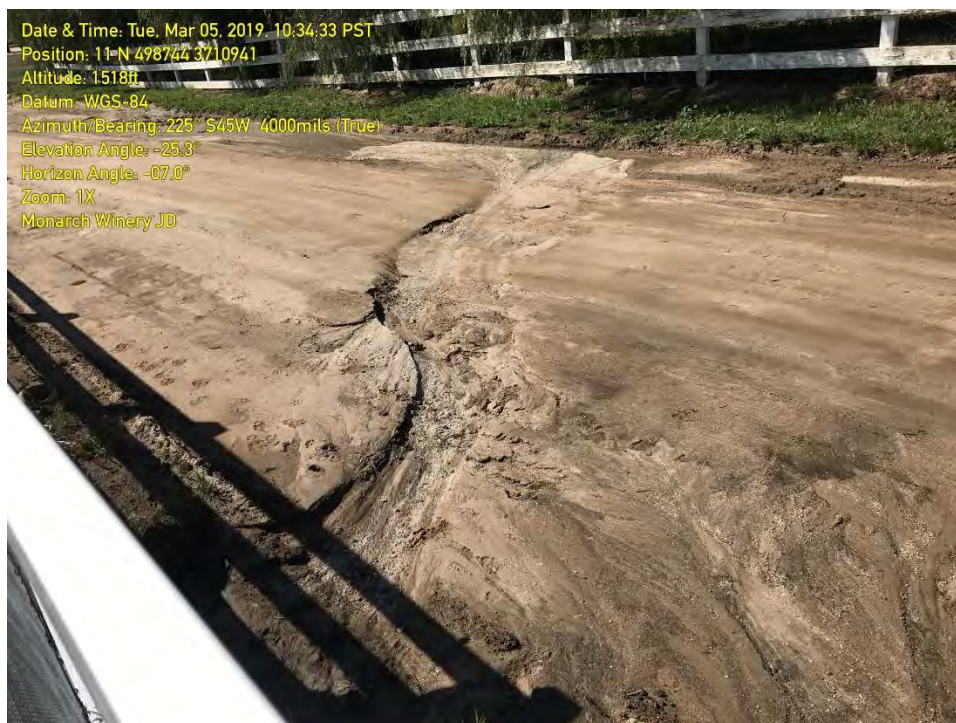
**PHOTOGRAPH 1:** Flow offsite through dirt driveway.

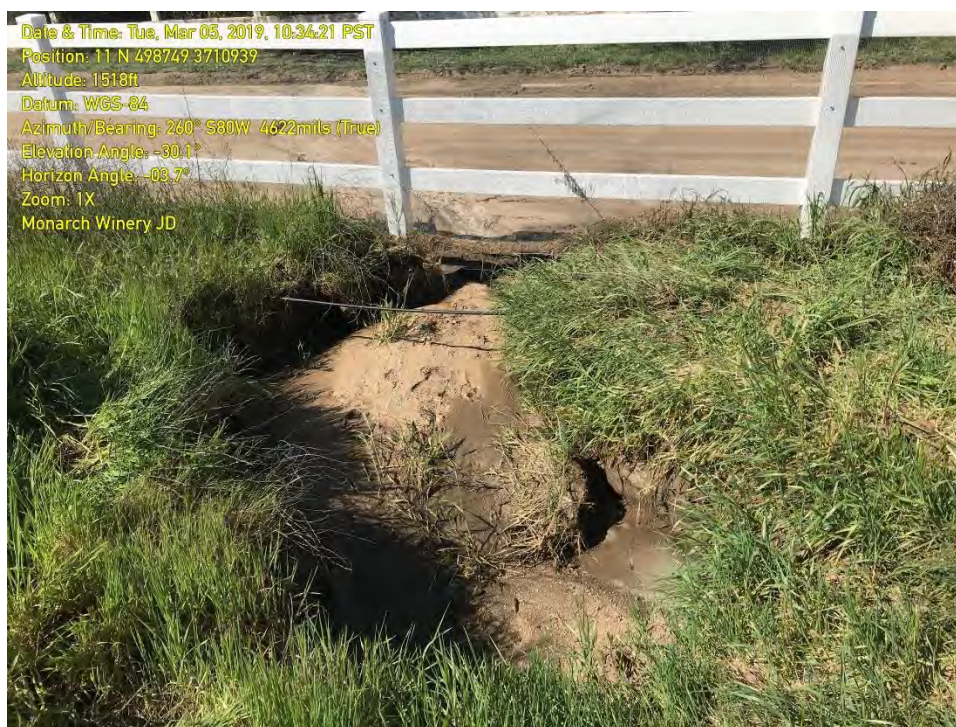
**PHOTOGRAPH 2:** Flow concentrating, then exiting the Site beneath a vinyl fence lined with wire.

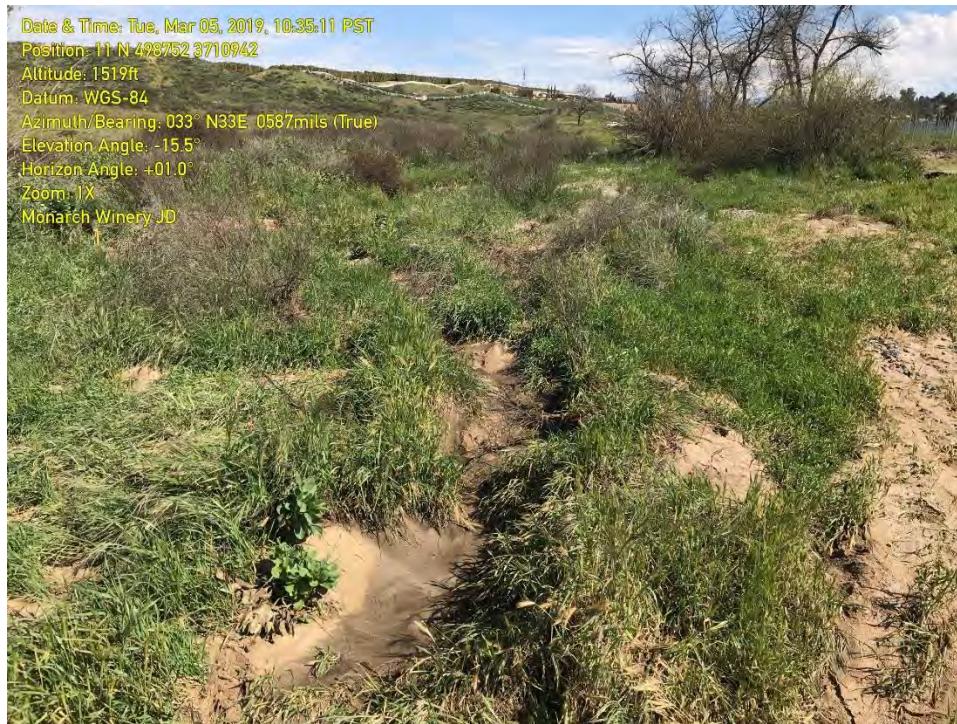
**PHOTOGRAPH 3:** Strong evidence of ordinary flow in the western portion of the Site.

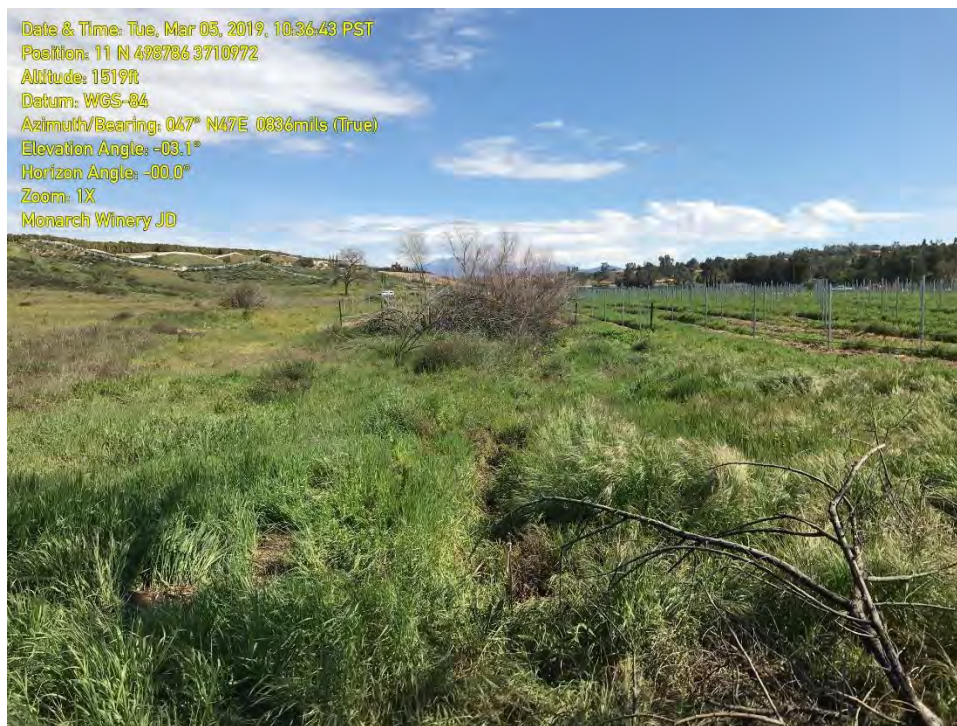
**PHOTOGRAPH 4:** An OHWM coming from the edge of the vineyard. The OHWM began near the salt cedar and drought stressed mulefat pictured in the background.

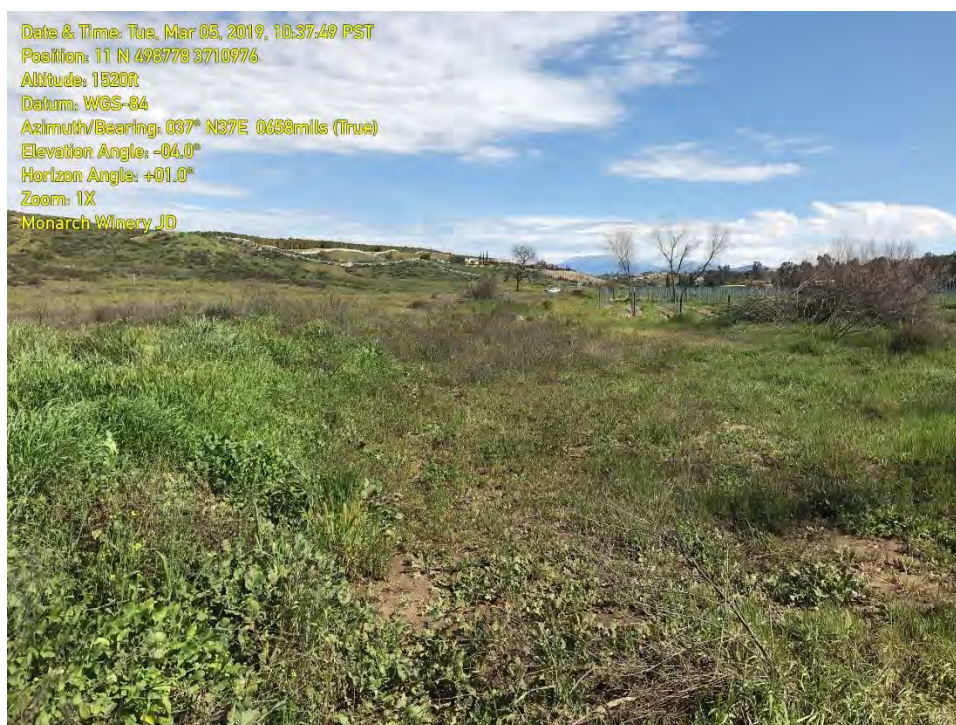
**PHOTOGRAPH 5:** Flows from a recent storm appeared to collect at this earthen bank coming off the vineyard from the right side of the photo. Weak evidence of flow was present upstream.

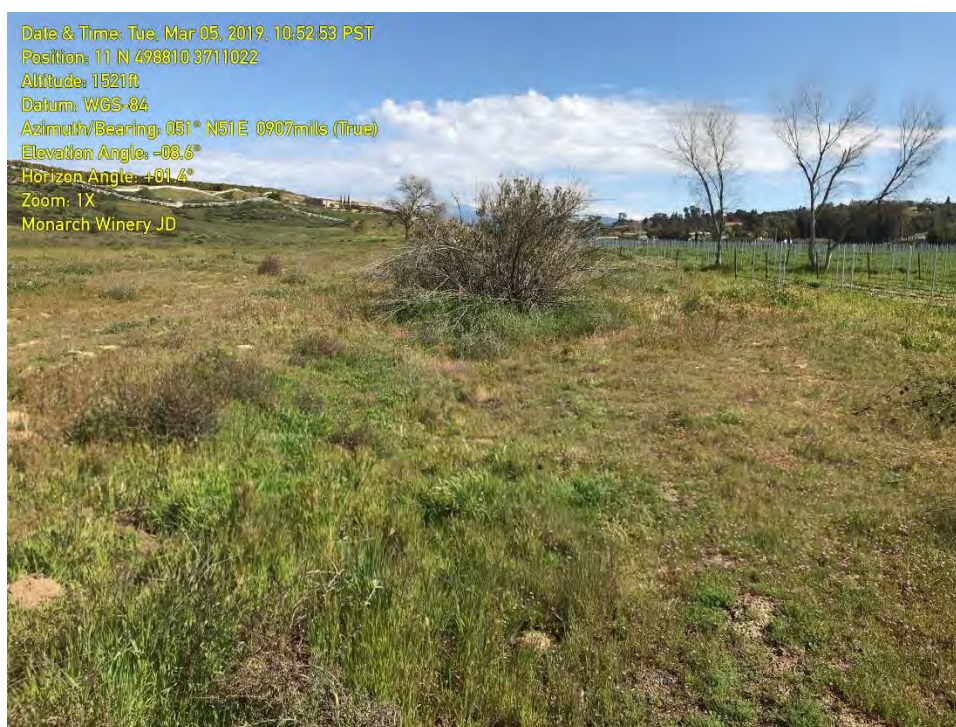
**PHOTOGRAPH 6:** Mulefat pictured in the “upland swale” area. Wetland sampling point A-C was assessed near the mulefat. Two cottonwoods were in the vineyard area outside of the estimated low flow area of the wash.

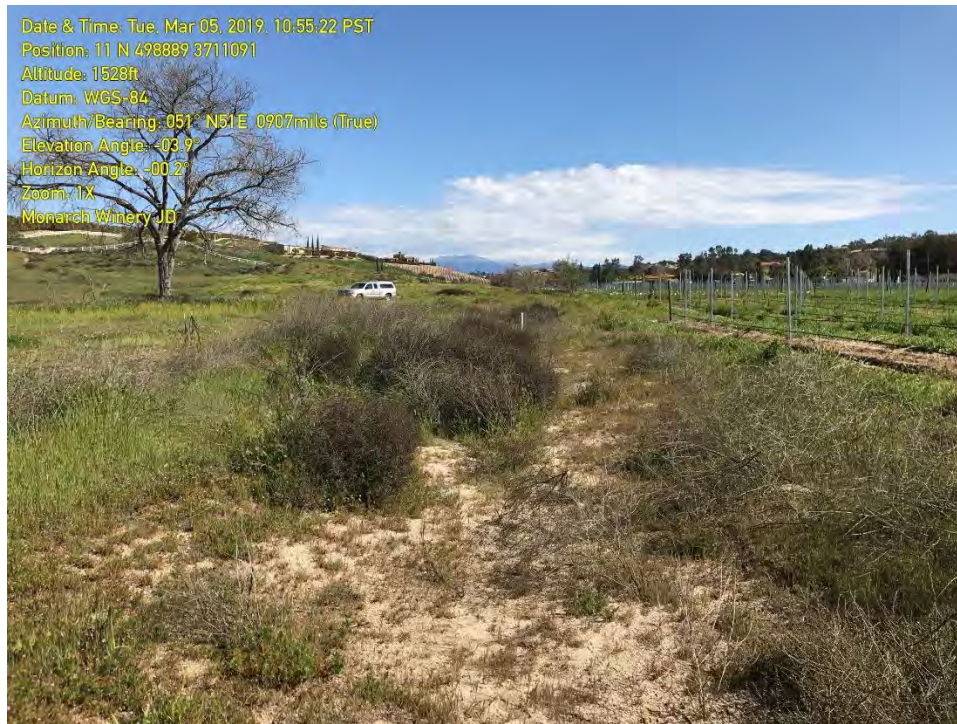
**PHOTOGRAPH 7:** Sandy substrates somewhat exposed in this area; however, evidence of recent flow was absent even subsequent to a storm that produced 6.04 inches of rain in four days. The cottonwood pictured was dead.

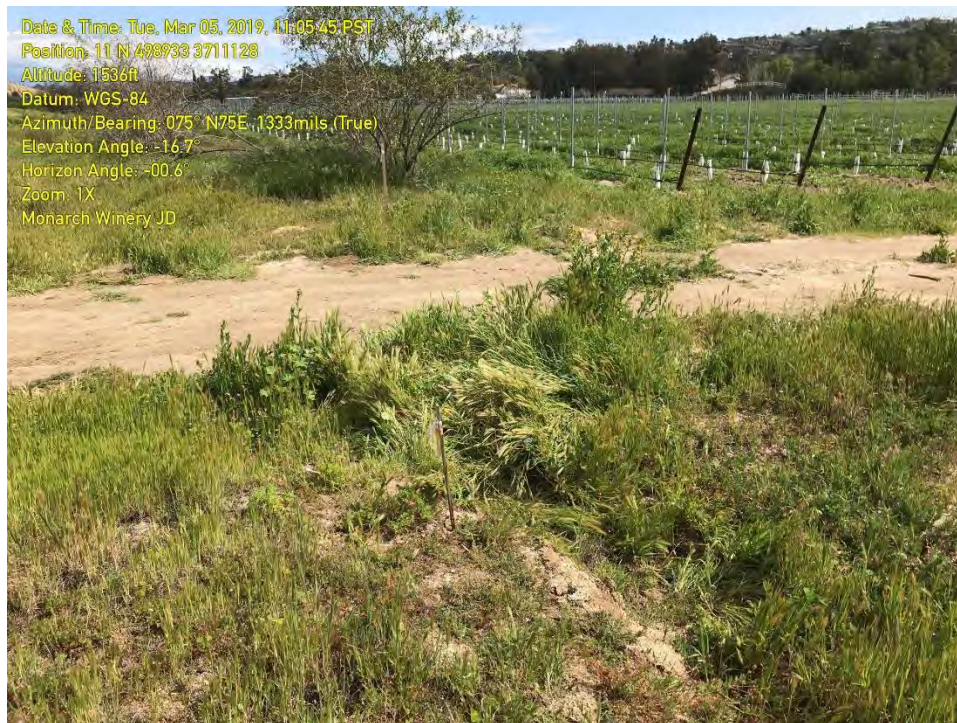
**PHOTOGRAPH 8:** A remnant channel is depicted in the foreground near the crossing. Blue elderberry is pictured in the background on the east side of the dirt road.

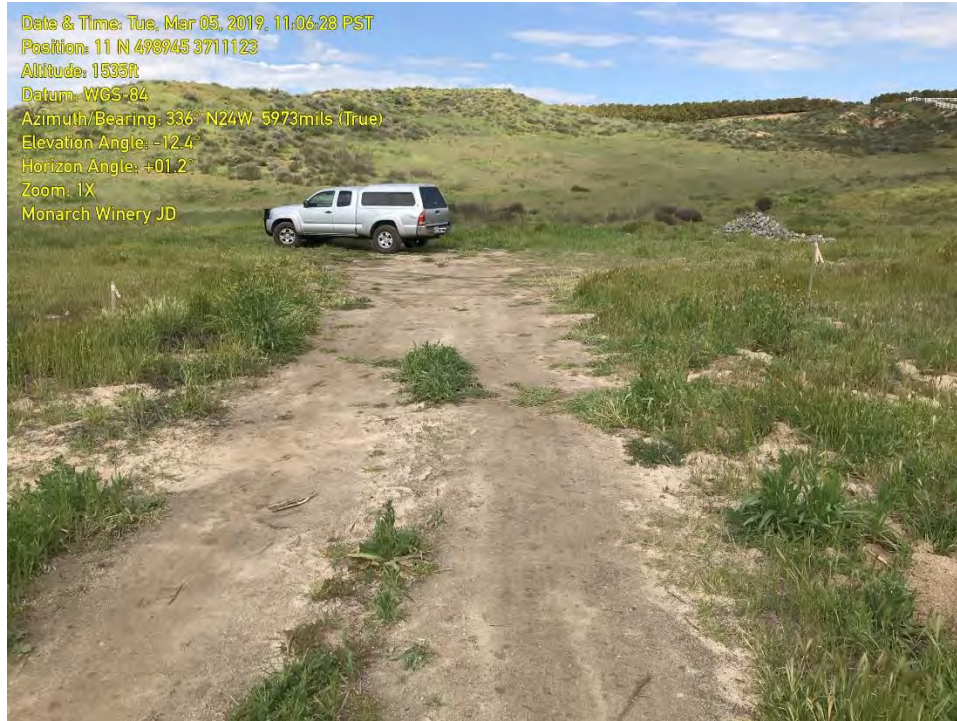
**PHOTOGRAPH 9:** No evidence of concentrated flow over the crossing was present.

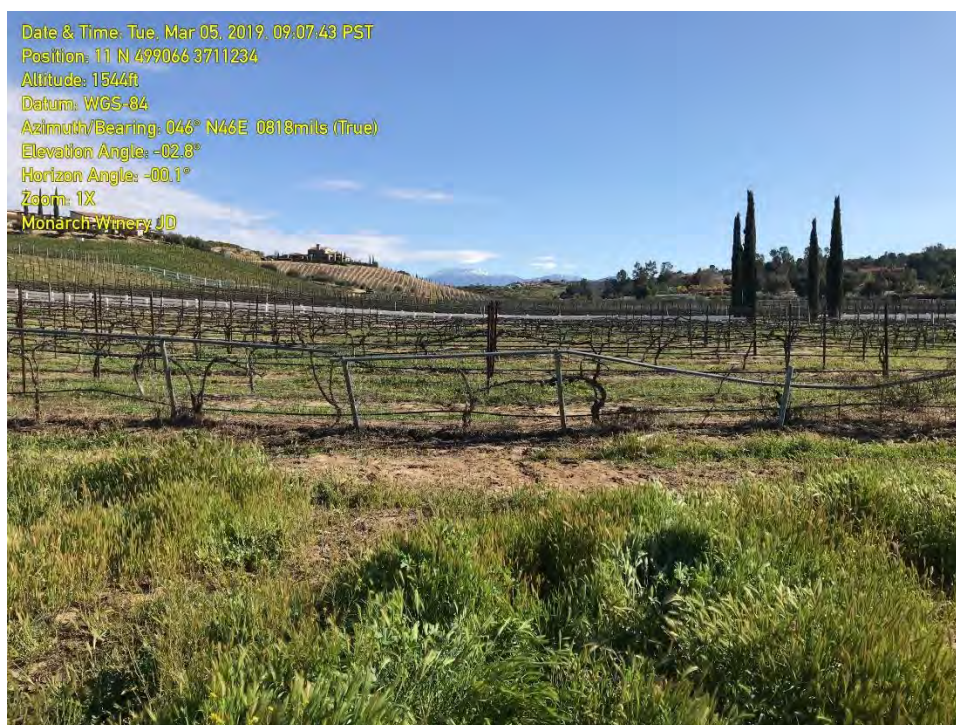
**PHOTOGRAPH 11:** The Property fence-line was bent and damaged in the upstream end indicating that strong surface sheetflow with debris (i.e., some Russian thistle was present on east side of fence) encountered this area. The fence-line likely dissipates flows since evidence of concentrated flow downstream of the fence was absent.
