**DETERMINATION OF BIOLOGICALLY EQUIVALENT OR SUPERIOR
PRESERVATION**

**PARCEL MAP NO. 36950
PLOT PLAN NO. PP25838
(GPA 01151, EA 42802, CFG 06184, CZ 07872)**

**ASSESSORS PARCEL NUMBERS:
314-040-001, 314-040-002, 314-040-003, and 314-040-008
COUNTY OF RIVERSIDE, CALIFORNIA**

**December 2015
(Revised July 2016)**

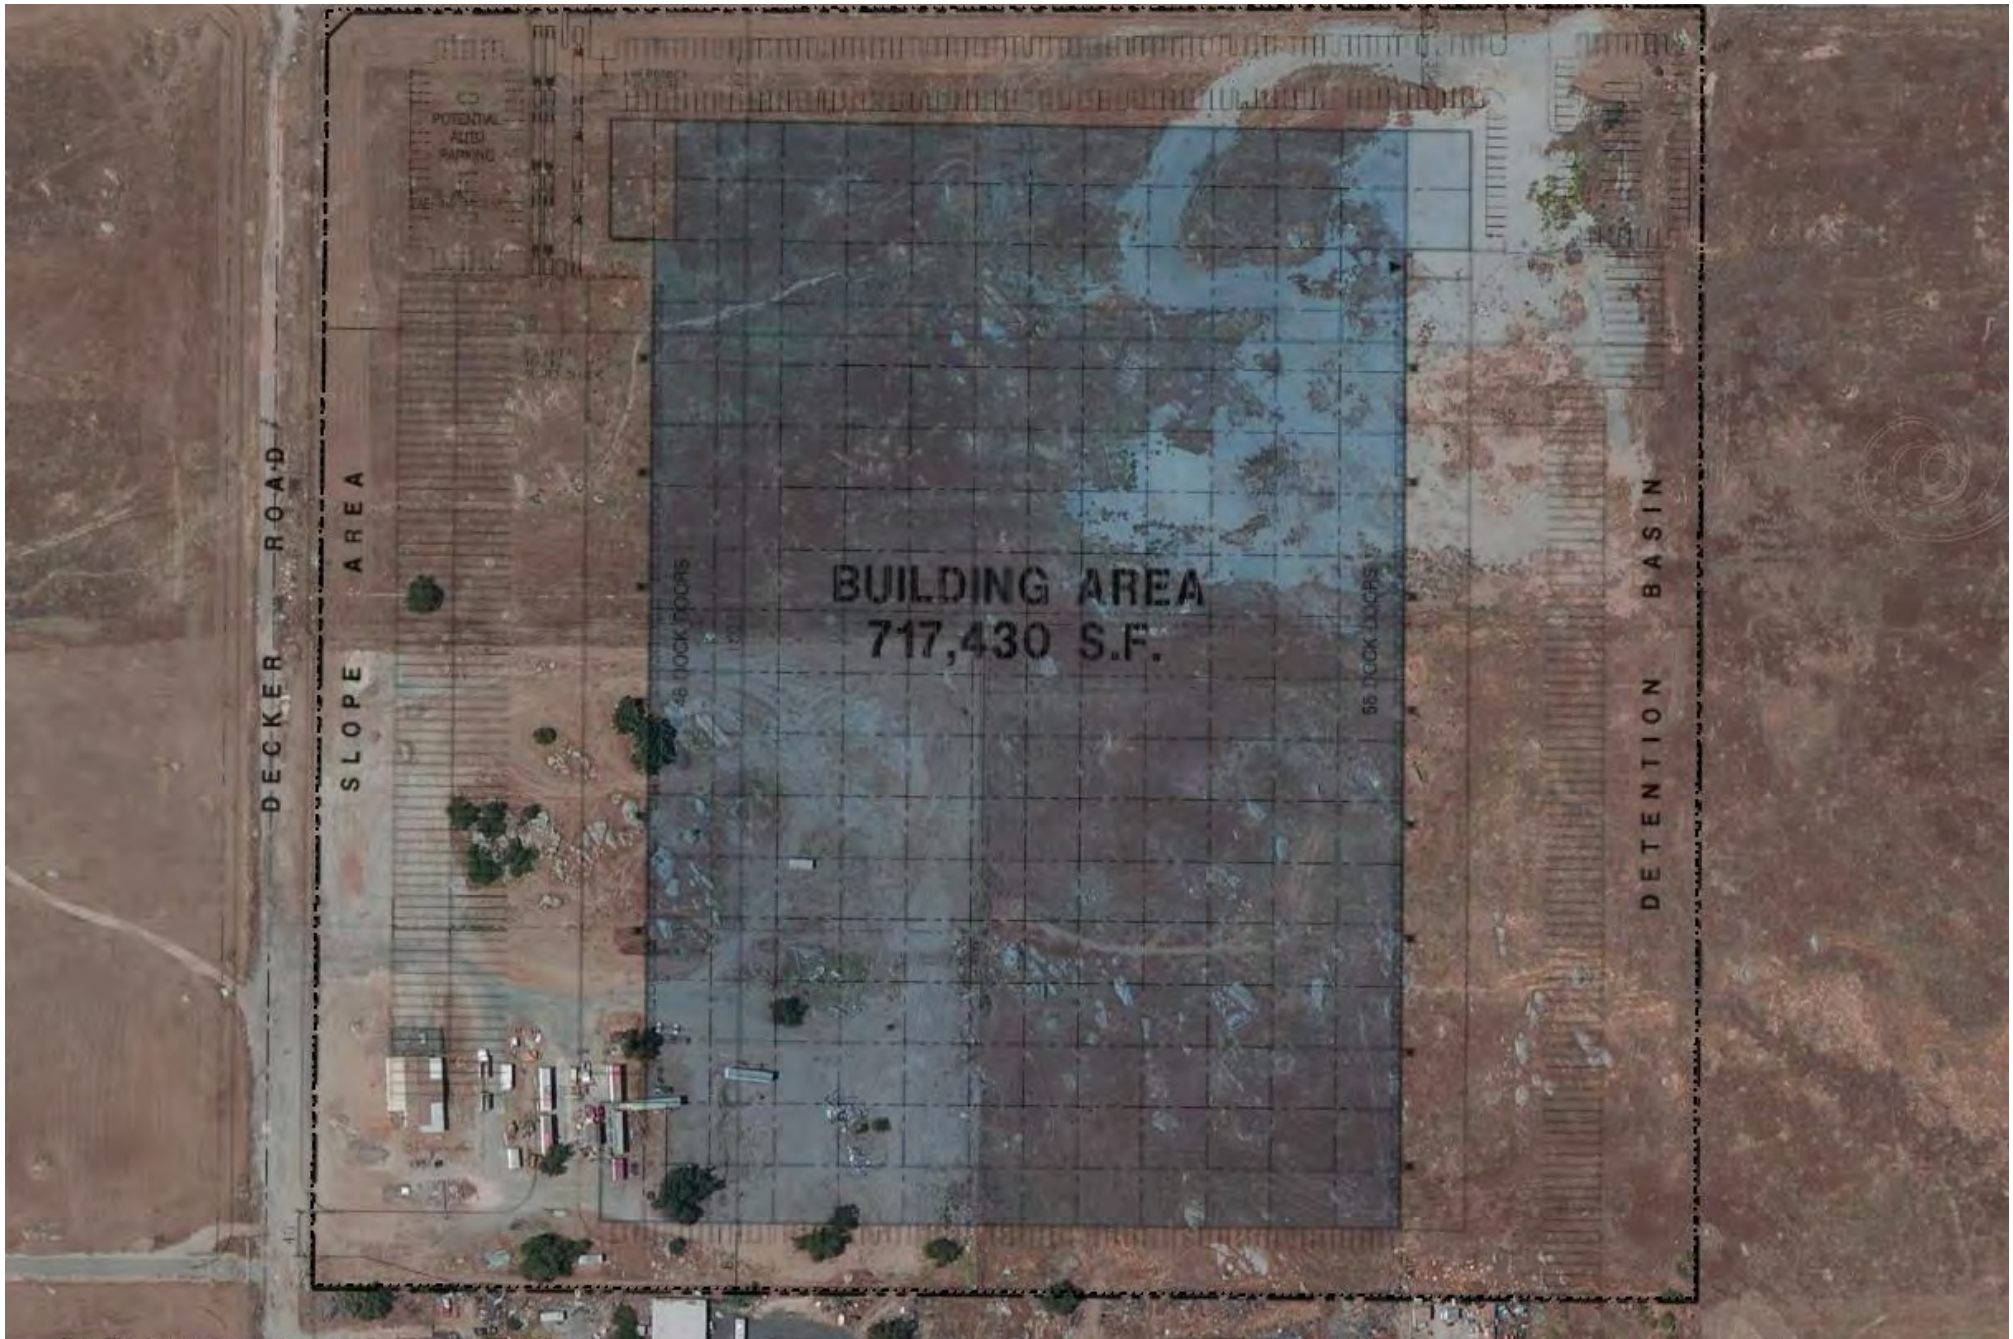
Figure 3
Project Plans
Planning Case No. 36950
Riverside County, California

The proposed project consists of the construction of a 717,430-square-foot warehouse with associated offices and parking stalls (Figure 3). The project will also include a water quality detention basin. All 34.4 acres of the project site will be impacted.

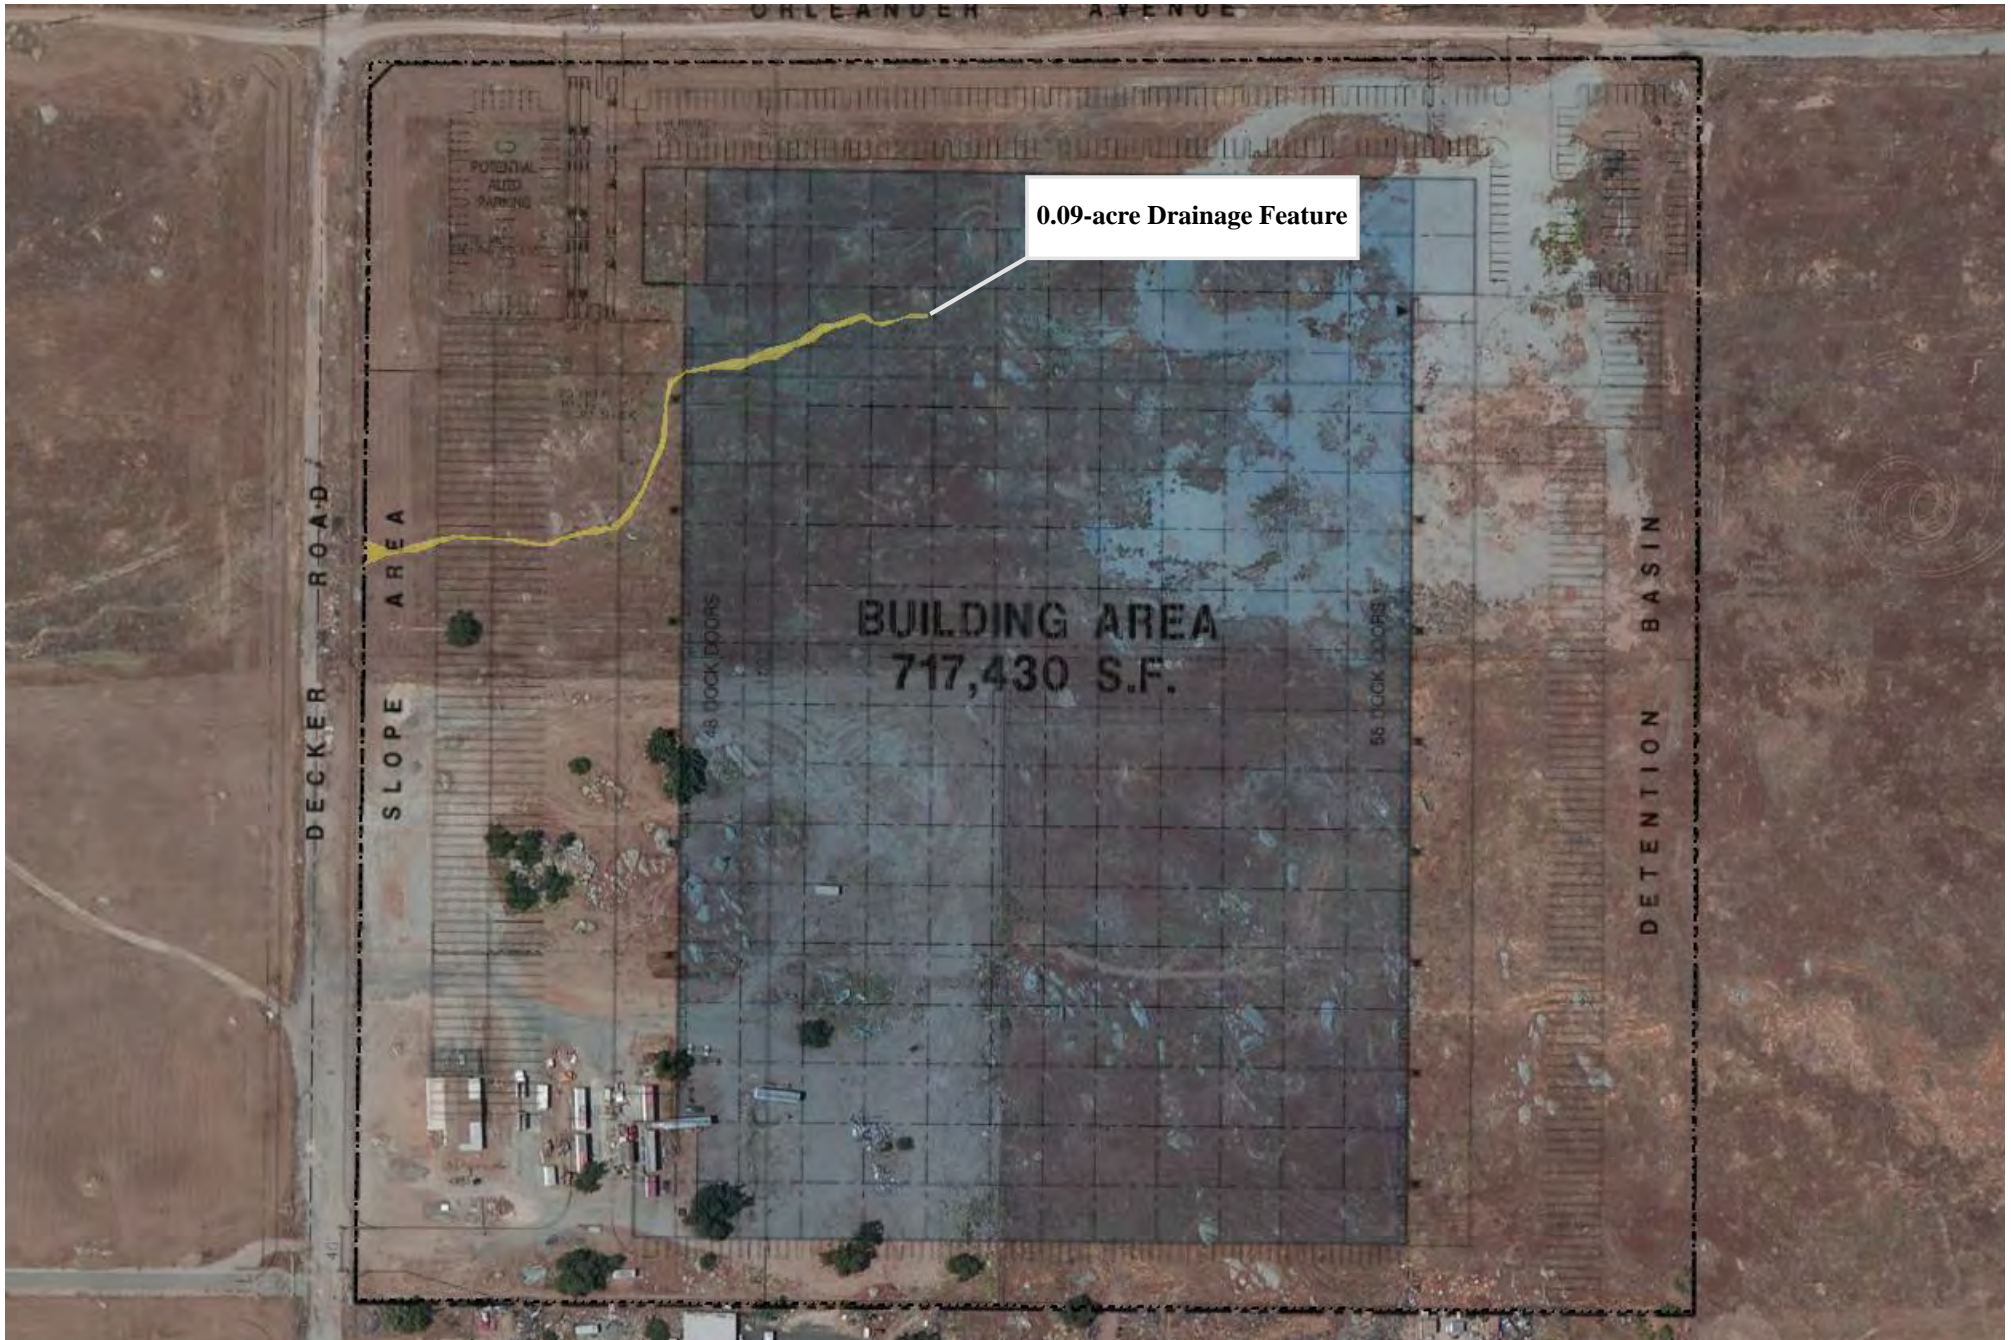
Figure 5
 Drainage Map
 Planning Case No. 36950
 Riverside County, California

The 34.4-acre project site contains one ephemeral drainage feature (Figure 5), encompassing a total area of 0.09 acre (approximately 677 feet in length). The drainage feature appears to be the remnants of a historical feature that previously conveyed water. The upstream terminus of this drainage was created by a man-made berm and Decker Road impeding downstream flows from upstream hydrologic sources. Flows from any hydrologic features upstream of the drainage now flow north on Decker Road and east on Oleander Avenue. A large stormwater inlet is located on the northeast corner of the project site; however, no defined bed, bank, or channel connects to the inlet. It is assumed that this stormwater inlet collects flood waters from upland sheet flow during large storm events.

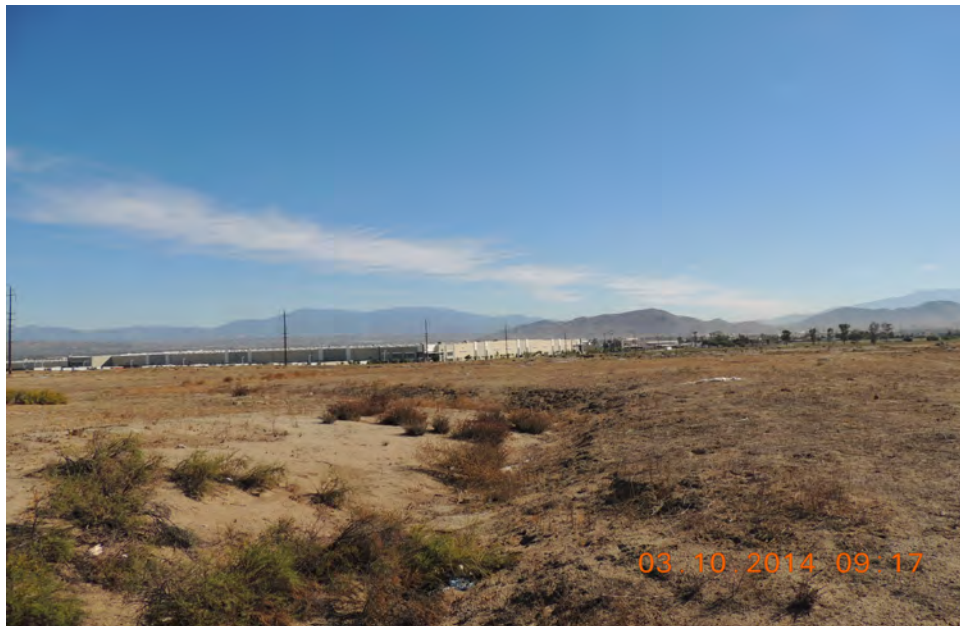
Westernmost portion of swale, facing est. Picture shows dominance of upland plant species and poorly defined channel.

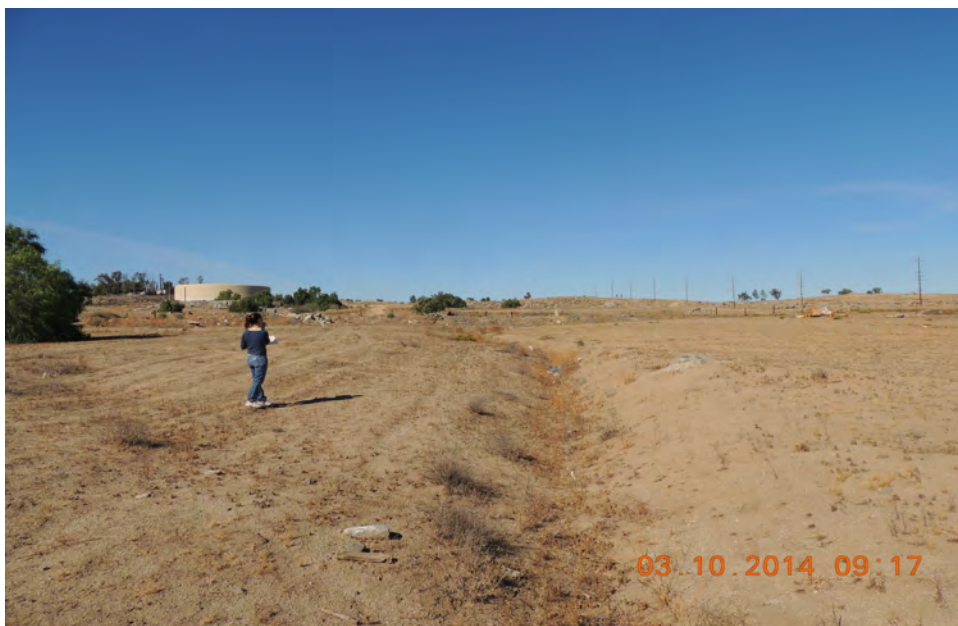
Middle portion of swale facing west. Poorly defined channel and lack of hydrology are present.

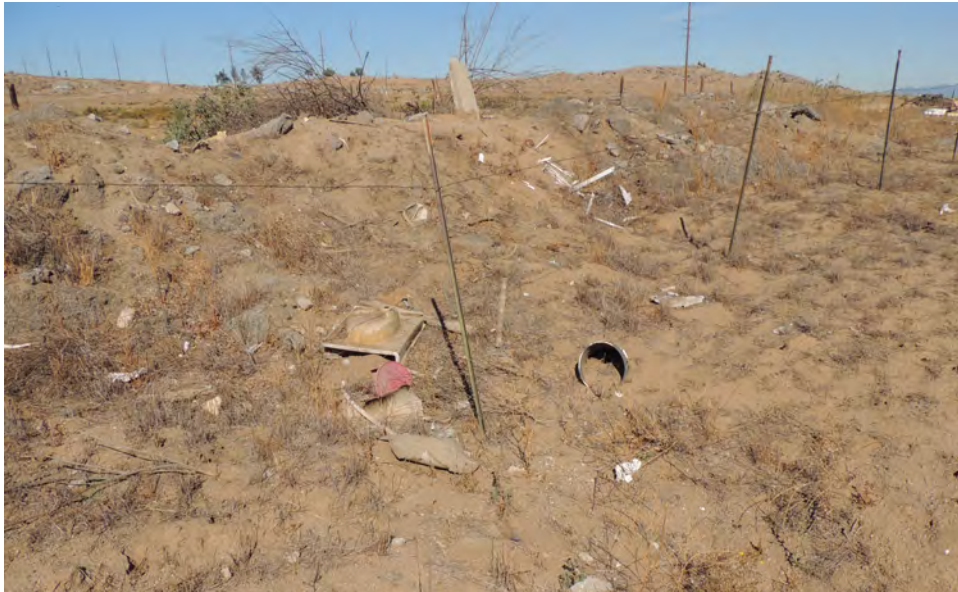
Berm located on the east side of Decker Road. This structure has completely isolated the swale from receiving upstream hydrology.

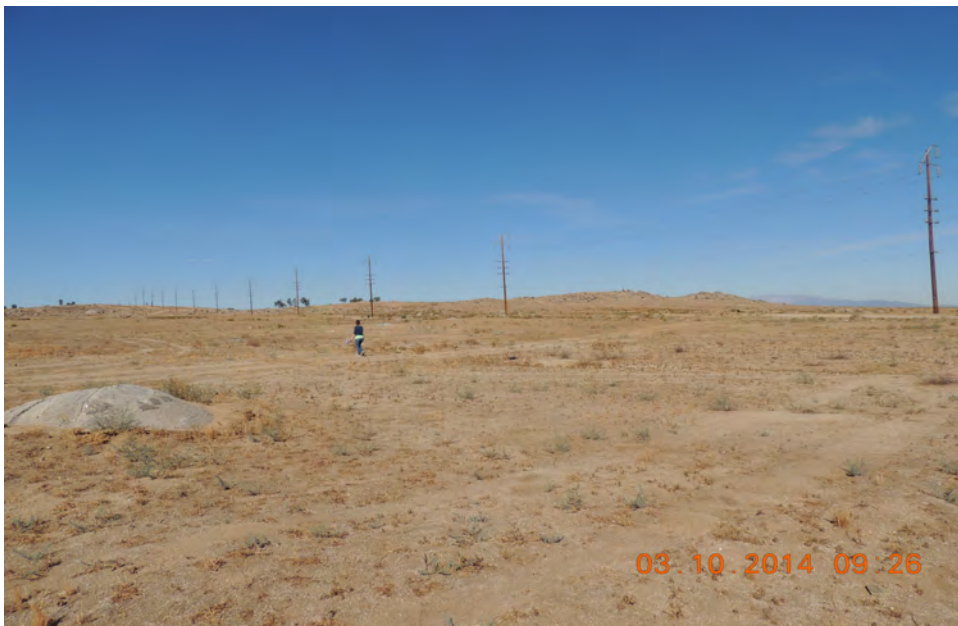
Easternmost section of the swale where it ends and disappears.
