## Phase I Environmental Site Assessment

# **Phase I Environmental Site Assessment: AES Distributed Energy Solutions Mountain View Wind Repower Project Whitewater, California 92282**

Tt Project No. 194-7160

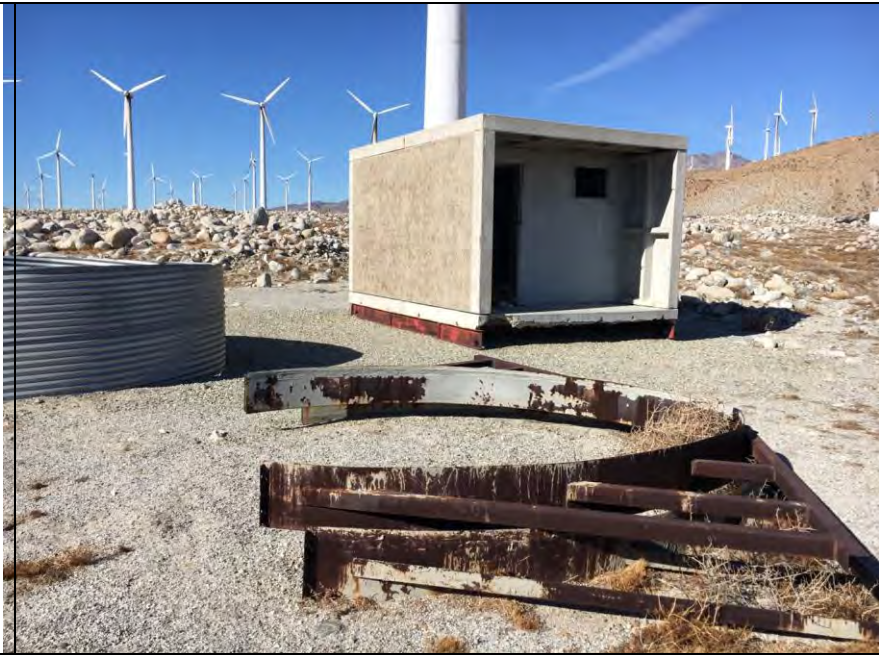
**Photo: 14**

**Vacant Concrete Structures** – Three vacant concrete structures were observed during the December 16, 2020 site reconnaissance. Two of the structures were single room 17 feet by 13 feet concrete tilt-up structures on skids and according to Mr. Jesse Lopez, once contained communication equipment used for the wind turbines. The third vacant structure appeared to be approximately five rooms, was constructed out of concrete block with footings, and was possibly used as a residence. Although some walls were still standing, no roof was observed on the structure. Within the multiroom structure appeared to be construction debris. Various piping was observed in and around the multiroom structure however no clear evidence of an underground storage tank was observed (other than some pipes sticking up). Additional demolition and removal consideration may be warranted. No staining or odors were observed in relation to any of the vacant concrete structures or associated piping however due to the unknown origins of the piping, they are considered a data gap and a business environmental risk.

View of one of the two abandoned single room concrete structures.
