## MAJESTIC THOUSAND PALMS PROJECT

### BIOLOGICAL RESOURCES AND MSHCP CONSISTENCY REPORT

Riverside County, California

December 9, 2022

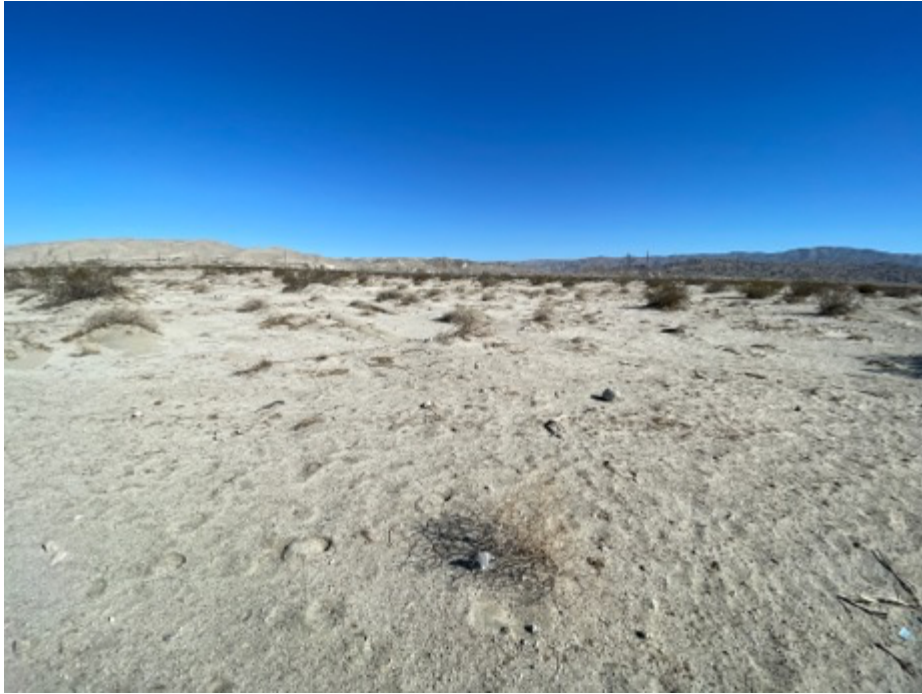
Photo 1. Overview of the northern portion of the project site, facing north. Photo shows sparse disturbed Sonoran creosote bush scrub on site. March 23, 2022.

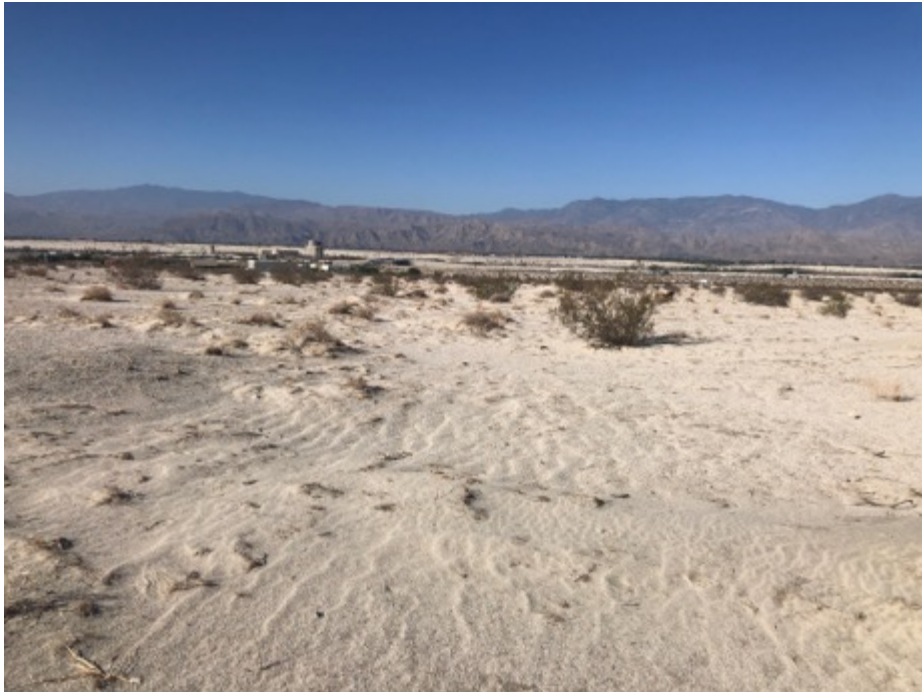
Photo 2. Overview of northwestern portion of the project site, facing south. Photo shows sparse disturbed Sonoran creosote such scrub and slight variations in topography and sediment. May 25, 2022.

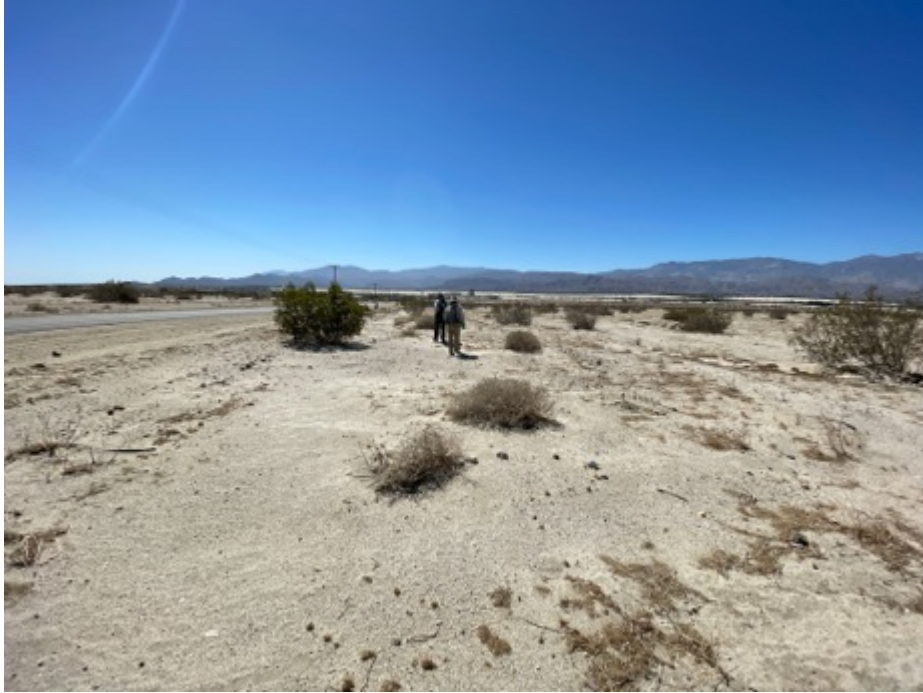
Photo 3. Overview of the western border and buffer of the project site, facing south. Photo shows sparse disturbed Sonoran creosote such scrub adjacent to Rio Del Sol Road. March 23, 2022.

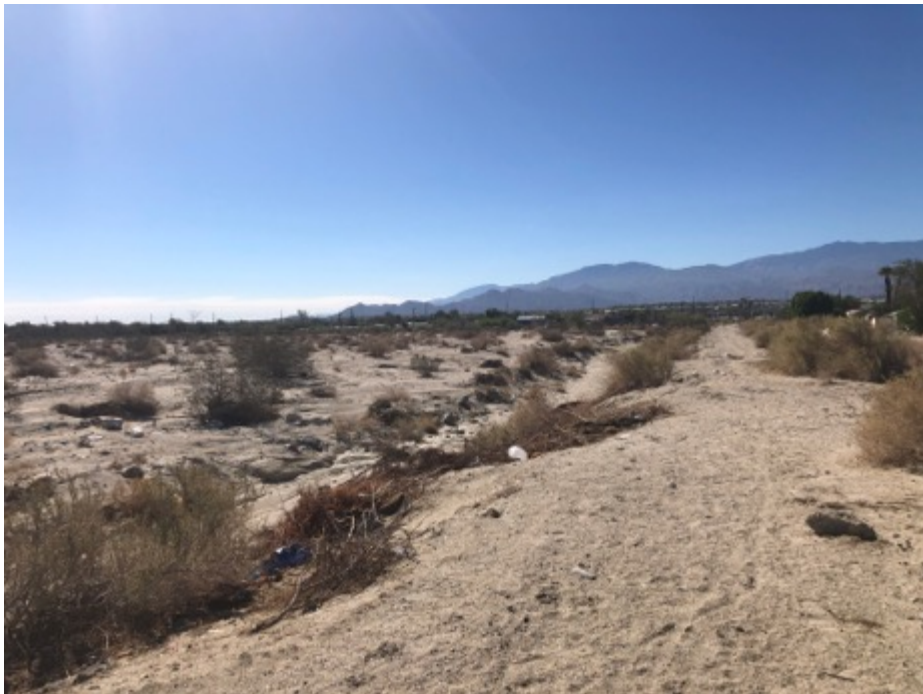
Photo 4. Overview of the disturbed desert saltbush scrub in the southern portion of the project site, facing southeast. September 21, 2022.

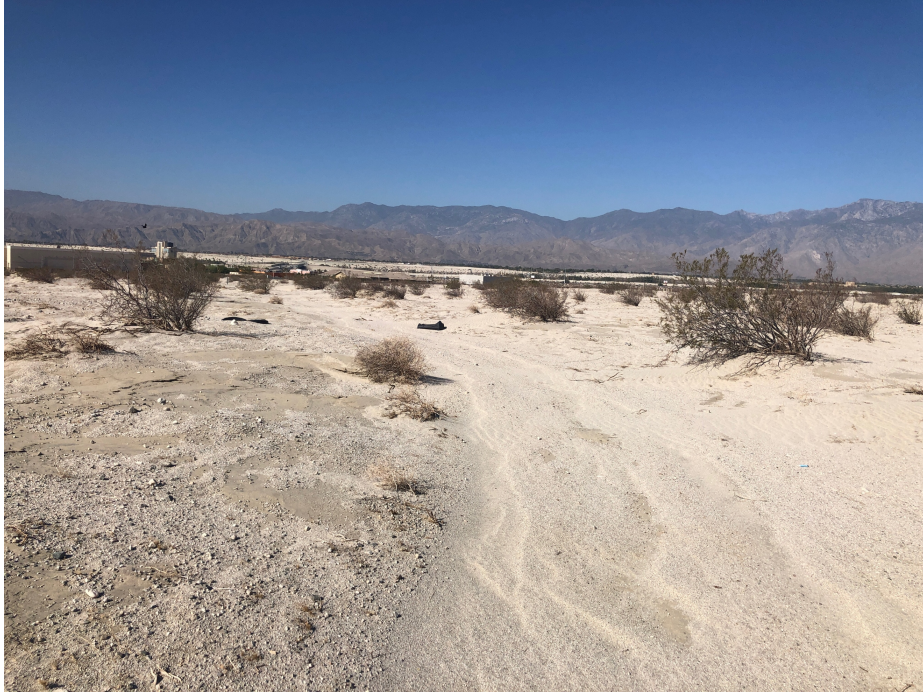
Photo 5. Downstream view of Non-wetland Water (NWW-) 1 within disturbed Sonoran creosote bush scrub in the northwestern portion of the project site, facing southwest. May 25, 2022.

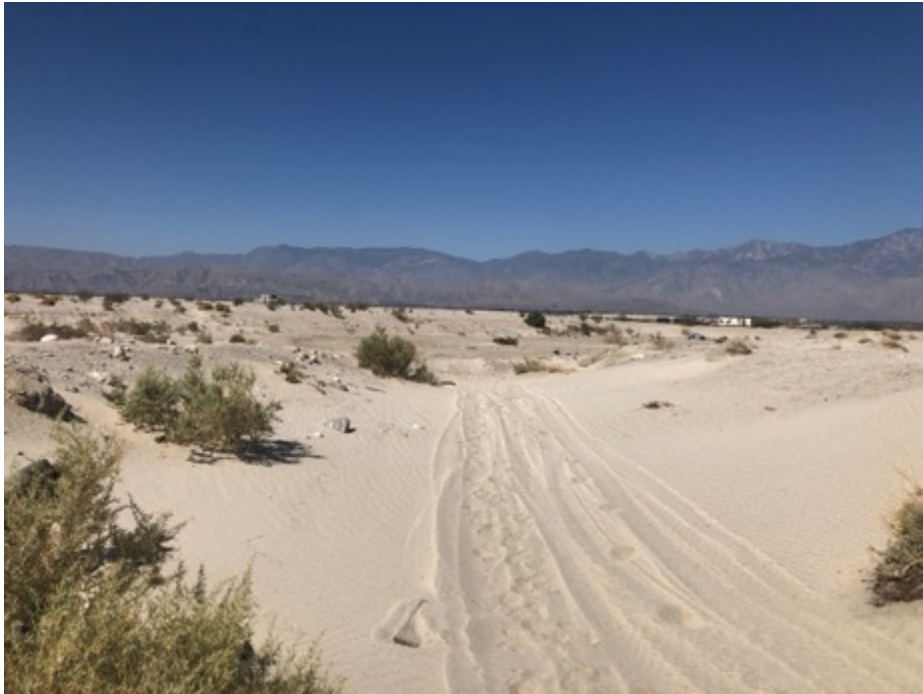
Photo 6. Downstream view of NWW-2 as it transitions to a detention basin within disturbed Sonoran creosote bush scrub in the northern portion of the project site, facing southwest. May 25, 2022.

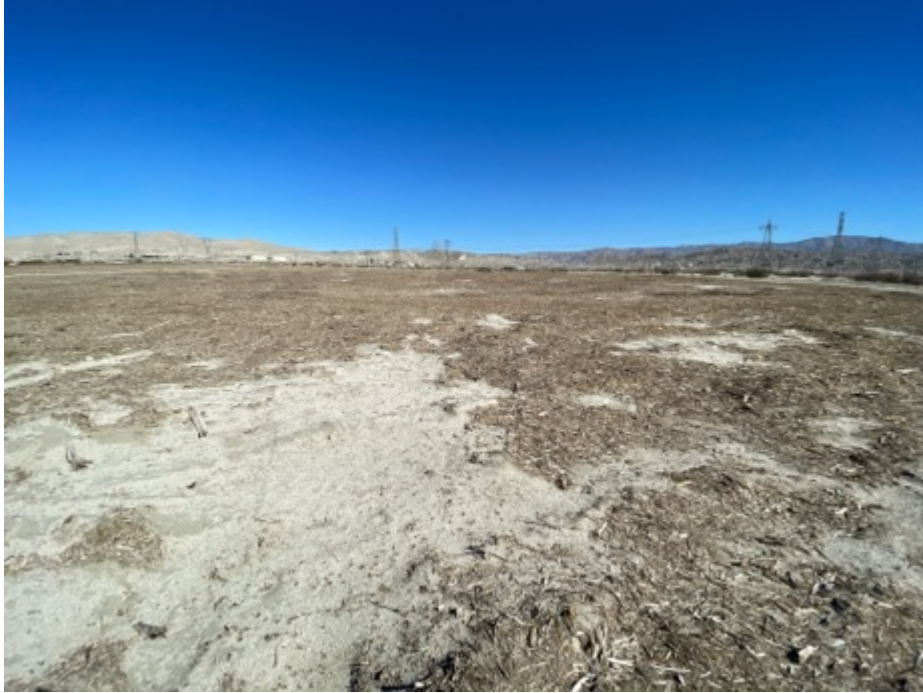
Photo 7. Land showing evidence of human activities/alterations (i.e., sprinkler heads and mulch) within the northern project boundary and buffer, facing north. March 23, 2022.

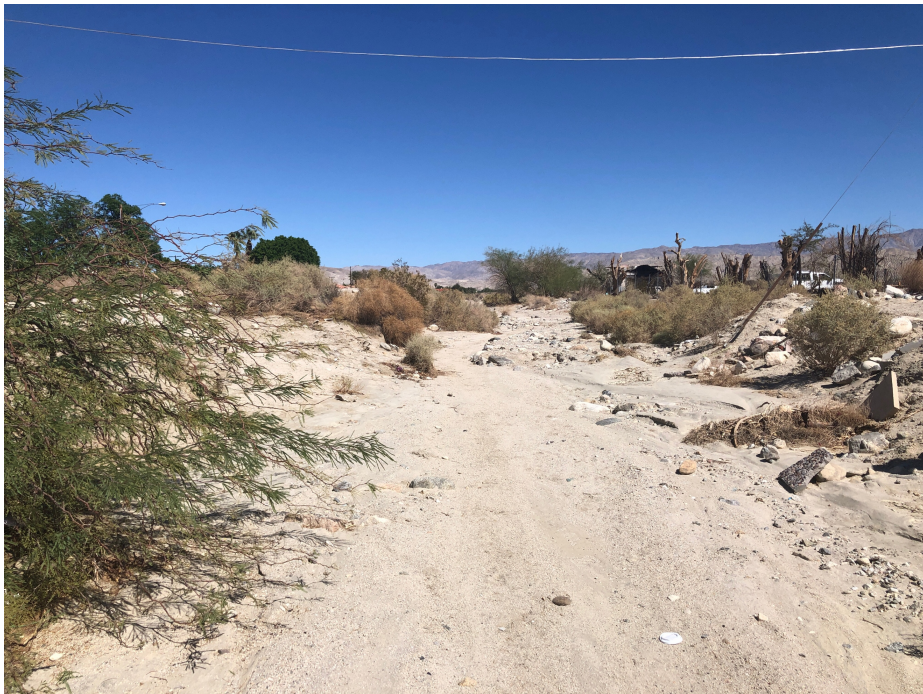
Photo 8. Upstream view of NWW-3 within disturbed desert saltbush scrub in the southeastern portion of the project buffer, facing north. September 21, 2022.

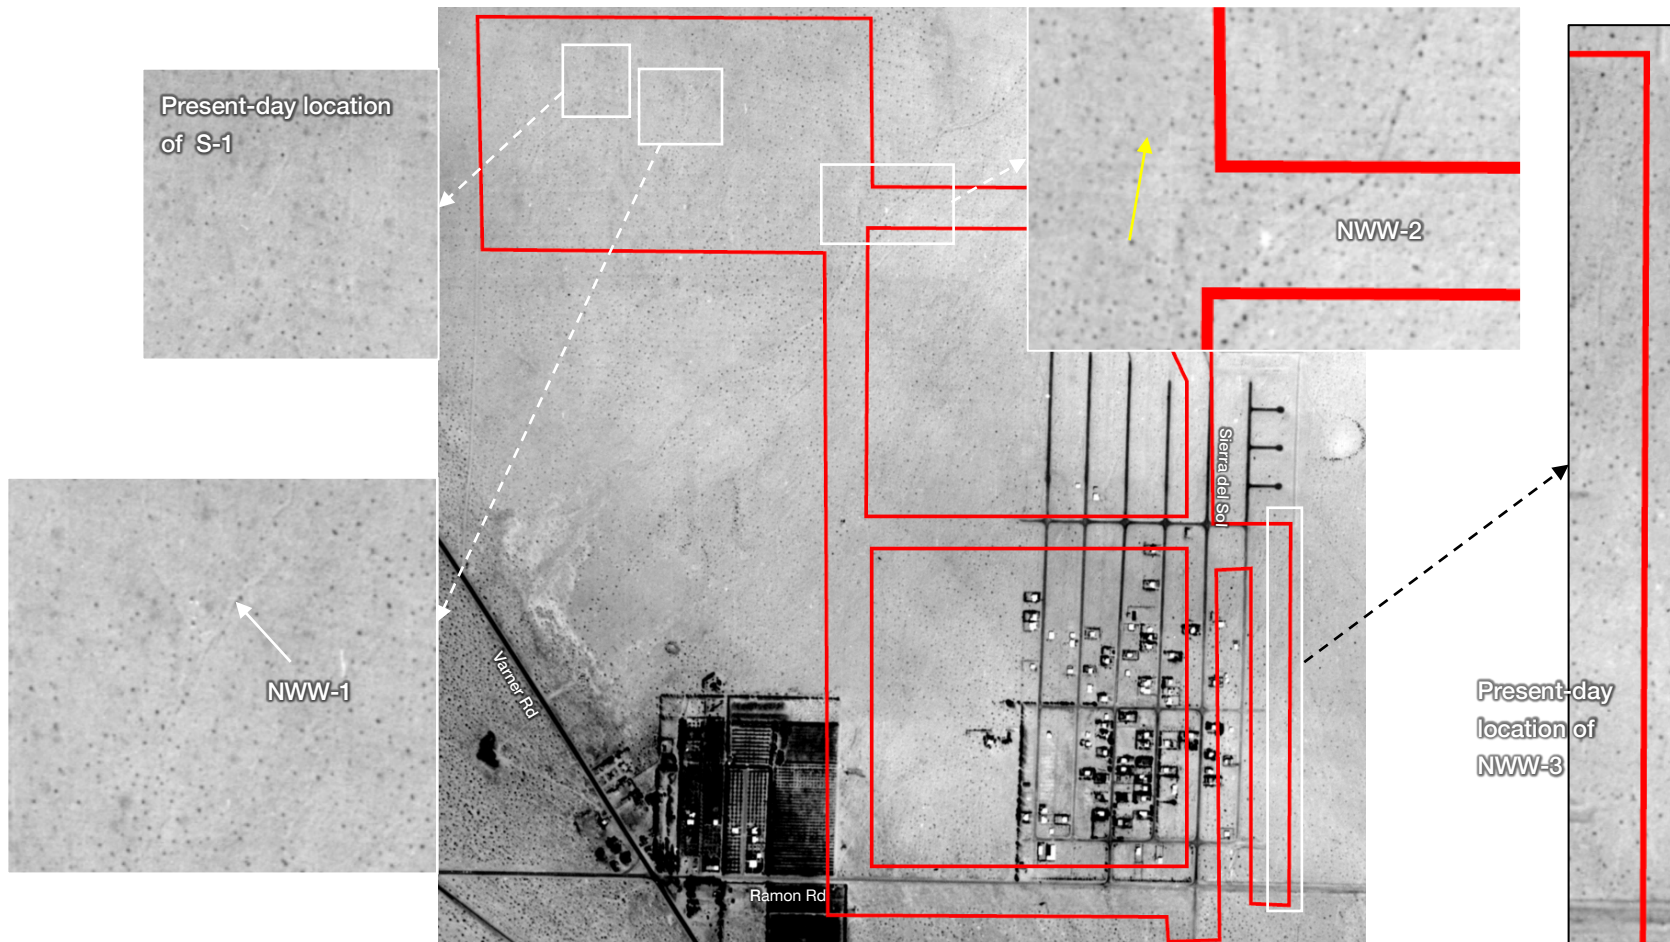
**September 1953** – Little development occurs within and surrounding the northern and western extents of the review area in the September 1953 aerial. Varner Road, Ramon Road, and Sierra del Sol appear in their approximate present-day locations. Residential development is present within and surrounding segments of the southern portion of the review area and an agricultural operation occurs to the southwest of the review area. Non-Wetland Water (NWW-) 1 and the northern portion of NWW-2 generally appear in their approximate present-day locations; however, NWW-2 appears to continue off site and the detention basin within NWW-2 is not present. NWW-3 (and San Miguelito Road directly to the west), Swale (S-) 1, and Basin (B-) 1 are not visible in the September 1953 aerial; no features are visible in the westernmost area mapped by the USGS NHD as “Stream/River” and by the USFWS NWI as “Riverine” (yellow arrow).

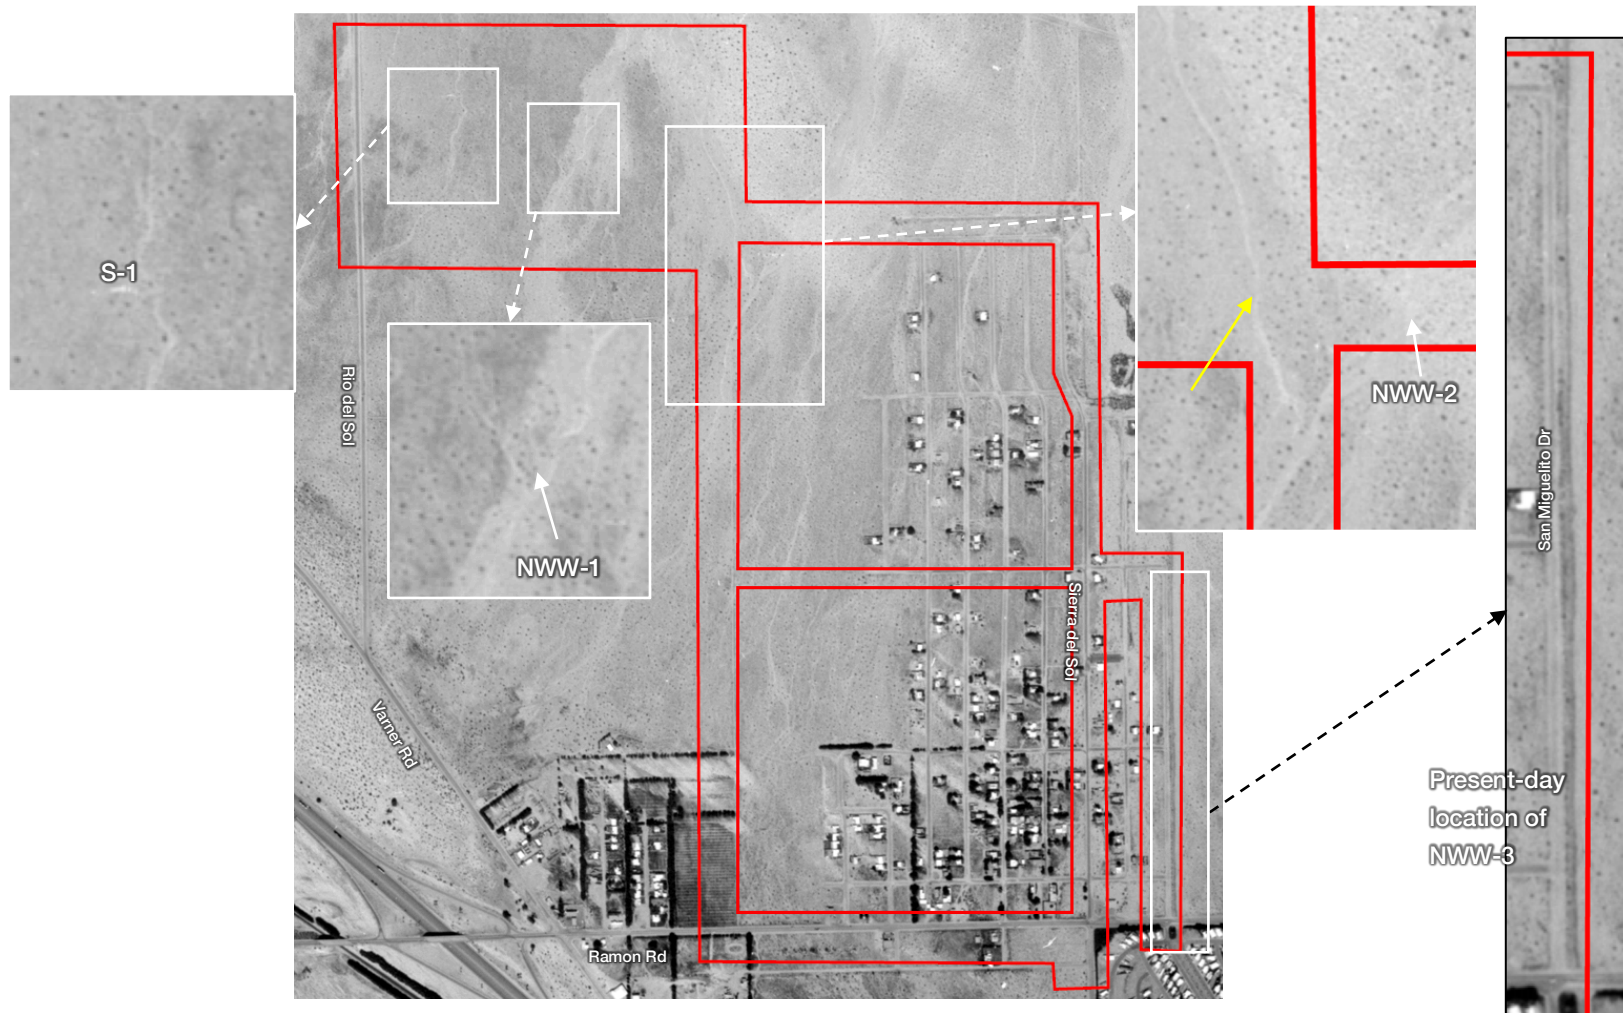
**March 1978** – Between September 1953 and March 1978, Rio Del Sol and San Miguelito Drive were constructed in their present-day locations. NWW-1 is generally visible in its present-day location; however, NWW-1 appears to extend farther northeast and southwest in the 1978 aerial. NWW-2 is less pronounced than in the 1953 aerial, yet the northern portion is still visible in roughly its present-day location; however, the detention basin within NWW-2 is not present and thus, NWW-2 appears to continue off site then briefly reenter the review area before continuing off site. A feature is visible traveling through the present-day location of S-1. NWW-3 and B-1 are not visible in the March 1978 aerial. A linear feature is visible in the westernmost area mapped by the USGS NHD as “Stream/River” and by the USFWS NWI as “Riverine” (yellow arrow).

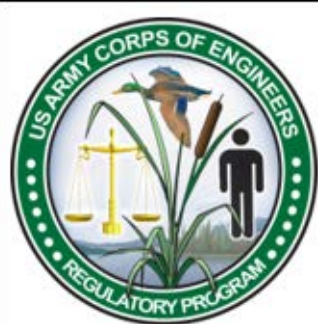
Coordinates	33.830275, -116.406042
Observation Date	2022-05-25
Elevation (ft)	299.69
Drought Index (PDSI)	Extreme drought (2022-04)
WebWIMP H <sub>2</sub> O Balance	Dry Season

30 Days Ending	30 <sup>th</sup> %ile (in)	70 <sup>th</sup> %ile (in)	Observed (in)	Wetness Condition	Condition Value	Month Weight	Product
2022-05-25	0.104331	0.638976	0.011811	Dry	1	3	3
2022-04-25	0.374409	1.337402	0.92126	Normal	2	2	4
2022-03-26	0.95315	3.11378	0.299213	Dry	1	1	1
Result							Drier than Normal - 8

Figure and tables made by the  
**Antecedent Precipitation Tool**  
Version 1.0

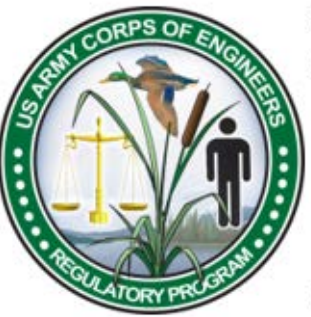
Coordinates	33.830275, -116.406042
Observation Date	2022-09-21
Elevation (ft)	299.69
Drought Index (PDSI)	Severe drought (2022-08)
WebWIMP H <sub>2</sub> O Balance	Dry Season

30 Days Ending	30 <sup>th</sup> %ile (in)	70 <sup>th</sup> %ile (in)	Observed (in)	Wetness Condition	Condition Value	Month Weight	Product
2022-09-21	0.0	0.147638	0.531496	Wet	3	3	9
2022-08-22	0.0	0.200394	0.0	Normal	2	2	4
2022-07-23	0.0	0.031496	0.0	Normal	2	1	2
Result							<b>Wetter than Normal - 15</b>

Figure and tables made by the  
**Antecedent Precipitation Tool**  
 Version 1.0

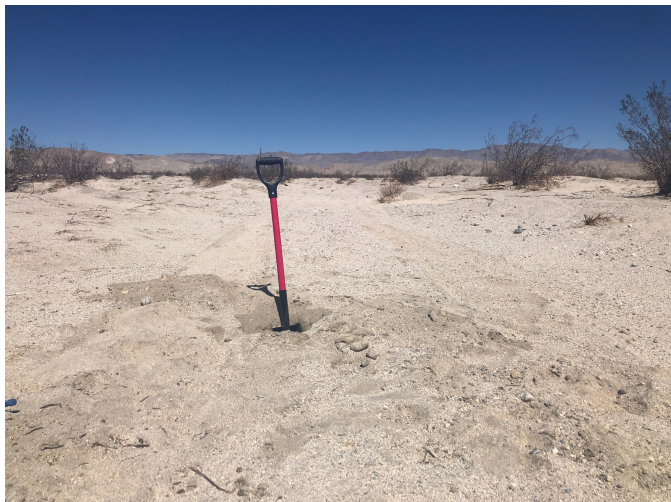
Photo 3. View of Wetland Data Form Point (WDP) 1, facing north, within NWW-1 in disturbed Sonoran creosote bush scrub. WDP 1 did not meet the wetland hydrology, hydrophytic vegetation, or hydric soil parameters (33.831460, -116.401022). September 21, 2022.

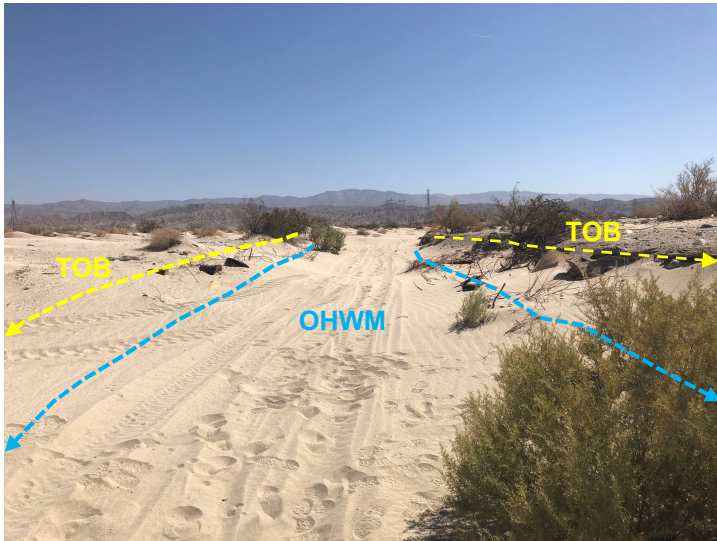
Photo 5. Upstream view of ODP 2, facing northeast, within NWW-2 (33.830868, -116.394854). May 25, 2022

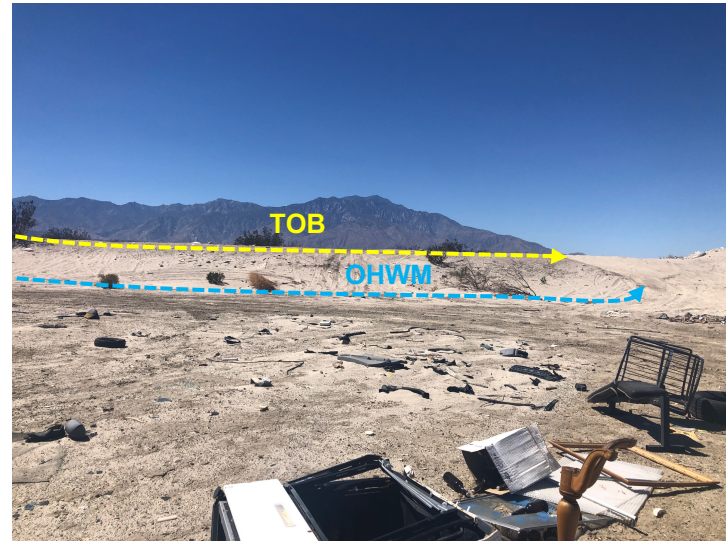
Photo 6. View of ODP 5 within NWW-2, within the detention basin, facing west. ODP 5 exhibited a break in bank slope, change in average sediment texture, change in vegetation species, and change in vegetation cover (33.830557, -116.396274). September 21, 2022.

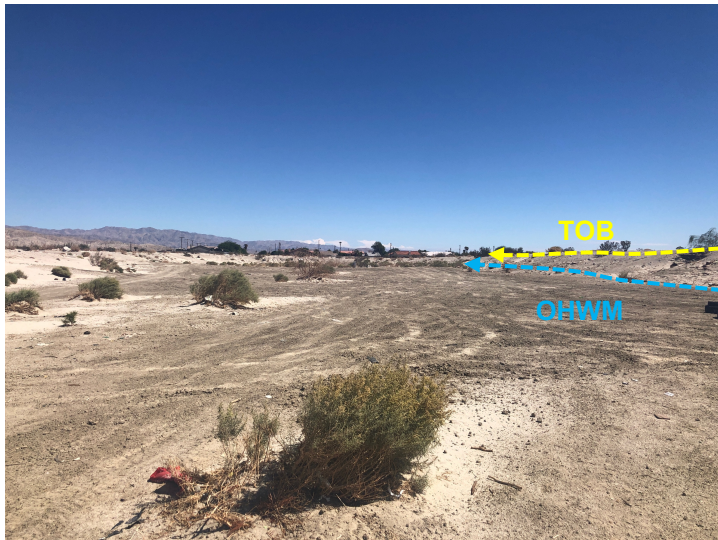
Photo 7. View of ODP 5, facing east, within NWW-2 (33.830571, -116.396271). September 21, 2022.

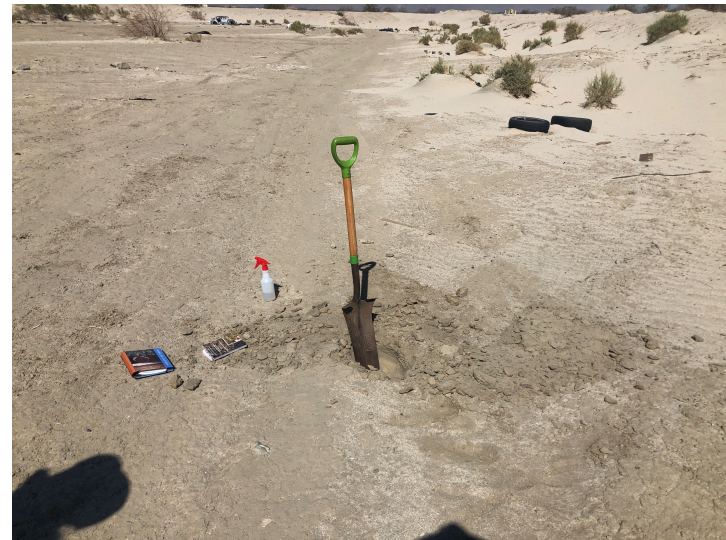
Photo 8. View of WDP 2, facing west, within NWW-2 after the feature transitions to a detention basin. WDP 2 met the wetland hydrology parameter; however, WDP 2 did not meet the hydrophytic vegetation or hydric soil parameters (33.830669, -116.395343). May 25, 2022

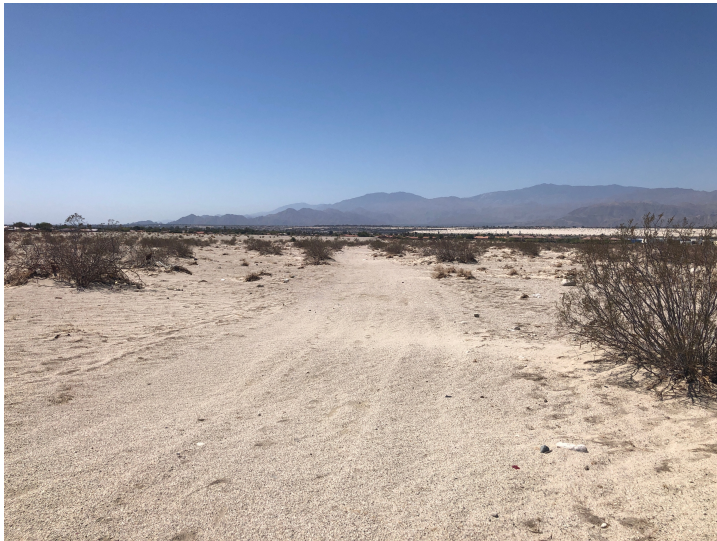
Photo 9. View of westernmost area where U.S. Fish and Wildlife Service (USFWS) National Wetlands Inventory (NWI) maps a “Riverine” feature and the U.S. Geological Survey (USGS) National Hydrography Dataset (NHD) maps a “Stream/River” feature, facing south, within disturbed Sonoran creosote bush scrub. The area is currently used as a road; no OHWM indicators were observed (33.833992, -116.397776). May 25, 2022

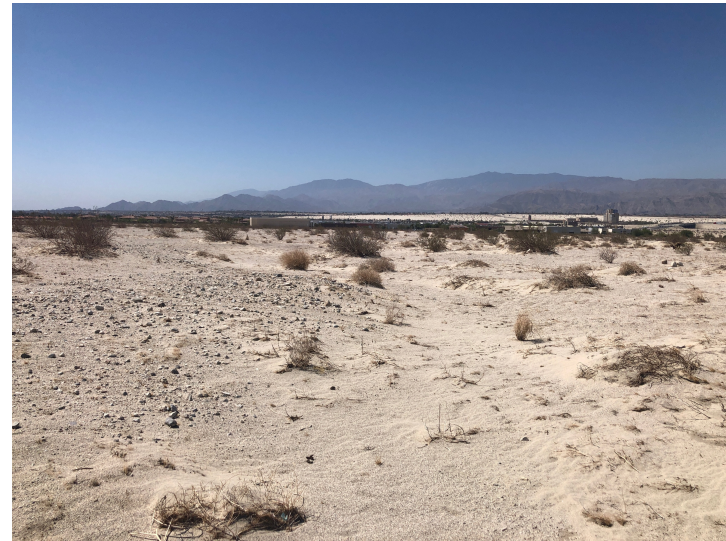
Photo 10. View of ODP 3 within Swale (S-) 1, facing south, within disturbed Sonoran creosote bush scrub. S-1 did not exhibit any bed and bank indicators, there was no change in sediment texture or break in slope, and vegetation did not differ between the swale and the adjacent upland area (33.833575, -116.403317). May 25, 2022

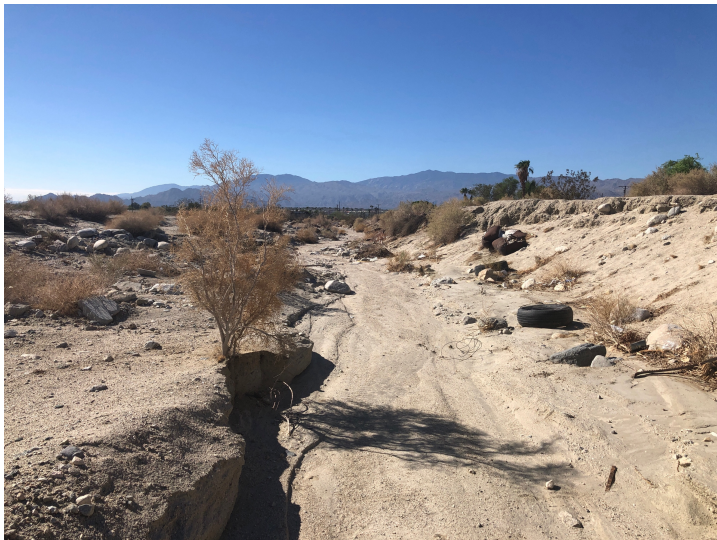
Photo 11. View of NWW-3, facing south, within disturbed desert saltbush scrub (33.821389-116.386061). September 21, 2022.

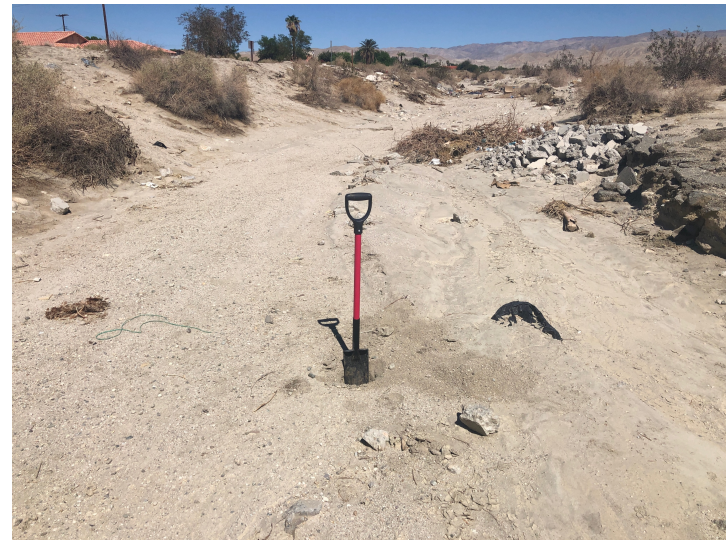
Photo 12. View of WDP 3, facing northwest, within NWW-3, within disturbed desert saltbush scrub. WDP 3 met the wetland hydrology parameter; however, WDP 3 did not meet the hydrophytic vegetation or hydric soil parameters (33.819578, -116.385974). September 21, 2022.

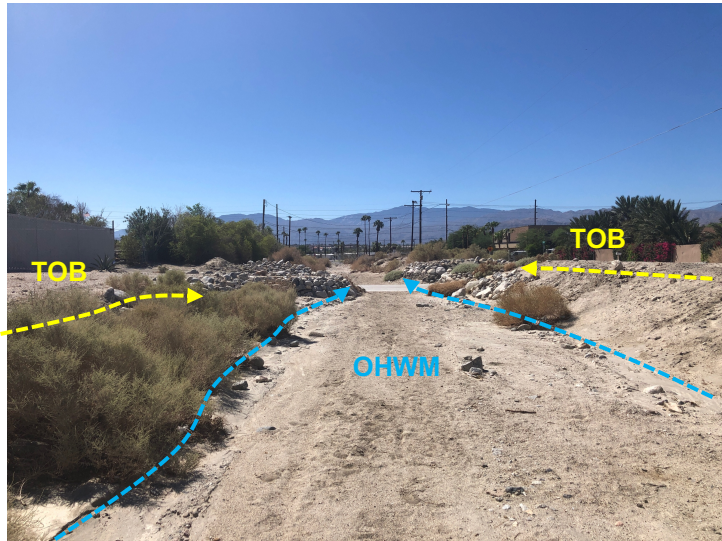
Photo 13. Downstream view of ODP 4 within NWW-3, facing south, within disturbed desert saltbush scrub. ODP 4 exhibited a break in bank slope, change in average sediment texture, change in vegetation species, and change in vegetation cover (33.818154, -116.386089). September 21, 2022.

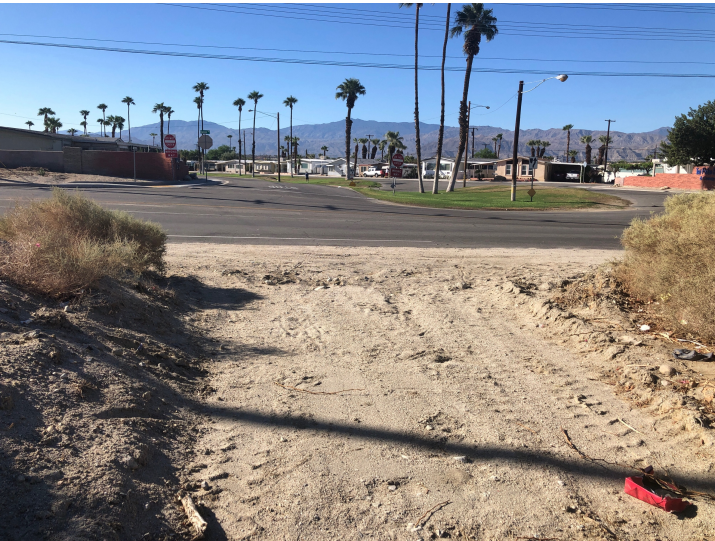
Photo 15. Downstream extent of NWW-3, facing south, where it dissipates at Ramon Road (33.816621, -116.386044). September 21, 2022.

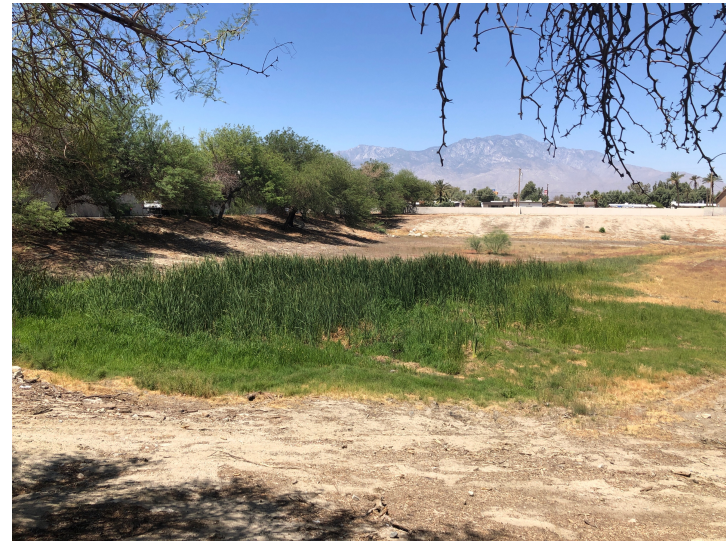
Photo 16. View of artificially constructed and maintained detention basin (B-)-1 that generally occurs outside of the review area, facing west, within a developed area (33.817503, -116.397087). May 25, 2022

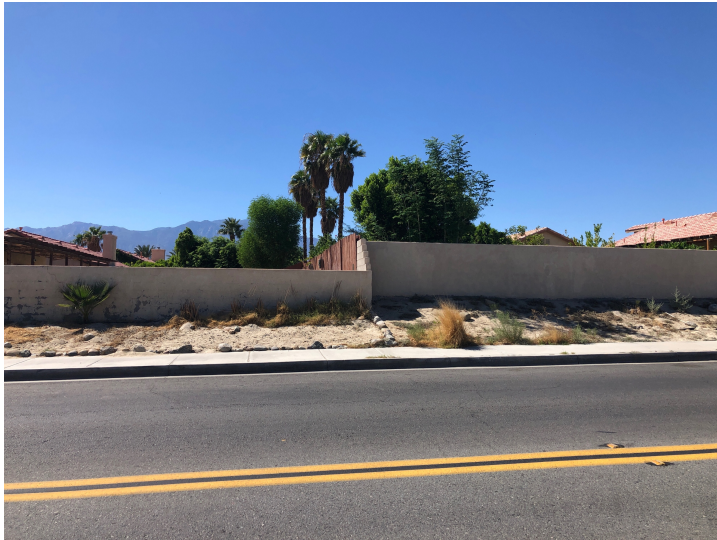
Photo 17. View of area mapped as Myoma fine sands, 5 to 15 percent slopes (soil rated as hydric per the NRCS), facing east, within the southwestern portion of the review area. Area is a developed, private property; therefore, a wetland sampling point was not taken (33.819544, -116.396834). September 21, 2022.

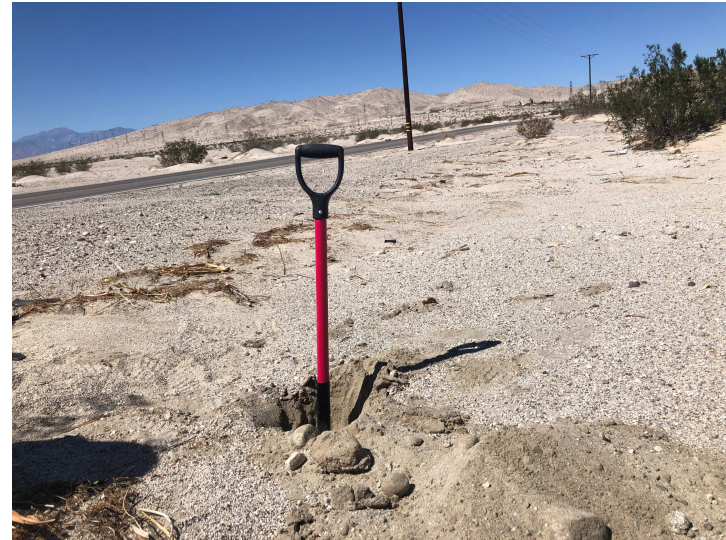
Photo 18. View of WDP 4, facing north, within disturbed Sonoran creosote bush scrub. WDP 4 did not meet the wetland hydrology, hydrophytic vegetation, or hydric soil parameters (33.832213, -116.405639). September 21, 2022.
