**Ethanac Motorcycle Park
CUP 190014 and CEQ 190083
General Biological Assessment
Riverside County, California**

October 28, 2020

Project Number: LIL19-103

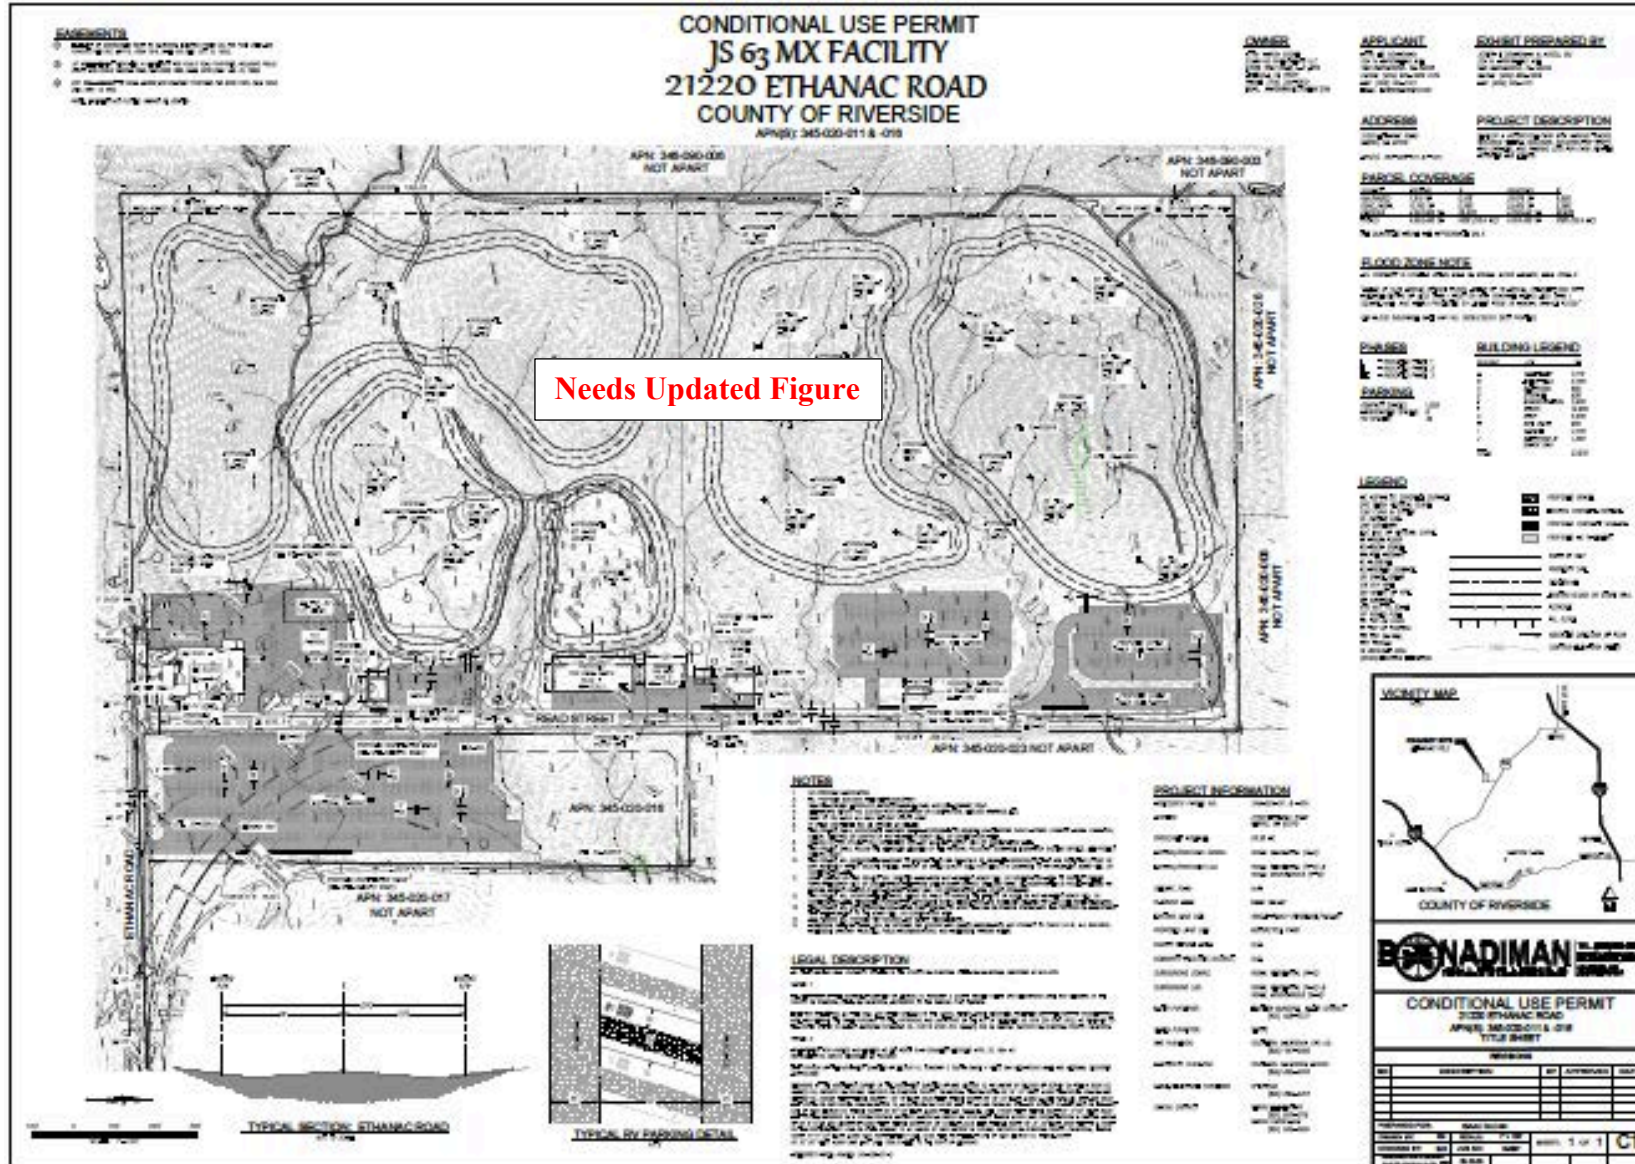
Figure 3. Project Layout

The five proposed tracks include: the Side x Side/Quad Track (approximately 4,000 feet in length) on the southwestern corner of the site in an "L" shape, the Beginner/Peewee Track (approximately 1,600 feet in length) on the southern area above the Super Moto Track in an oval shape, the SX Track Pad (approximately 1,200 feet in length) in the center of the site in a rounded shape, the Veteran Track (approximately 2,400 feet in length) on the northern portion of the site in a "C" shape, and the Main Track (approximately 2,500 feet in length) on the farthest north portion of the site in a rounded shape. All tracks will be 25 feet in width.

Parking on the project site would include a total of 1,217 spaces within three designated vehicle parking areas. There will be an additional 46 spaces for R.V. parking for day use as well as overnight dry-camping use on the southern portion of the project site.

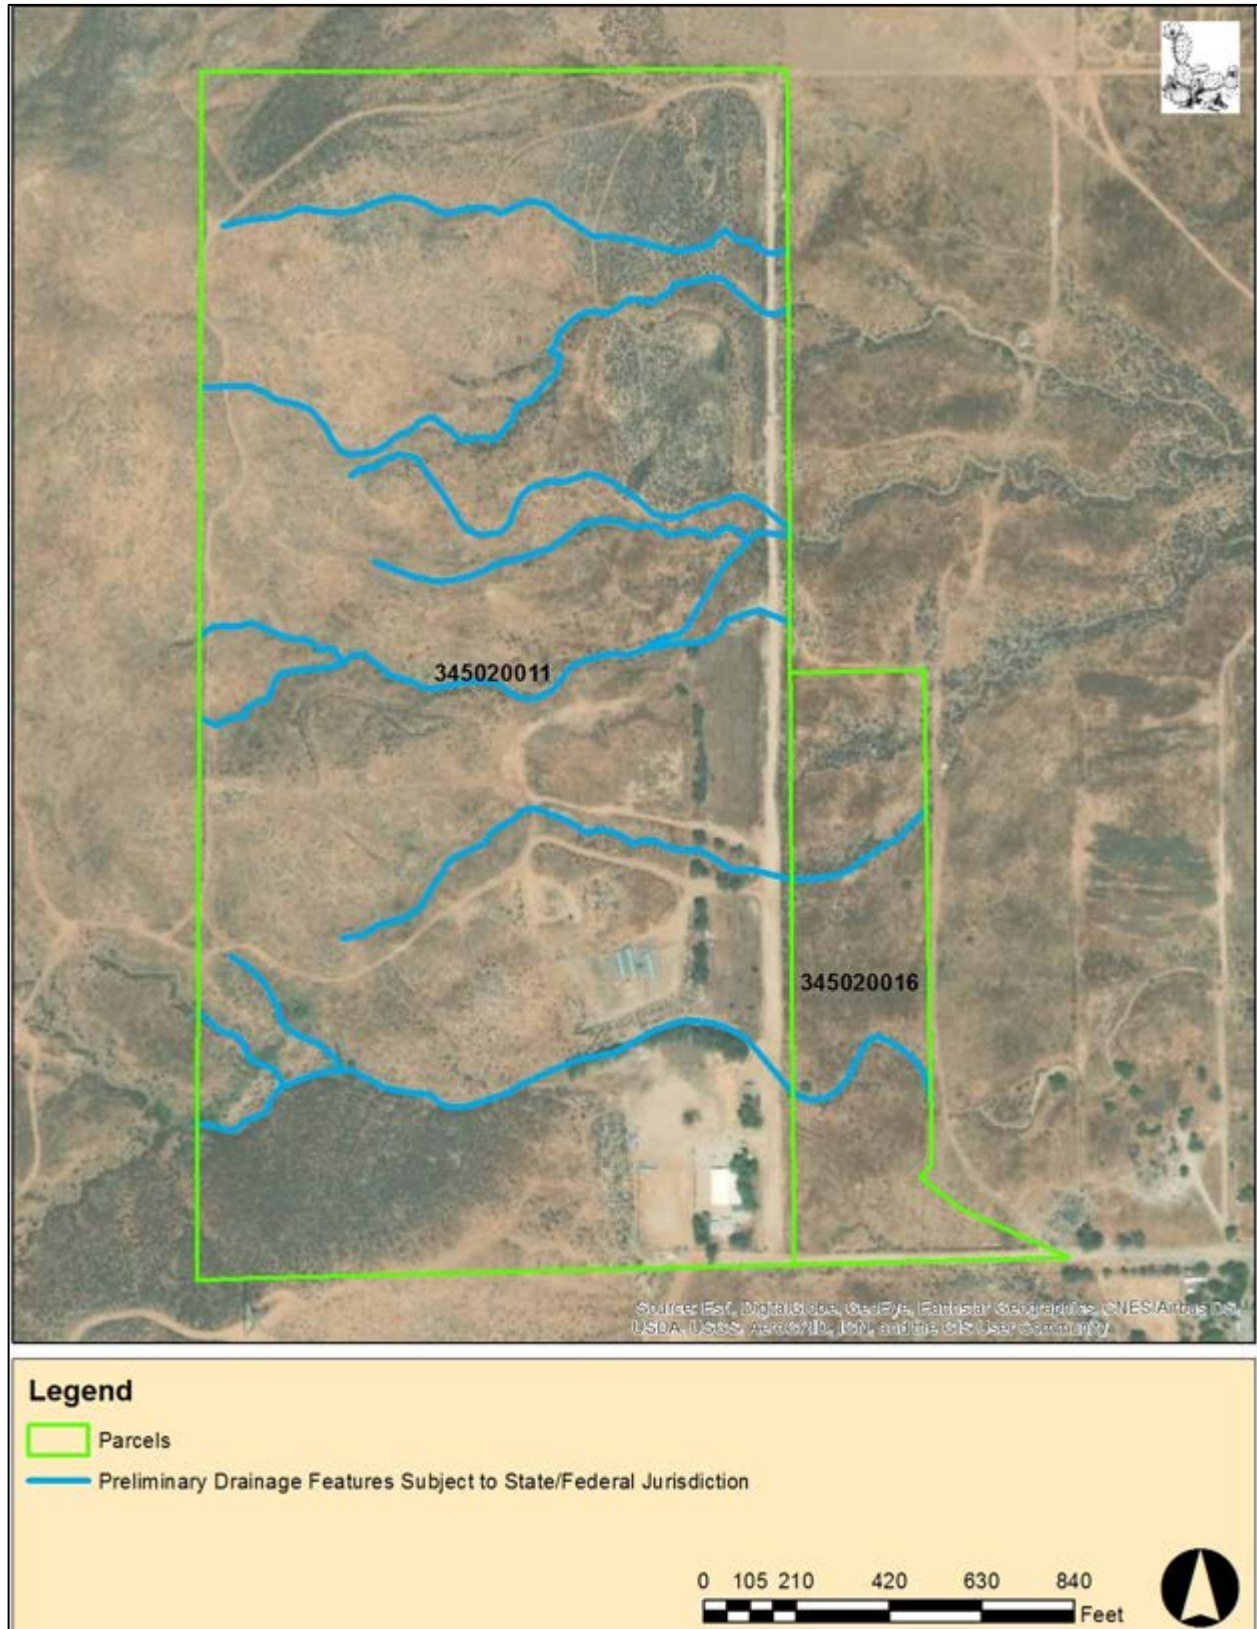
Figure 5. Aerial Topography Showing Mountains and Hill and Gully System.

The property has several drainages (Figure 5). Potential jurisdictional water features were identified and preliminarily delineated via a desktop analysis that employed Google Earth (2018) and ESRI ArcGIS (2018, 2019) imagery. This included the use of historical imagery from Google Earth that allowed the examination of historic waterflow fluctuations. The desktop delineation was then verified during the field surveys.

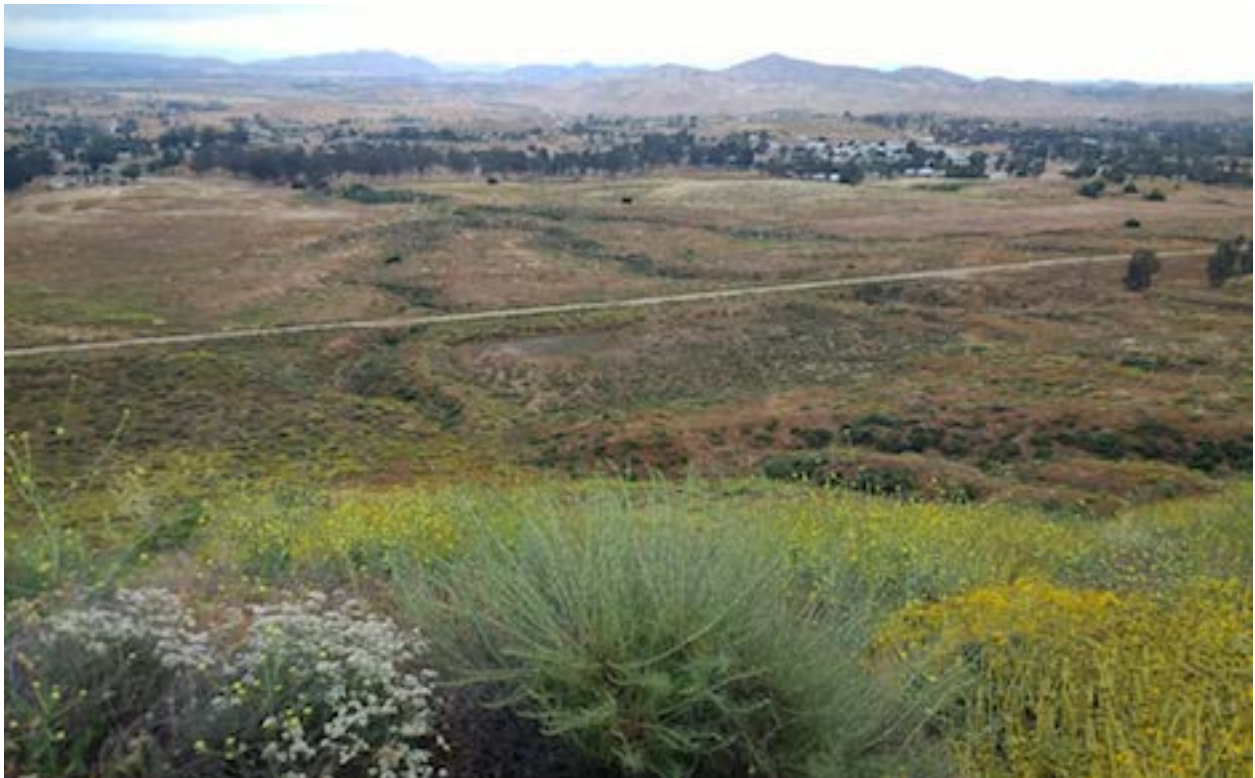
Photo 2. Overview of the six northern drainages to their joining together off site (in the background). Looking east southeast.

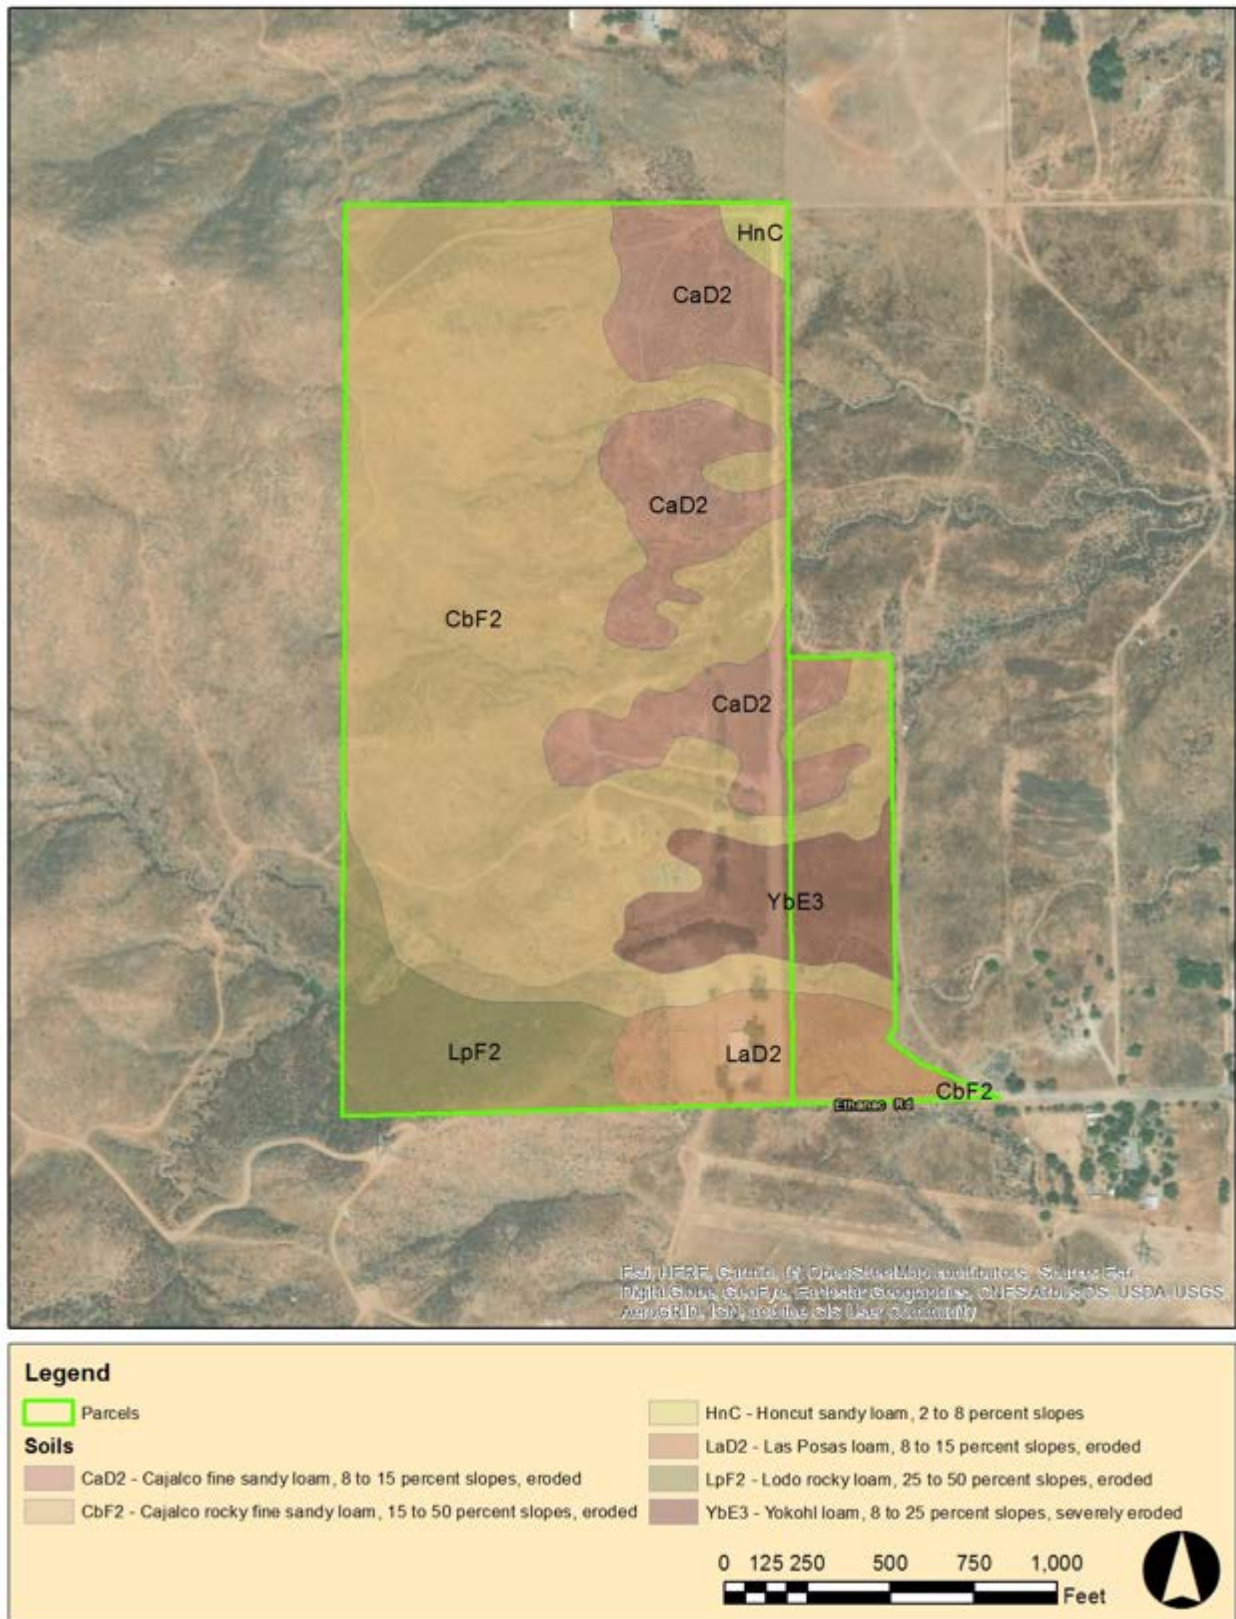
Figure 6. Composition of the Property Soils

There are six soil types on the property (Figure 6, Natural Resources Conservation Service 2019¹). The mountainous areas of the site are composed mostly of a single soil type, while the rest of the soil types are found predominately in the lower flat areas and hill and gully system.

Cajalco rocky fine sandy loam (CbF2) is an eroded soil found on 15 to 50 percent slopes. It is a well-drained soil found on hillsides. This soil is derived from residuum weathered from gabbro, and is a non-hydric soil that never ponds or flood. Cajalco rocky fine sandy loam is the dominant soil on the property.

Cajalco fine sandy loam (CaD2) is an eroded soil found on eight to 15 percent slopes. It is a well-drained non-hydric soil that never ponds or floods. This soil is derived from residuum weathered from gabbro and is found on hillsides. On the property it occurs predominately in the eastern part of the western parcel and extending into the eastern parcel. It occurs mostly along the drainages.

Honcut sandy loam (HnC) is found on two to eight percent slopes. It is a well-drained non-hydric soil that never ponds or floods. This soil is an alluvium derived from igneous rock that occurs on alluvial fans. Honcut sandy loam is non-saline to very slightly saline. It occupies the second smallest area on the property, occurring only in the extreme northeast corner of the eastern parcel.

Yokohl loam (YbE3) is a severely eroded soil found on eight to 25 percent slopes. It is formed of alluvium derived from igneous rock, and is found on alluvial fans. This soil is non-hydric, non-saline to very slightly saline. Yokohl loam is well drained and never ponds or floods. It occurs in and around the southernmost drainage on the project site.

Lodo rocky loam (LpF2) is an eroded soil found on 25 to 50 percent hill slopes. It is formed of metamorphosed residuum that has weathered from sandstone. This soil is somewhat excessively drained, non-hydric and never ponds or floods. Lodo rocky loam occurs on the steeper hillsides in the southern area of the project site.

Las Posas loam (LaD2) is an eroded soil found on eight to 15 percent hill slopes. It is formed from residuum weathered from gabbro. This soil is well-drained, non-hydric that never ponds or floods. Los Posas loam occurs at the base of the mountain slopes in the southern section of the project site.

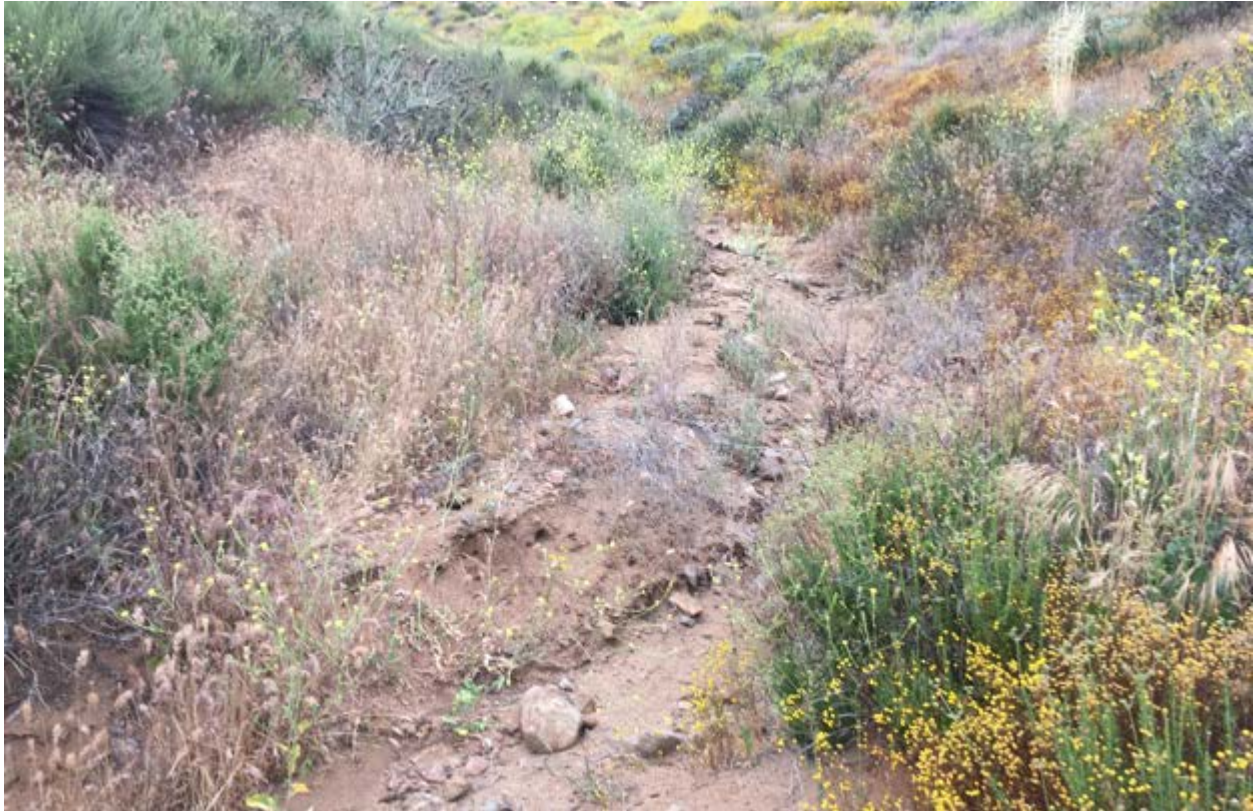
The plant communities along the drainages are dominated by coastal sage scrub mixed with occasional open areas of annual grassland. The bottom of most of the drainages are eroded bare soil (Photo 3).

Photo 3. Dry bottom drainage on the western parcel.

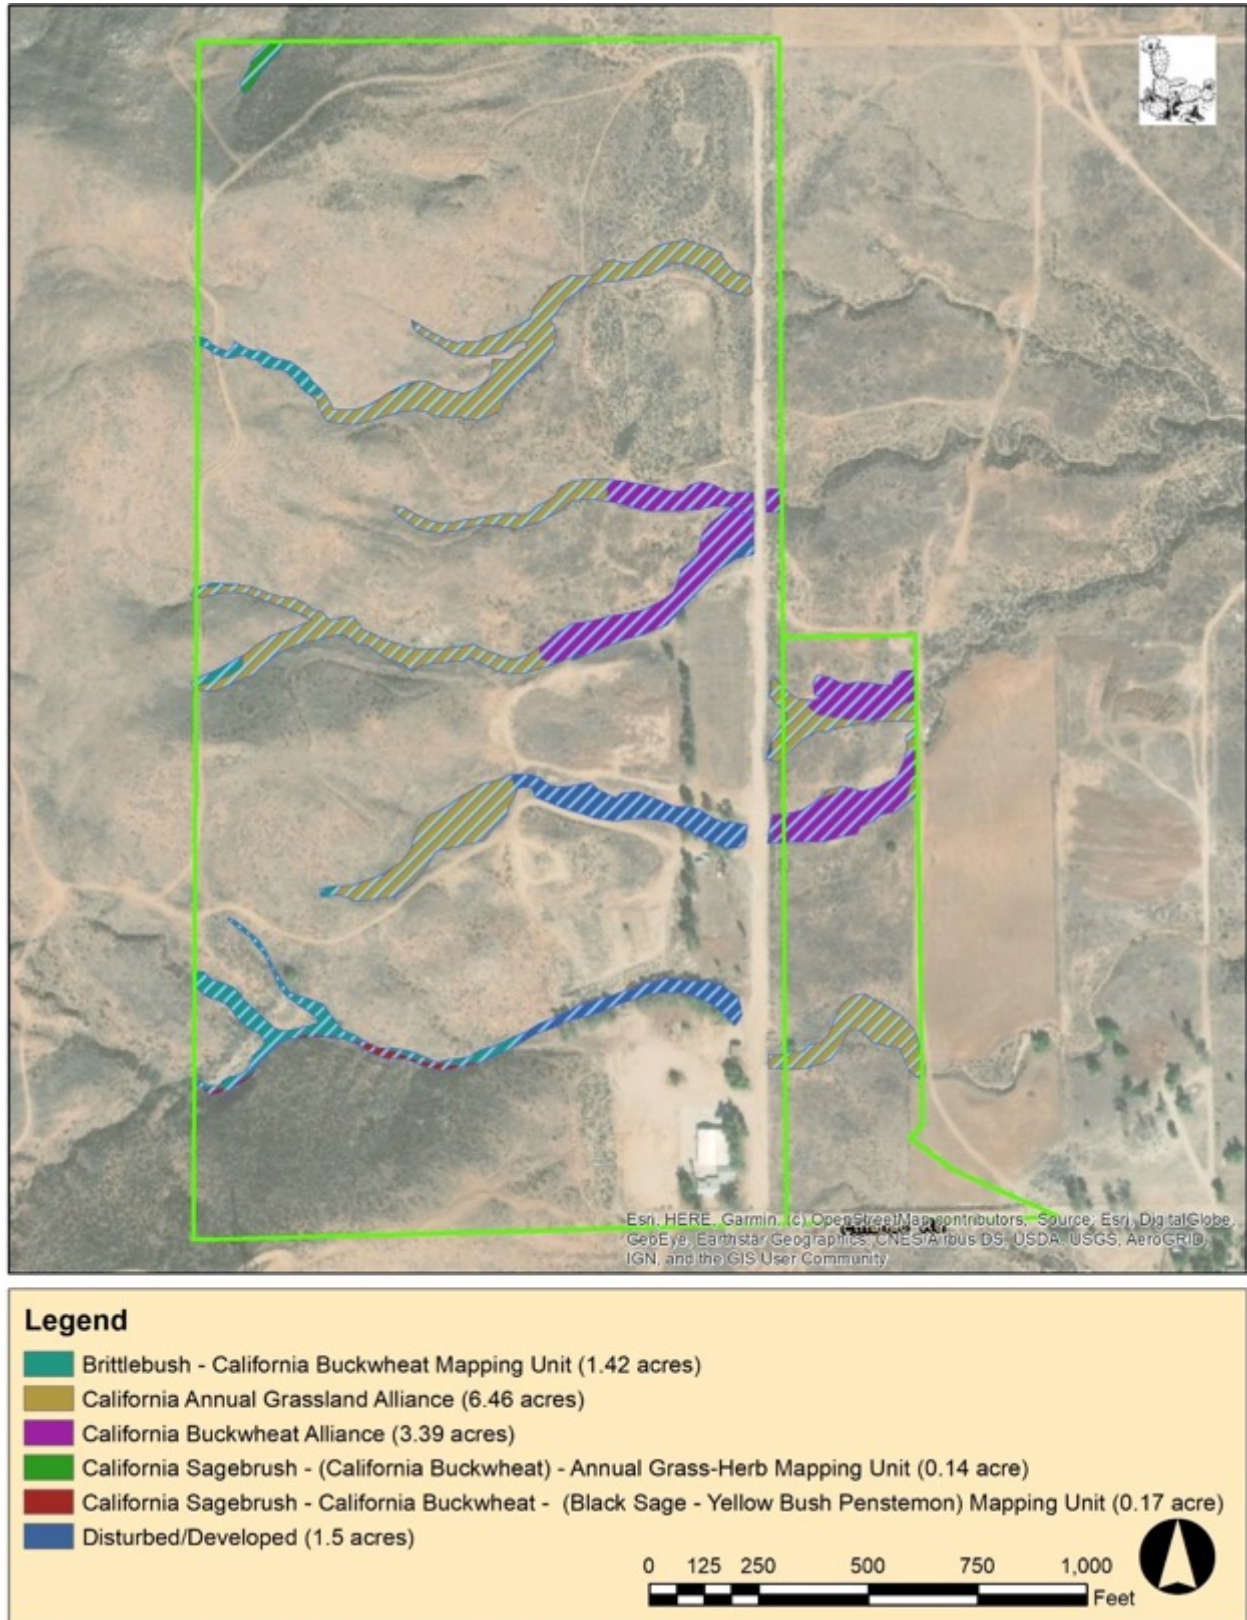
Figure 8. Jurisdictional Areas and Associated Vegetation/

Based on information provided by the Regional Conservation Authority (RCA), these drainages meet the definition of riverine waters, but because they lack connections to riparian resources, they are not protected MSHCP riverine resources.

All the drainages on the property are well-defined and may come under the jurisdiction of the CDFW. There are impacts to all of drainages under the proposal site plan, and we recommend the preparation of a jurisdictional delineation and informal consultation with the CDFW to determine jurisdiction and whether mitigation will be required.

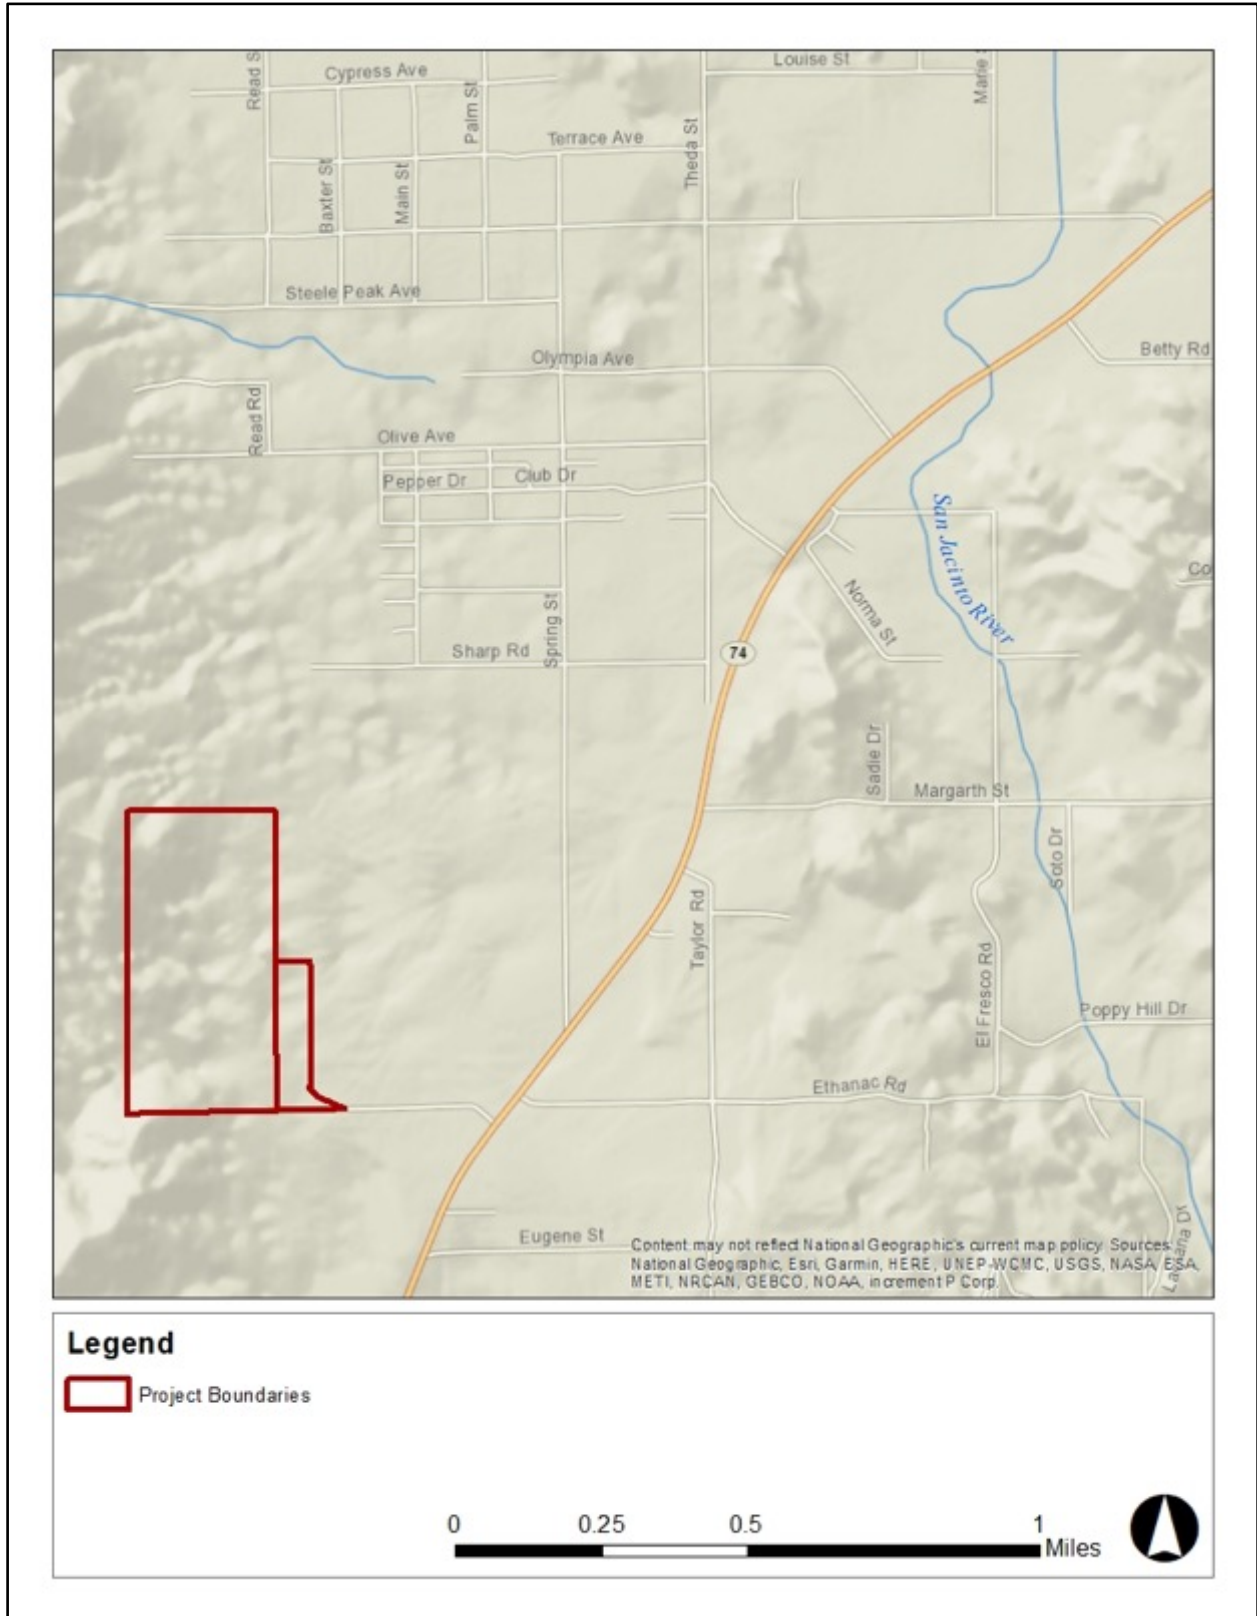
Figure 9. Project Site in Relation to the San Jacinto River.

The San Jacinto River segment closest to the subject drains to Canyon Lake and Lake Elsinore. The mainstem is located 1.3 miles east of the eastern project boundary (Figure 9). We examined water movement between the project site and the San Jacinto River (analysis area) to determine if there is connectivity between waters on the project site and the San Jacinto River.

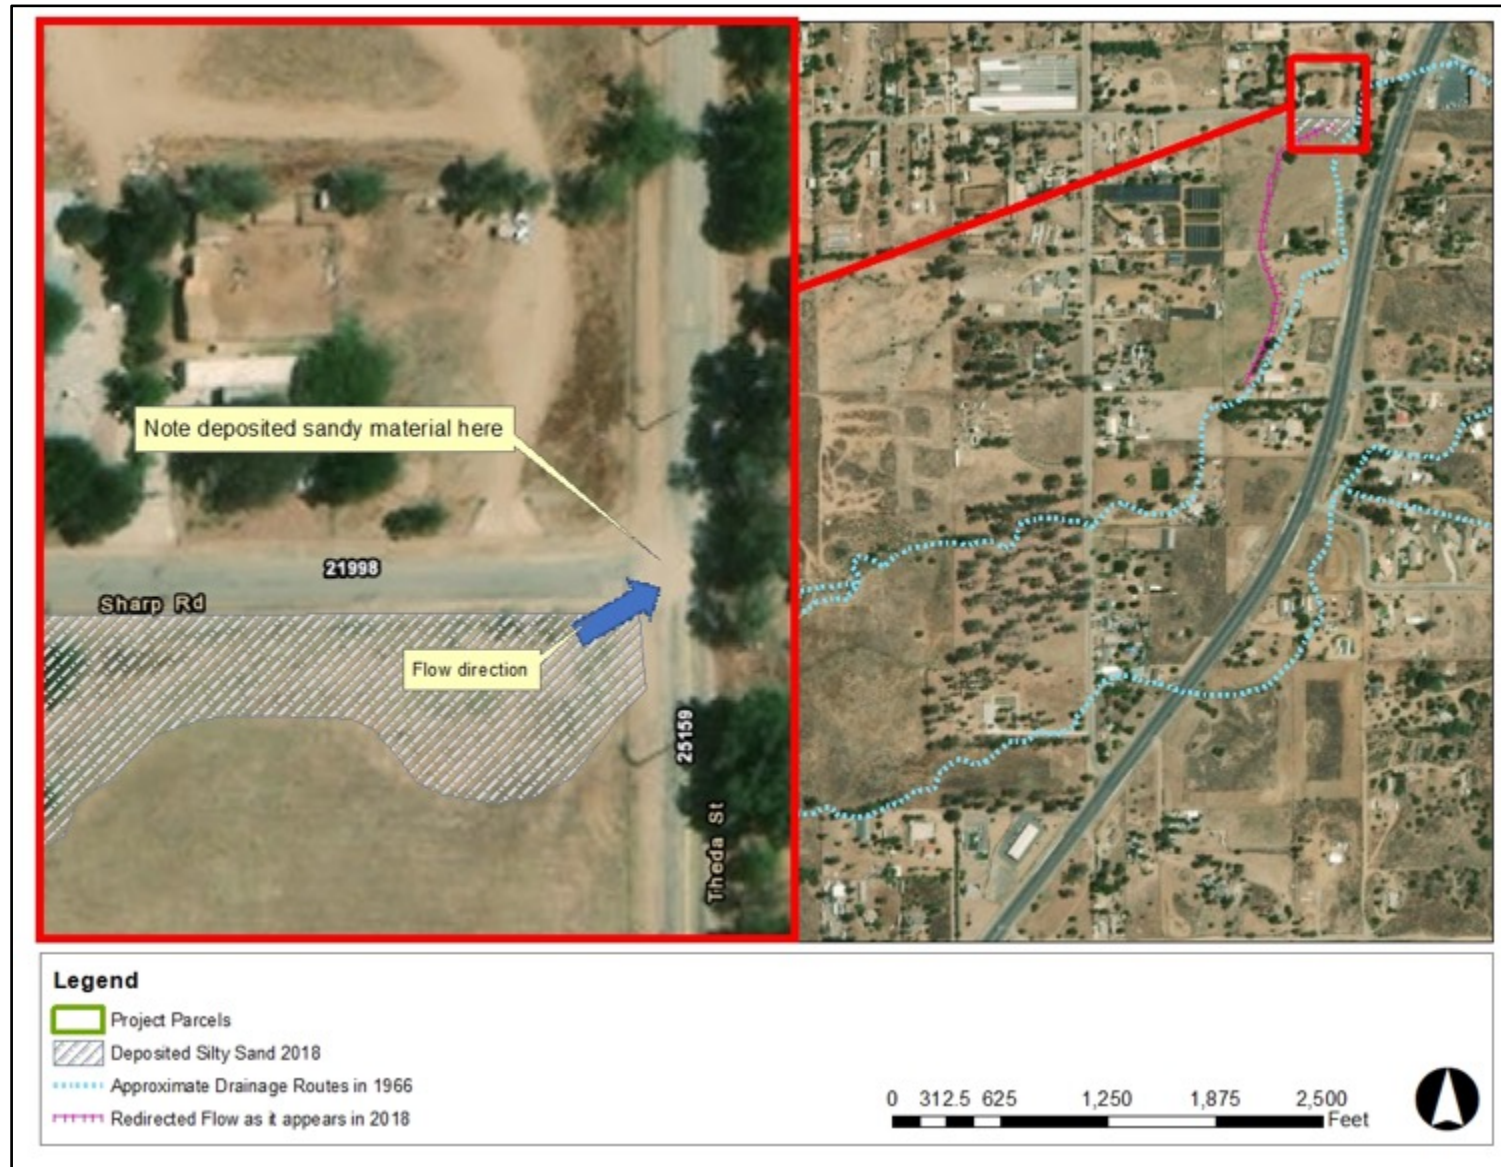
Figure 14. Modified Drainage and Deposited Alluvium from Flooding.

A review of Federal Emergency Management Agency (FEMA) Flood Information Rate Maps (FIRM) for this area shows that FEMA has not yet assigned a specific flood hazard (Zone D – Undetermined Flood Hazard) for this area, acknowledging that there is a possible flood risk here. Flooding only occurs during heavier rainfall years when rerouted drainages are unable to direct waters adequately to the San Jacinto River via removed historic drainages. Man-made structures and roads between Theda Street and Spring Road east of the Project Site obstruct flows and cause occasional flooding.

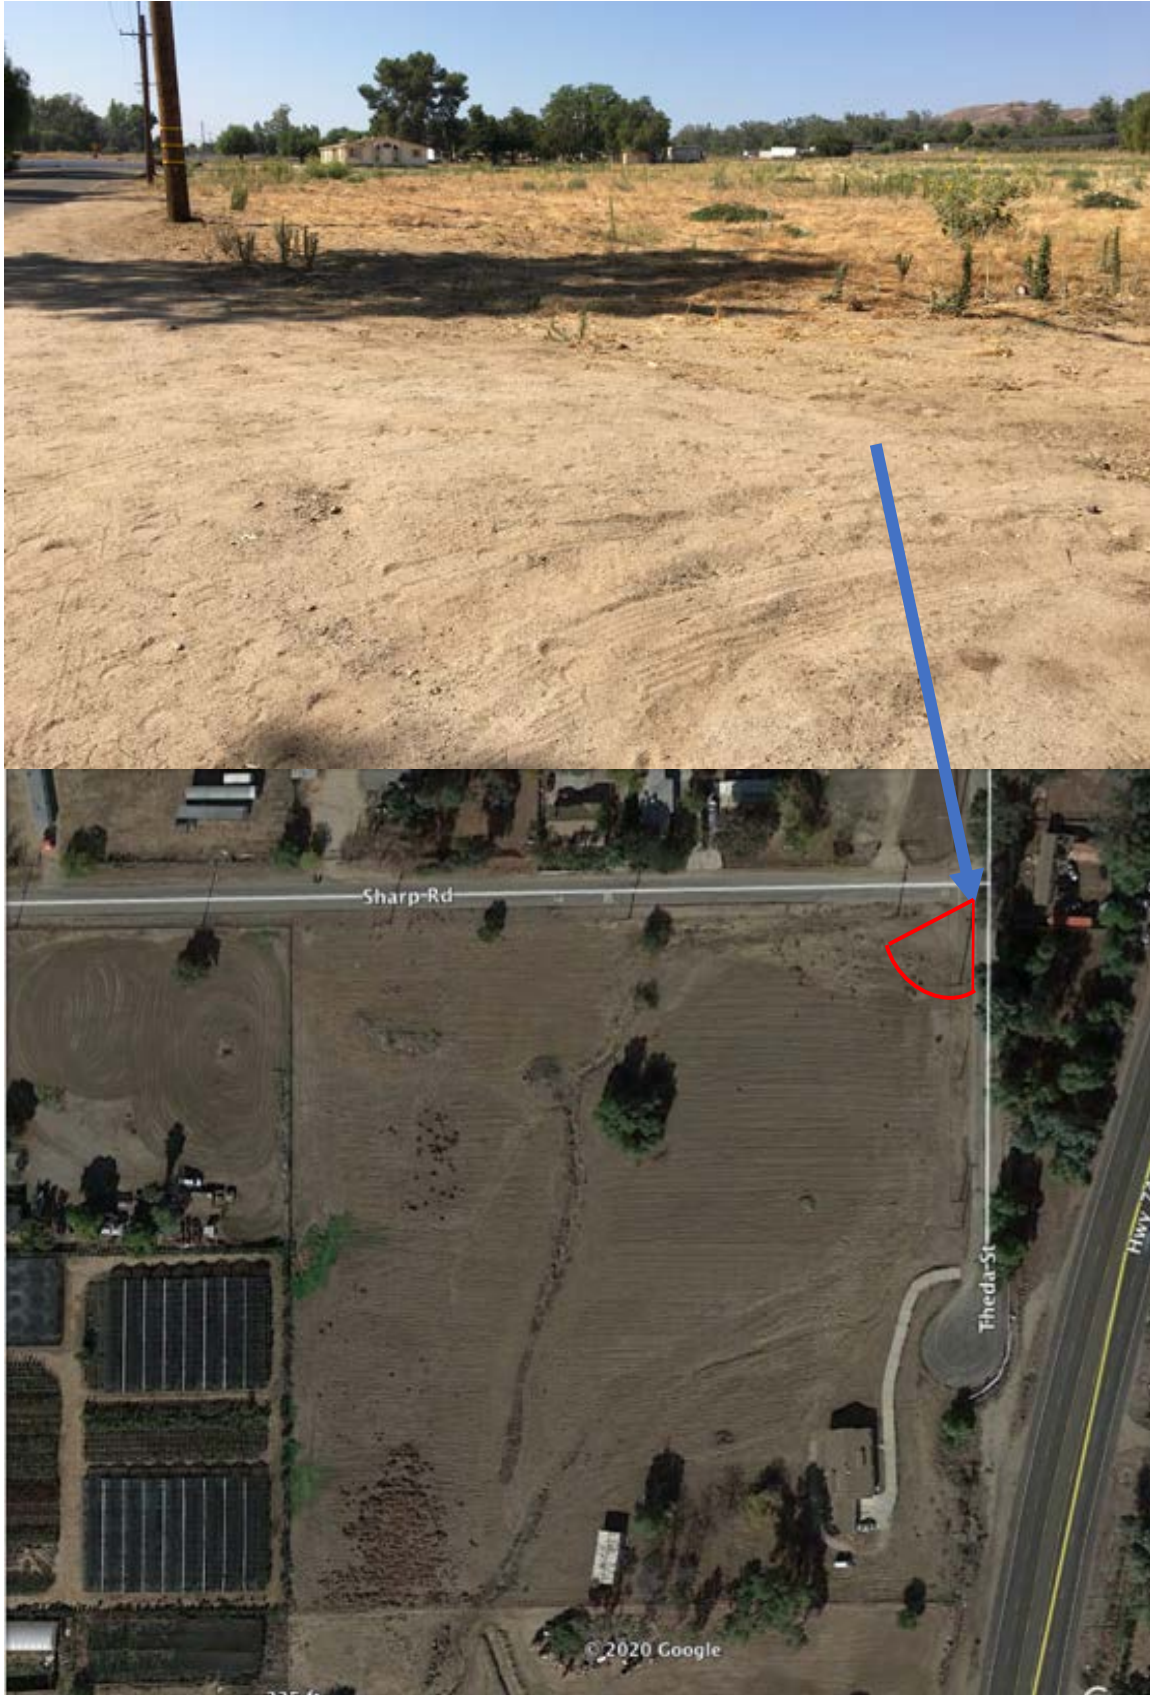
Photo 9. Southwestern Corner of Sharp Road and Theda Street (Photo faces slightly southwest)
