Phase II Environmental Site Assessment

Northwest Corner of Harvill Avenue and Placentia Avenue Perris, Riverside County, California

October 16, 2019

Project No.: 185804524

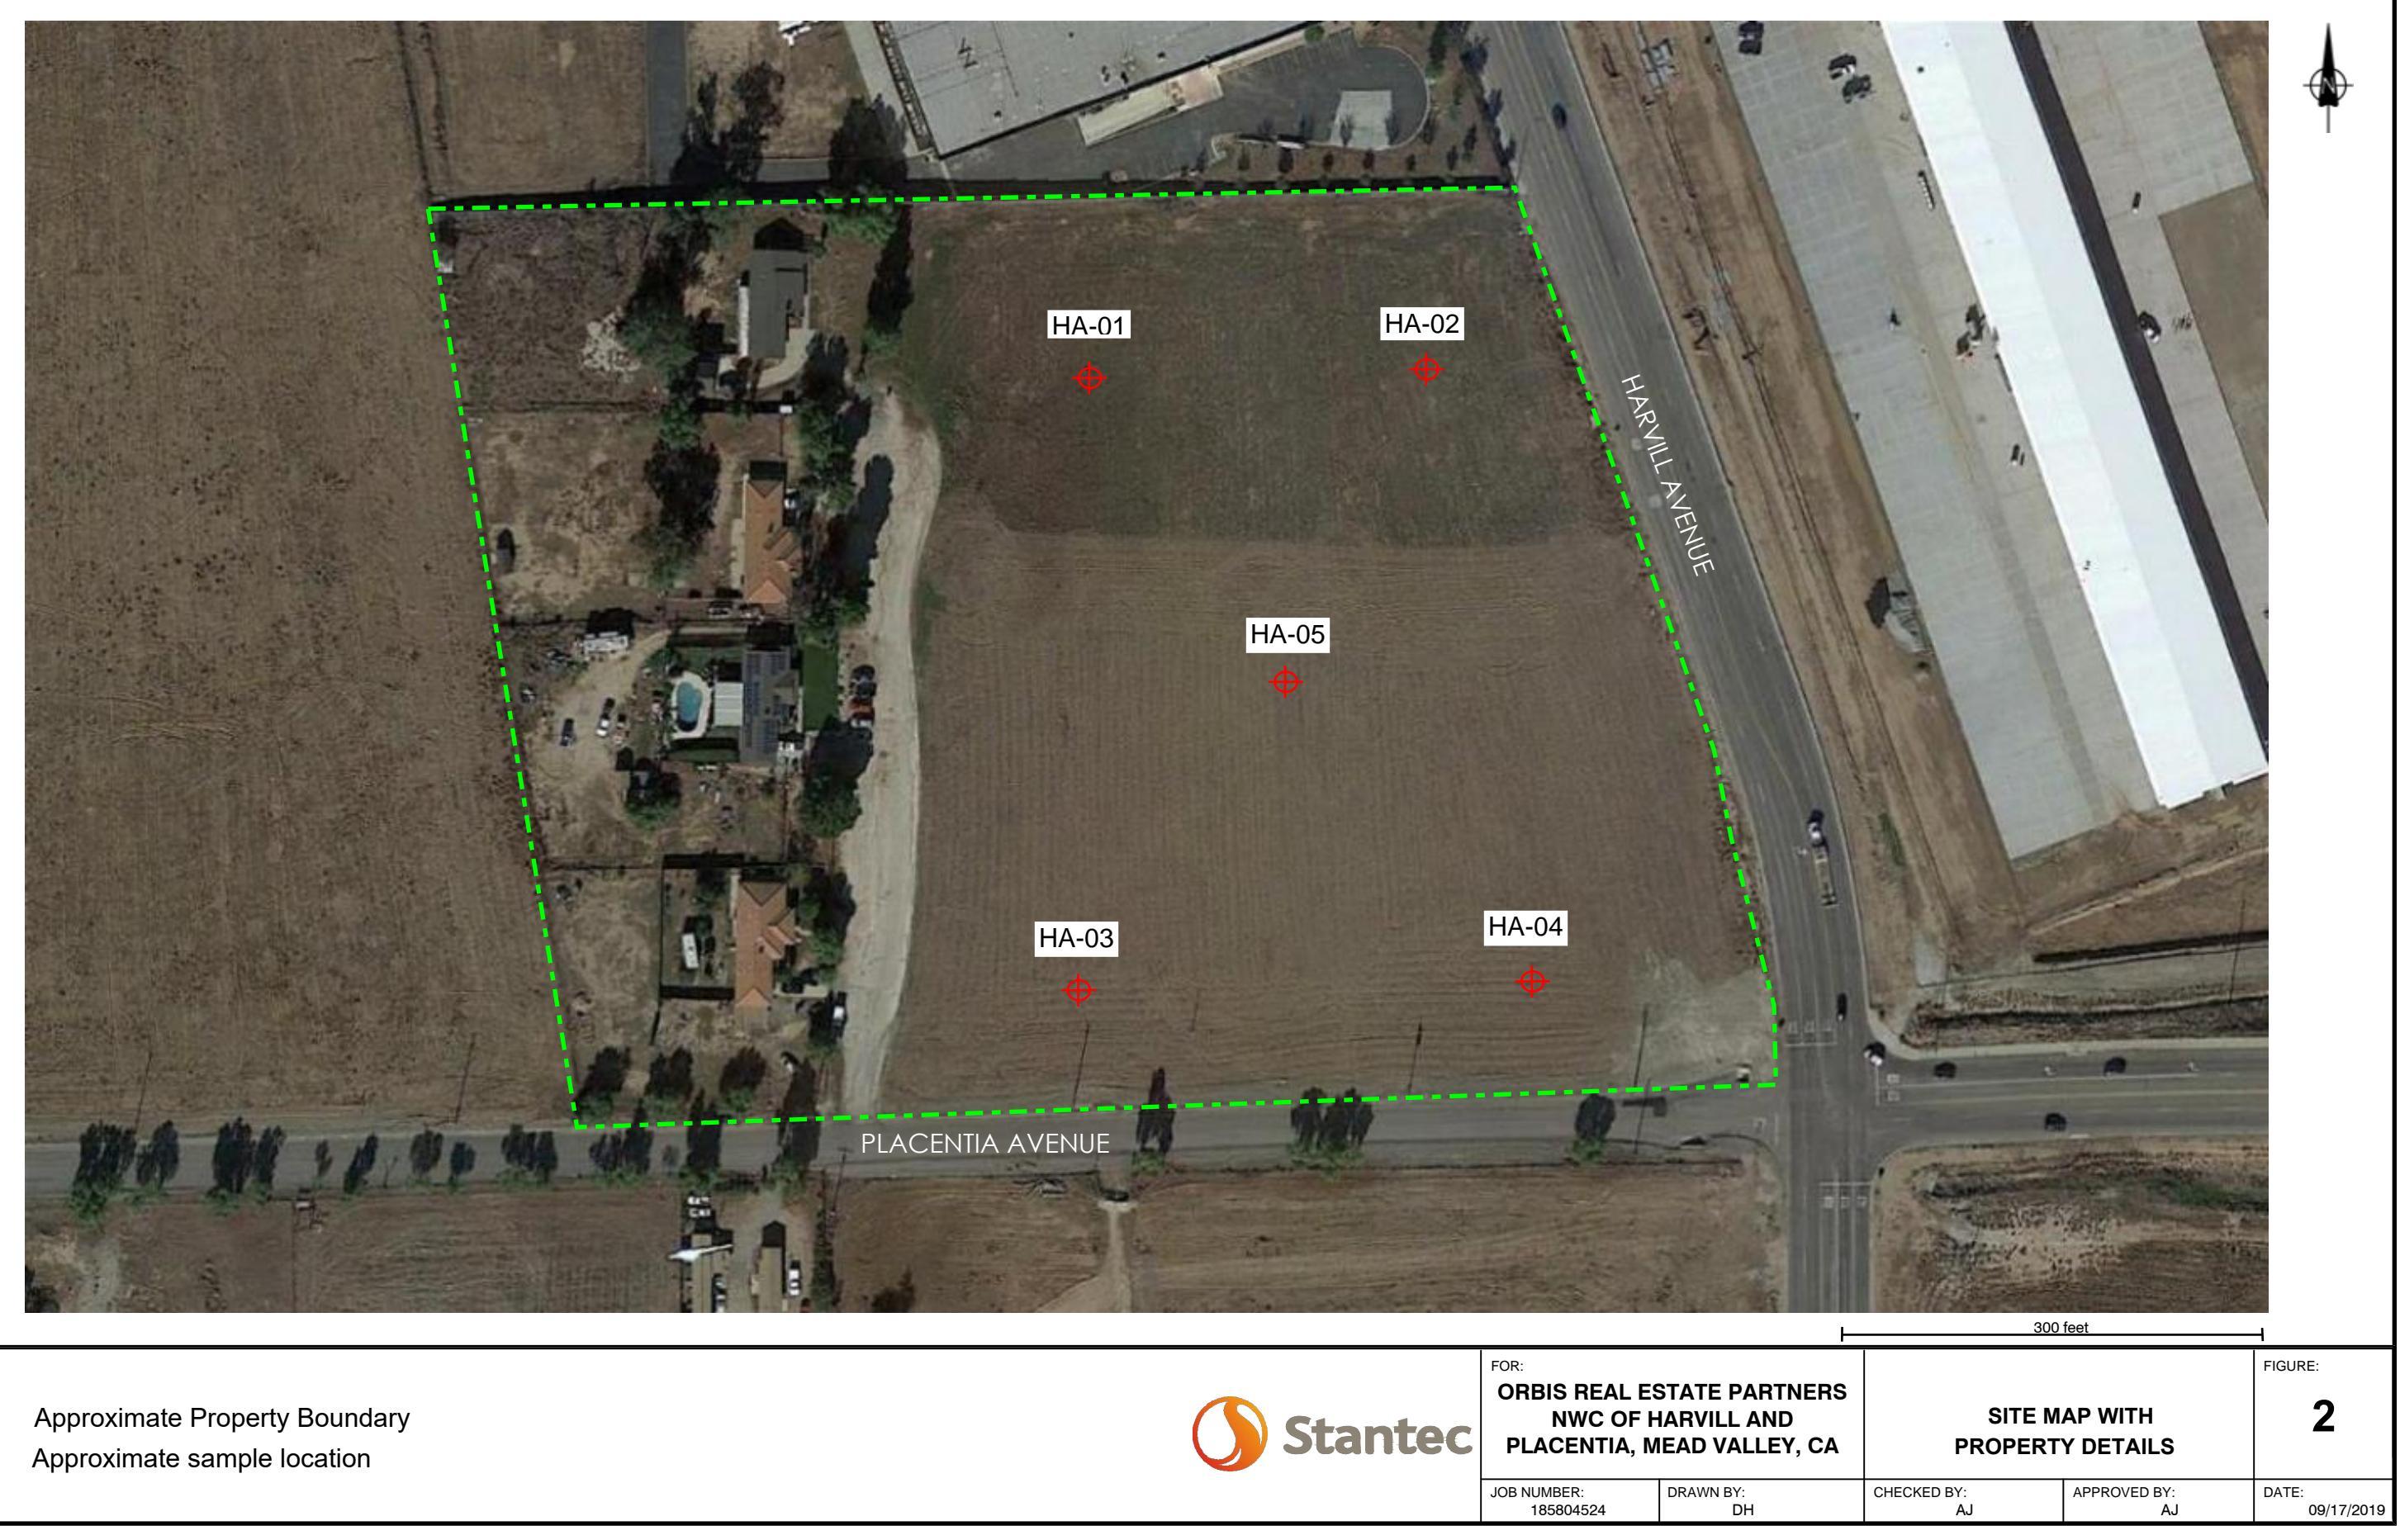
Stantec advanced five (5) soil borings (HA-01 through HA-05) to approximately 3 feet below ground surface (bgs). All five borings were spread out through the vacant lot as depicted in Figure 2. Soil samples were collected at the 1-foot and 3-foot intervals. The 1-foot samples were analyzed for arsenic and lead by EPA Method 6010B, and organochloride pesticides (OCP) by EPA Method 8081A. The 3-foot samples were placed on hold pending the results of the 1-foot sample.

On September 18, 2019, Stantec personnel oversaw the advancement of five (5) soil borings at the Property. Soils encountered during this investigation consisted primarily of poorly graded sand and silty sand to a maximum explored depth of three feet bgs. No staining or odorous soils were observed in any borings during this investigation. No groundwater was not encountered during this investigation. Boring locations are provided in Figure 2.

(1) Refer to Figure 2 for sampling locations
