Appendix H: Safety Element Technical Background Report

Natural Hazard Mapping, Analysis, and Mitigation: a Technical Background Report in Support of the Safety Element of the New Riverside County 2000 General Plan

Prepared for the Department of Regional Planning, County of Riverside

August, 2000

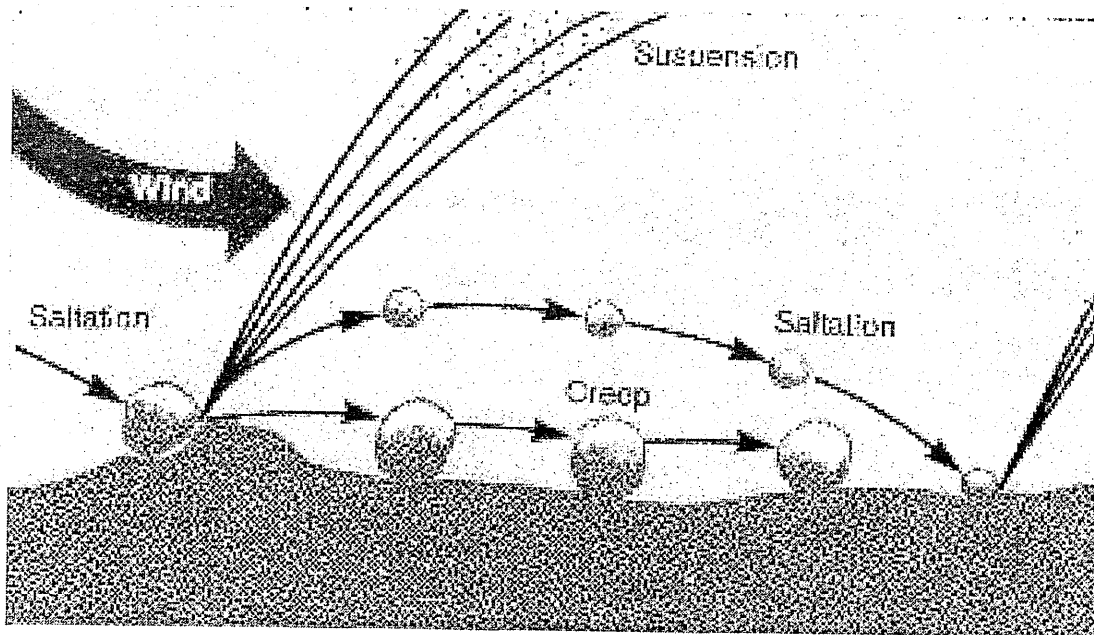
Figure 2-10: Wind-induced soil movement is initiated as a result of wind forces exerted against the surface of the ground and includes suspension, saltation, and surface creep. Soil can be blown high into the atmosphere, however, most soil movement takes place at or below one meter.
