**Highgrove Residential and Commercial Development  
At Mount Vernon Avenue and Center Street Project**

### Geotechnical Soils Report

Report No. 2101-06-B-4

**Subject:** *Response to County of Riverside Geology Review Comments, Tentative Tract Map 37743, Highgrove Area, County of Riverside, California*

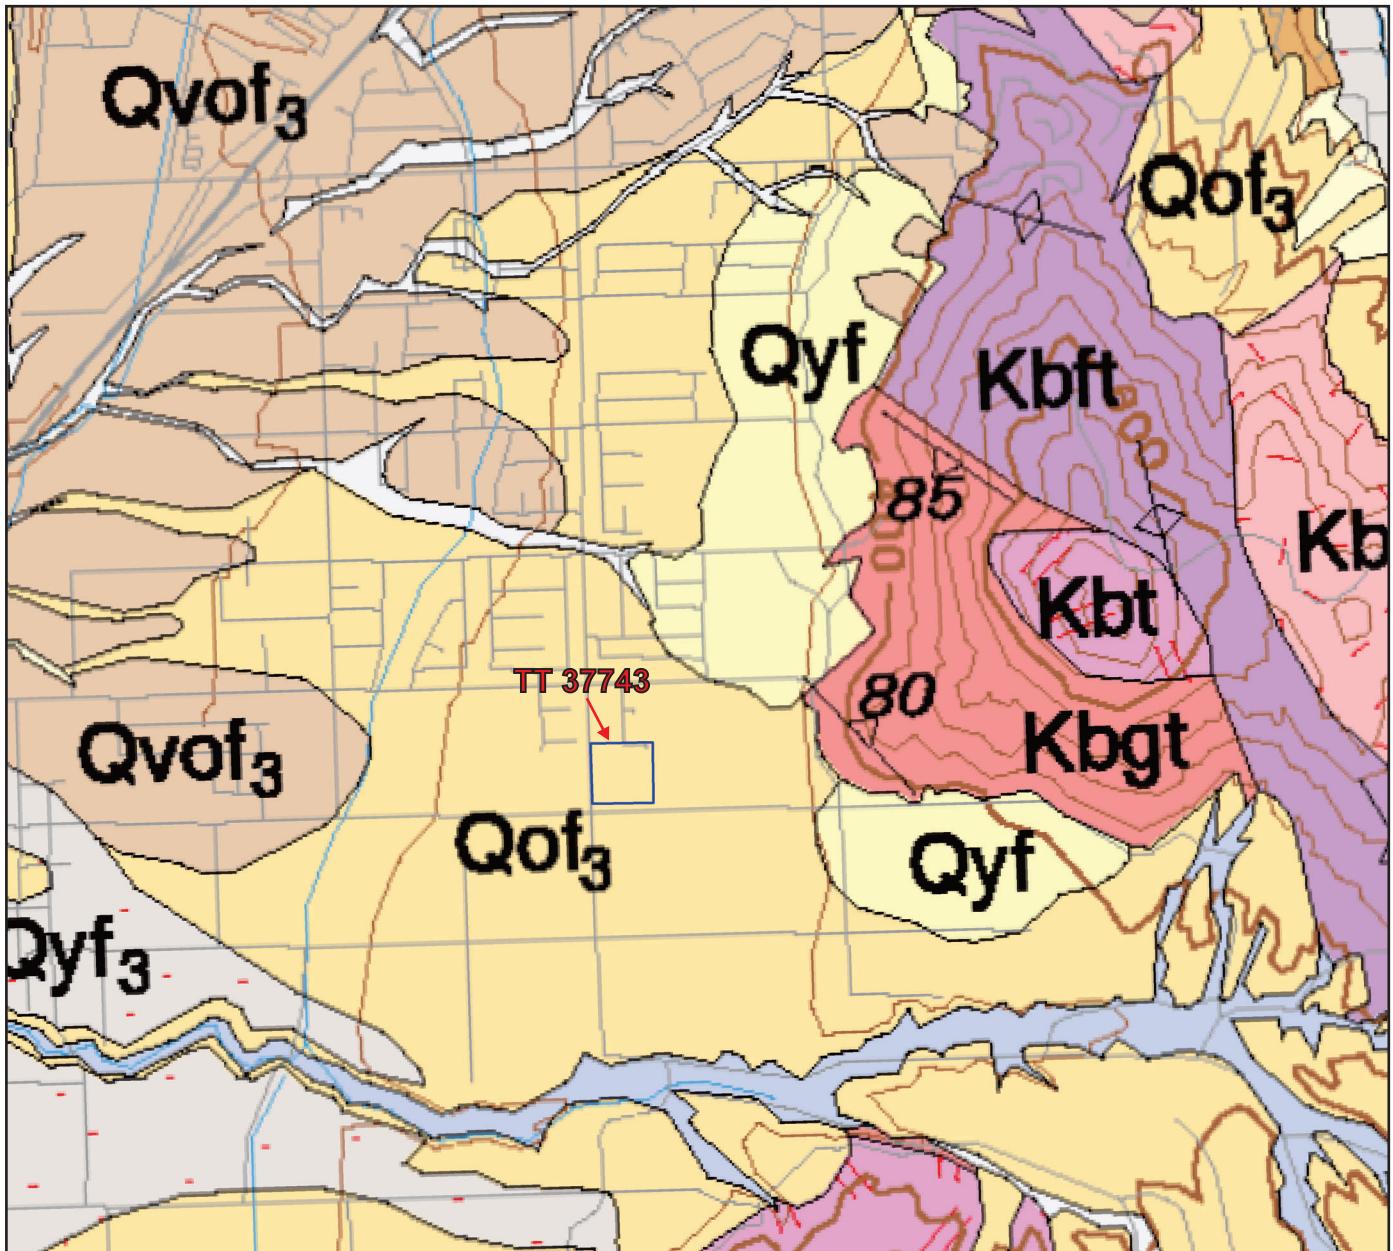
**REGIONAL GEOLOGIC MAP  
TENTATIVE TRACT 37743  
HIGHGROVE AREA  
COUNTY OF RIVERSIDE, CALIFORNIA**

The site is located within the within the Perris Block geomorphic province, a relatively stable zone of the Peninsular Ranges Structural Province (Woodford et al 1971). Two major active faults are present along the boundaries of this region. The San Jacinto Fault is located to the northeast and the Elsinore Fault is located to the southwest of the site.

The site is underlain by old alluvial fan deposits. Bedding was not observed within this unit, and it is assumed that it exists as a flat-lying unit with a slight dip to the west. No faults have been mapped within the site, or immediate site vicinity.

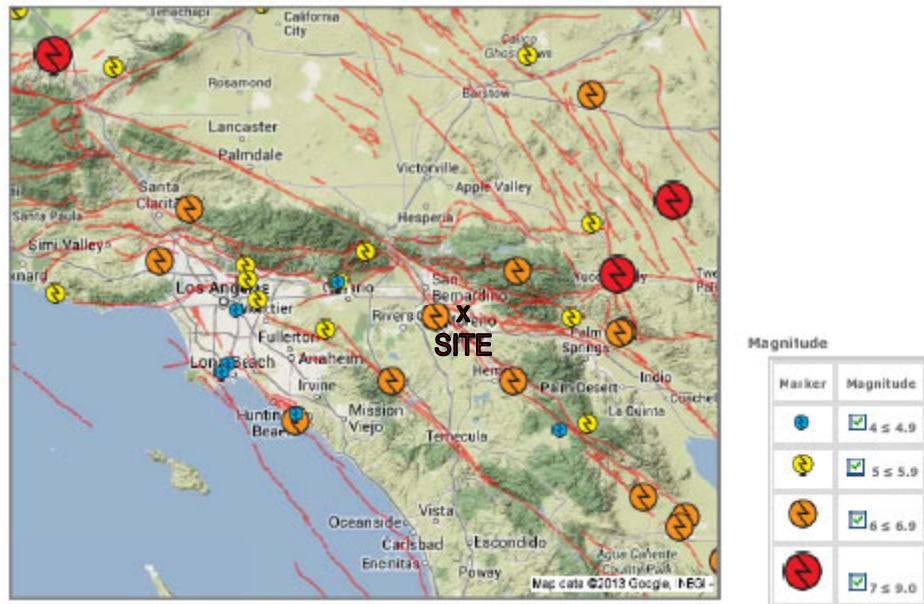
**FIGURE 5.7.2 - MAP OF HISTORIC EARTHQUAKES (1910-PRESENT)**

Earthquakes that have historically impacted the area include the 1857 Fort Tejon Earthquake, the 1858 San Bernardino Earthquake, the 1899 Cajon Pass earthquake, the 6.8 magnitude 1918 San Jacinto earthquake near Hemet, the 6.3 magnitude 1923 North San Jacinto earthquake near Highgrove, the 1981 Sylmar Earthquake, the 5.9 magnitude 1987 Whittier Narrows Earthquake, the 6.4 magnitude Big Bear earthquake, 6.7 magnitude 1994 Northridge Earthquake, and 5.4 magnitude 1990 Upland earthquake.

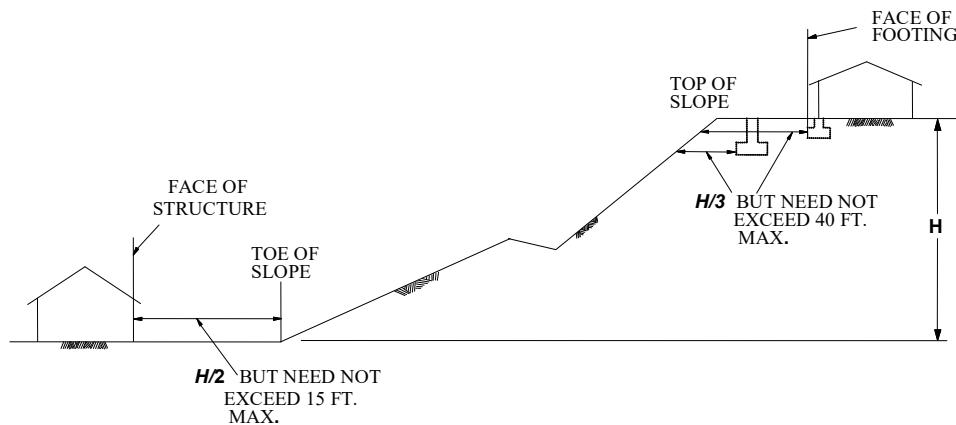
For the subject site, where foundations for residential structures are to exist in proximity to slopes, the footings should be embedded to satisfy the requirements presented in the following figure.

Improvements constructed in proximity to natural slopes or properly constructed, manufactured slopes can, over a period of time, be affected by natural processes including gravity forces, weathering of surficial soils and long-term (secondary) settlement. Most building codes, including the California Building Code, require that structures be set back or footings deepened where subject to the influence of these natural processes.

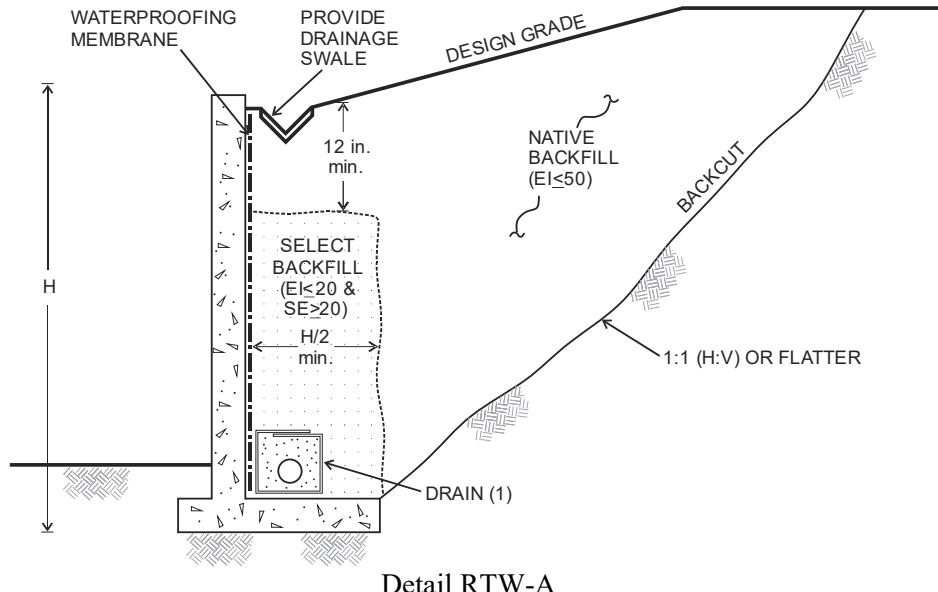
Detail RTW-A

Retaining walls should be provided with a drainage system adequate to prevent the buildup of hydrostatic forces as shown in Details RTW-A and RTW-B. Otherwise, the retaining walls should be designed to resist hydrostatic forces. Proper drainage devices should be installed along the top of the wall backfill and should be properly sloped to prevent surface water ponding adjacent to the wall. In addition to the wall drainage system, for building perimeter walls extending below the finished grade, the wall should be waterproofed and/or damp-proofed to effectively seal the wall from moisture infiltration through the wall section to the interior wall face.

NOTES: (1) DRAIN: 4-INCH PERFORATED ABS OR PVC PIPE OR APPROVED EQUIVALENT SUBSTITUTE PLACED PERFORATIONS DOWN AND SURROUNDED BY A MINIMUM OF 1 CUBIC FEET OF 3/4 INCH ROCK OR APPROVED EQUIVALENT SUBSTITUTE AND WRAPPED IN MIRAFI 140 FILTER FABRIC OR APPROVED EQUIVALENT SUBSTITUTE

The wall should be backfilled with granular soils placed in loose lifts no greater than 8 inches thick, at or near optimum moisture content, and mechanically compacted to a minimum 90 percent of the maximum dry density as determined by ASTM D1557. Flooding or jetting of backfill materials generally do not result in the required degree and uniformity of compaction and, therefore, is not recommended. No backfill should be placed against concrete until minimum design strengths are achieved as verified by compression tests of cylinders. The geotechnical consultant should observe the retaining wall footings, back drain installation, and be present during placement of the wall backfill to confirm that the walls are properly backfilled and compacted.

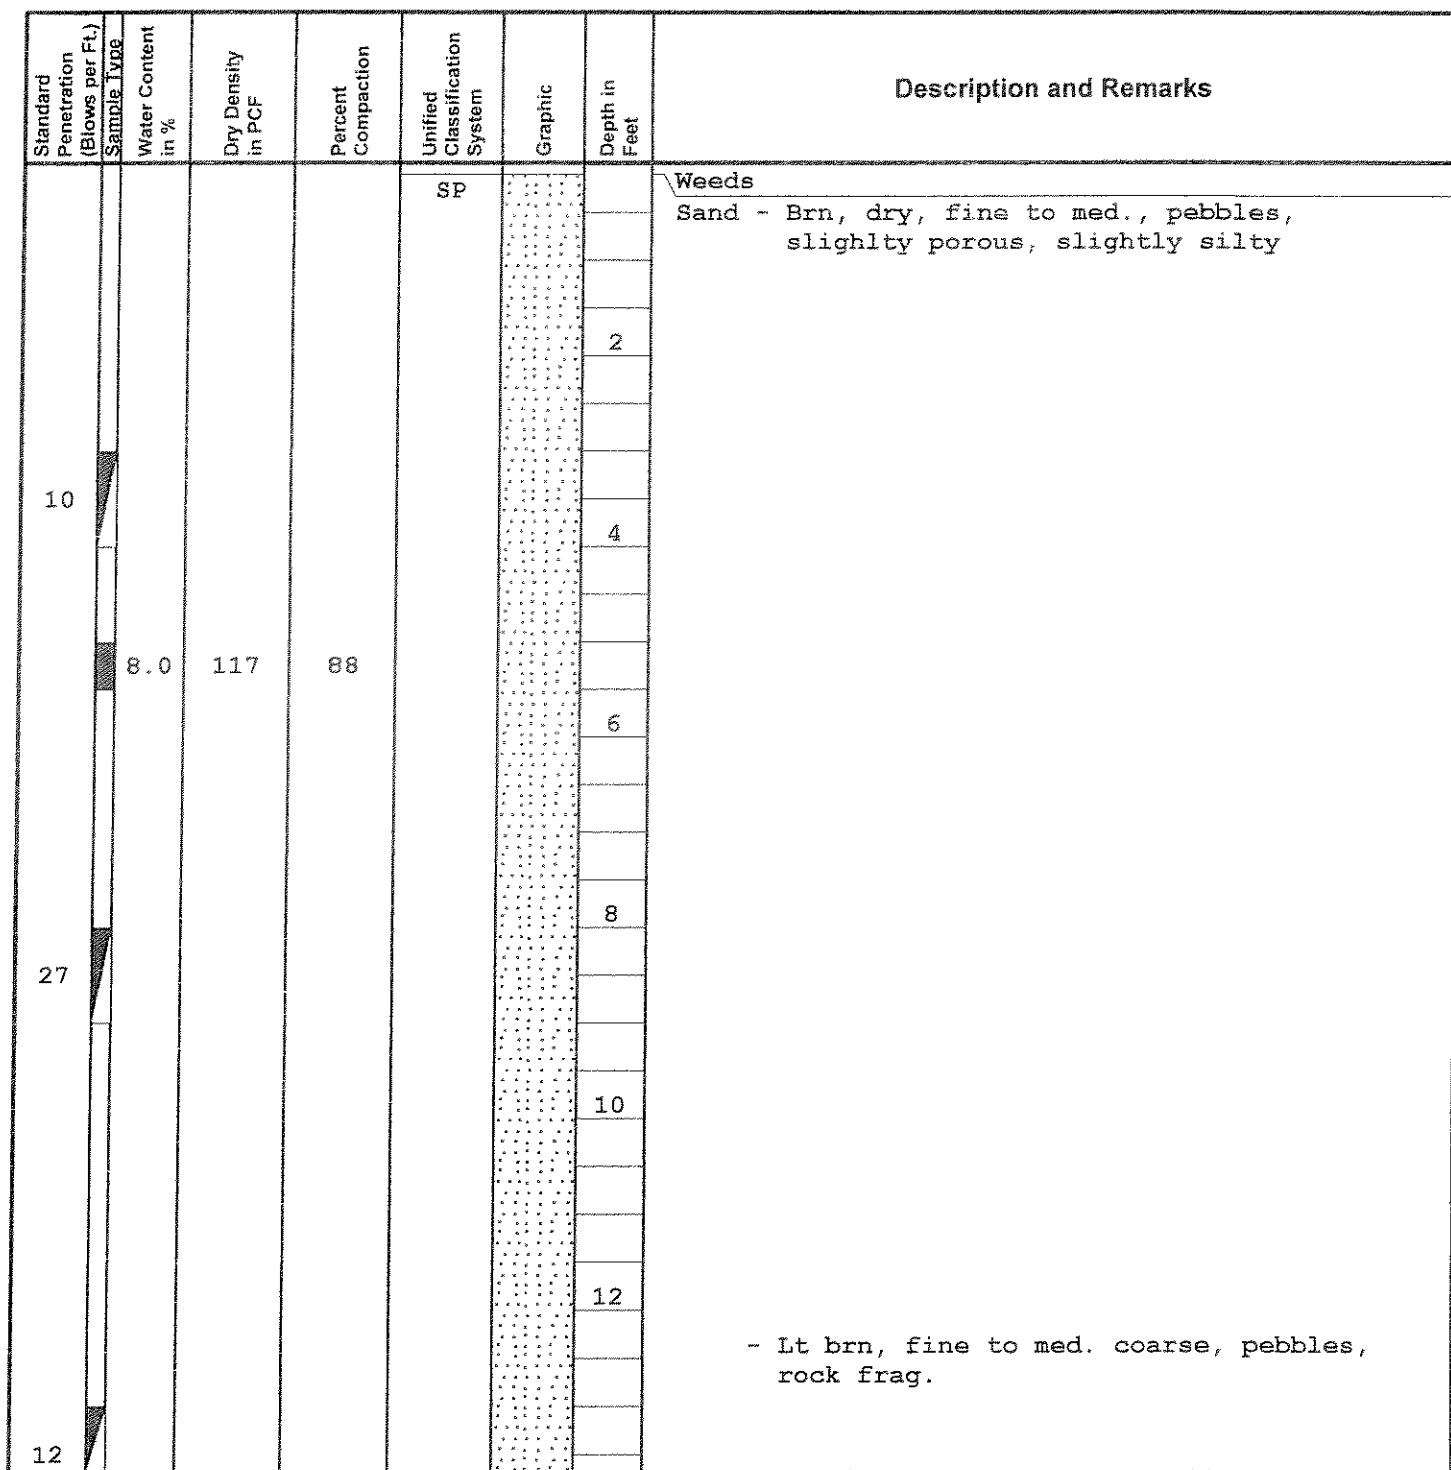
## LOG OF BORING B-2

Project: Victoria Homes / Tr. 32989				Job No.:	05156-F
Logged By:	John	Boring Diam.:		8"	Date: 29 Jun 05

Groundwater: None	Site Location	Plate #
Approx. Depth of Bedrock: None		
Datum: N/A		
Elevation: N/A	NEC Center & Mt Vernon Riverside County

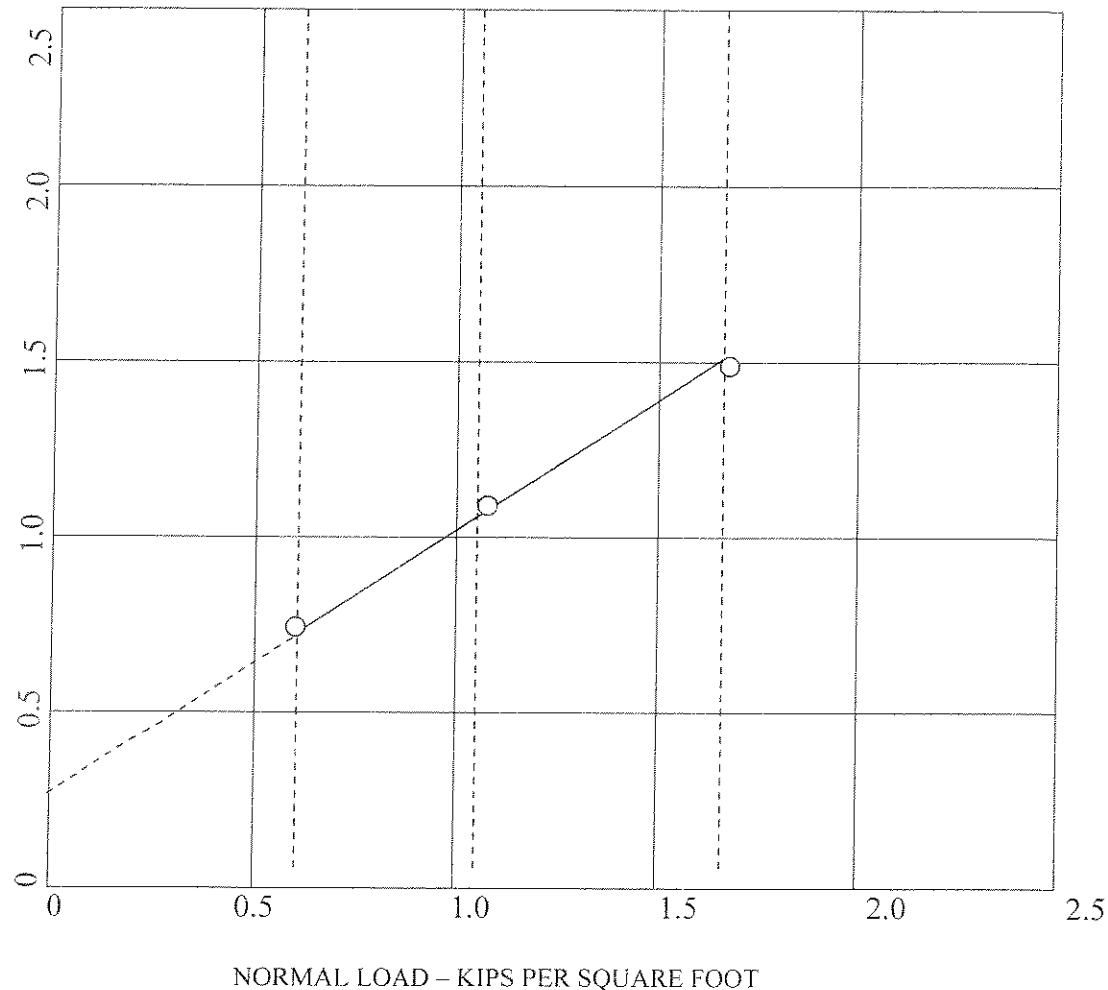
## DIRECT SHEAR TESTS

SYMBOL	LOCATION	DEPTH (ft)	TEST CONDITION	COHESION (psf)	FRICTION (degree)
○	B-1	0-3	Bulk-remolded to 90%	275	33

Material	Cohesion (psf)	Friction Angle (degrees)	Moist Density (pcf)
Compacted Fill and Older Alluvium	275	33	130

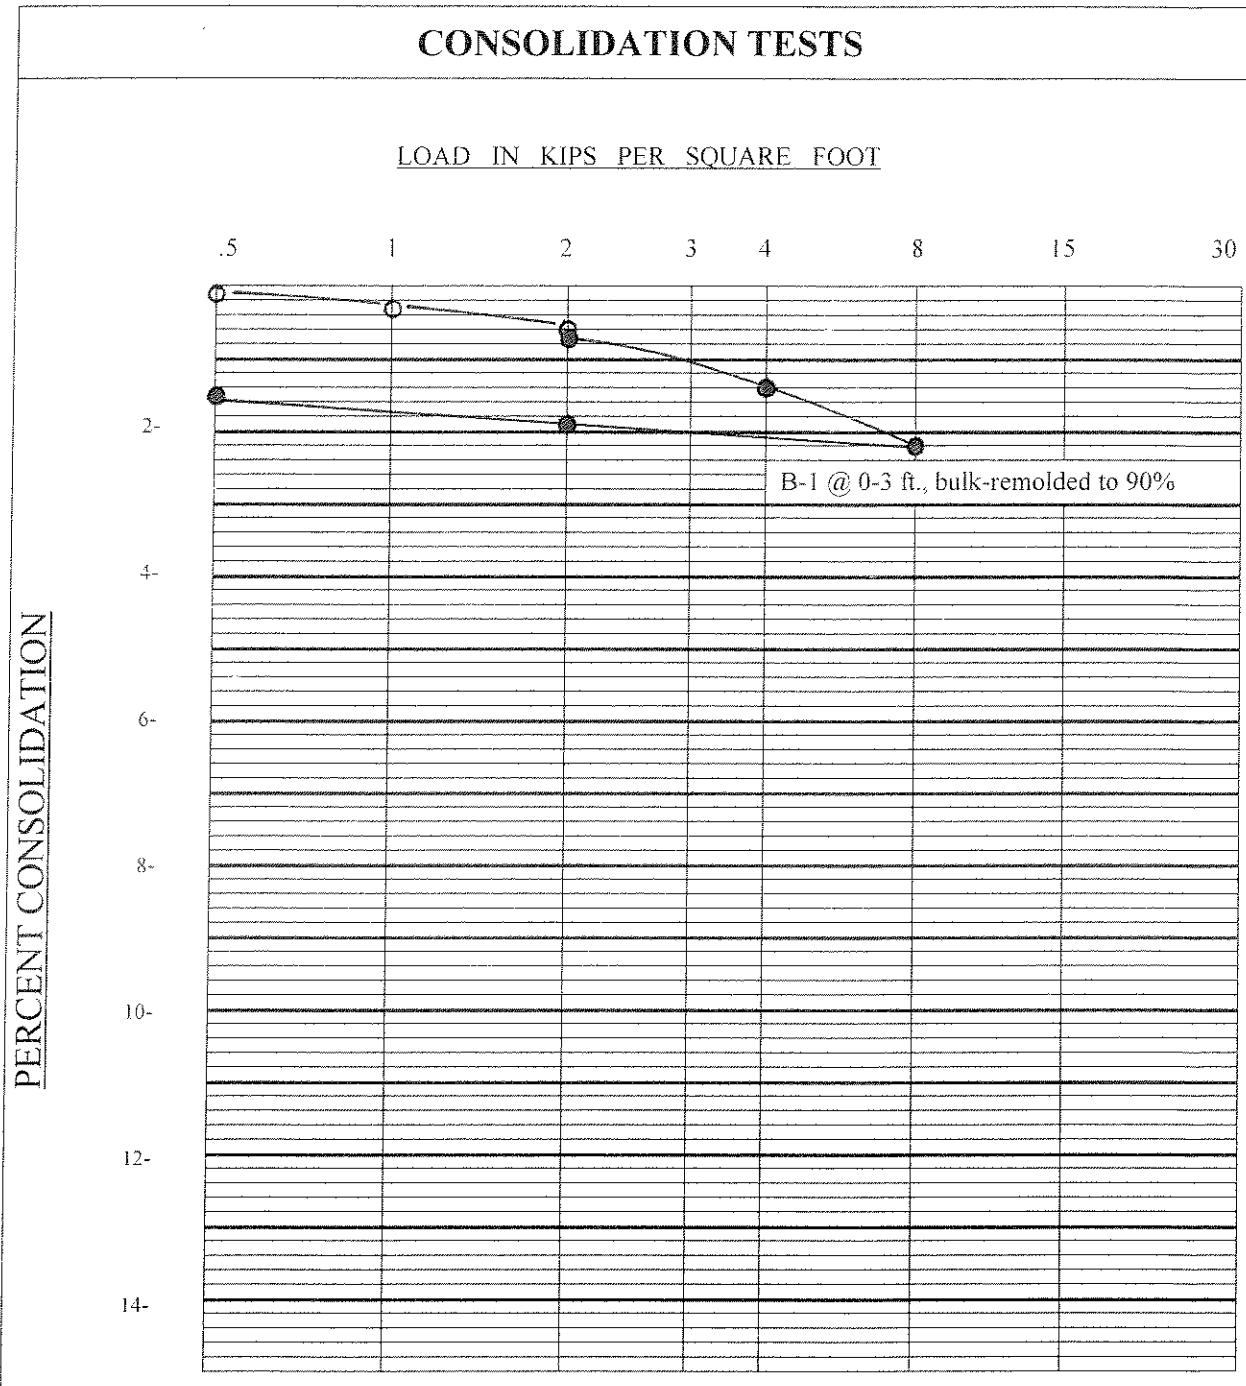
## CONSOLIDATION TESTS

● WATER PERMITTED TO CONTACT SAMPLE

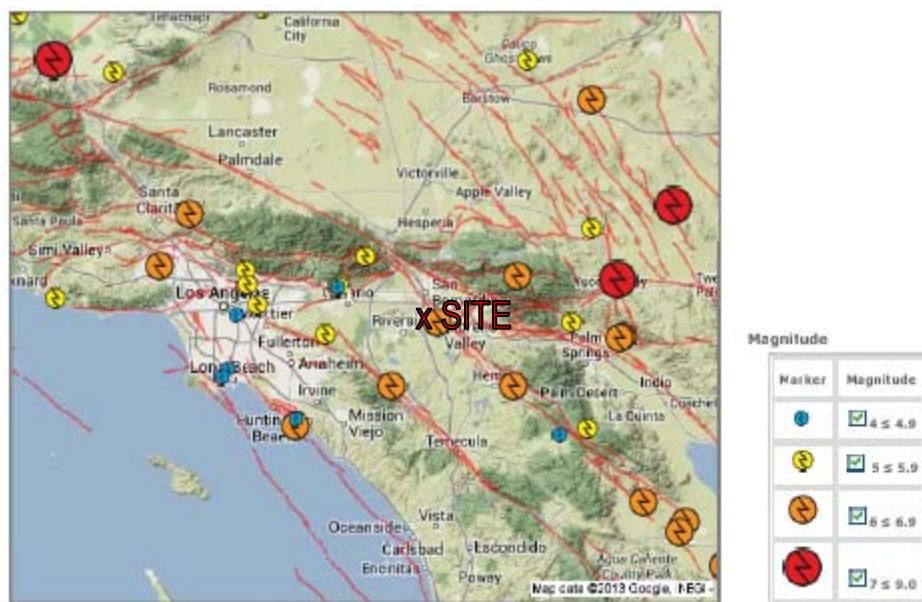
**FIGURE 5.7.2, MAP OF HISTORIC EARTHQUAKES (1910-PRESENT)**

Earthquakes that have historically impacted the area include the 1857 Fort Tejon Earthquake, the 1858 San Bernardino Earthquake, the 1899 Cajon Pass earthquake, the 6.8 magnitude 1918 San Jacinto earthquake near Hemet, the 6.3 magnitude 1923 North San Jacinto earthquake near Highgrove, the 1981 Sylmar Earthquake, the 5.9 magnitude 1987 Whittier Narrows Earthquake, the 6.4 magnitude Big Bear earthquake, 6.7 magnitude 1994 Northridge Earthquake, and 5.4 magnitude 1990 Upland earthquake.

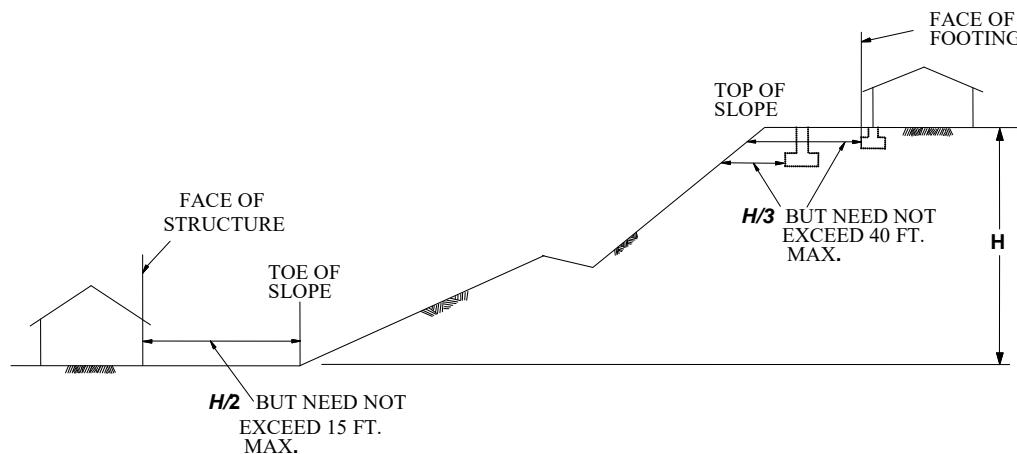
For the subject site, where foundations for residential structures are to exist in proximity to slopes, the footings should be embedded to satisfy the requirements

Improvements constructed in proximity to natural slopes or properly constructed, manufactured slopes can, over a period of time, be affected by natural processes including gravity forces, weathering of surficial soils and long-term (secondary) settlement. Most building codes, including the California Building Code, require that structures be set back or footings deepened where subject to the influence of these natural processes.

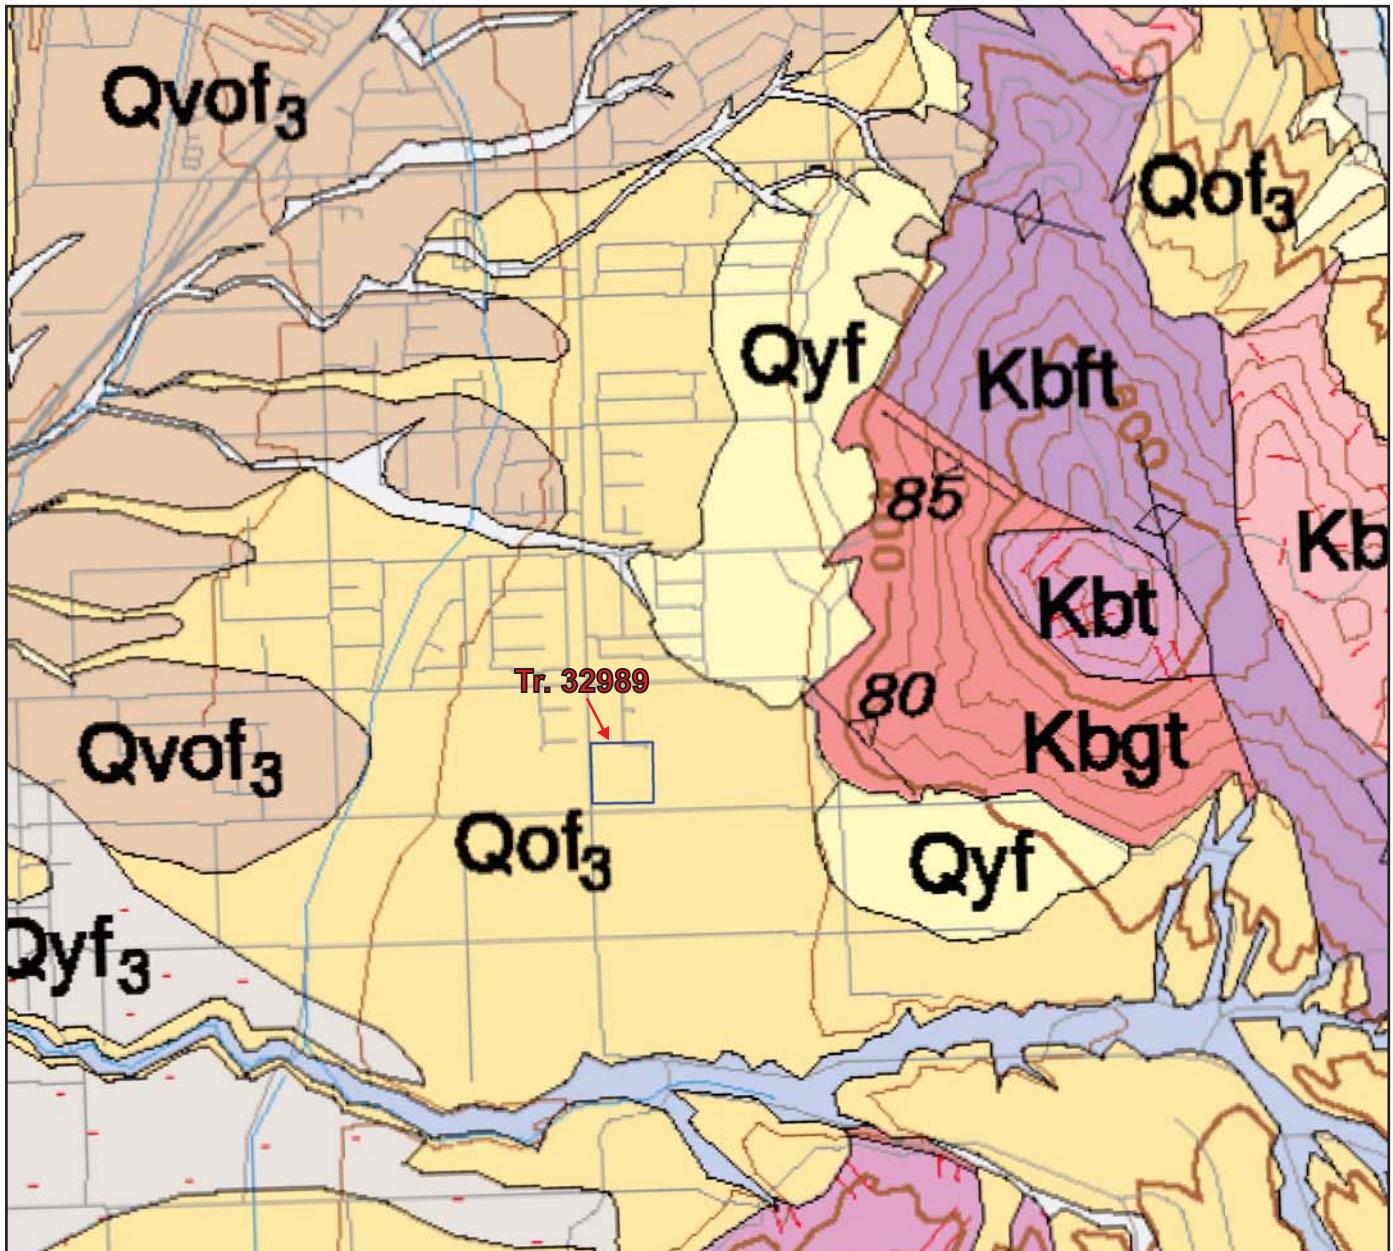
**FIGURE 2**

**REGIONAL GEOLOGIC MAP  
TRACT 32989  
HIGHGROVE AREA  
COUNTY OF RIVERSIDE, CALIFORNIA**

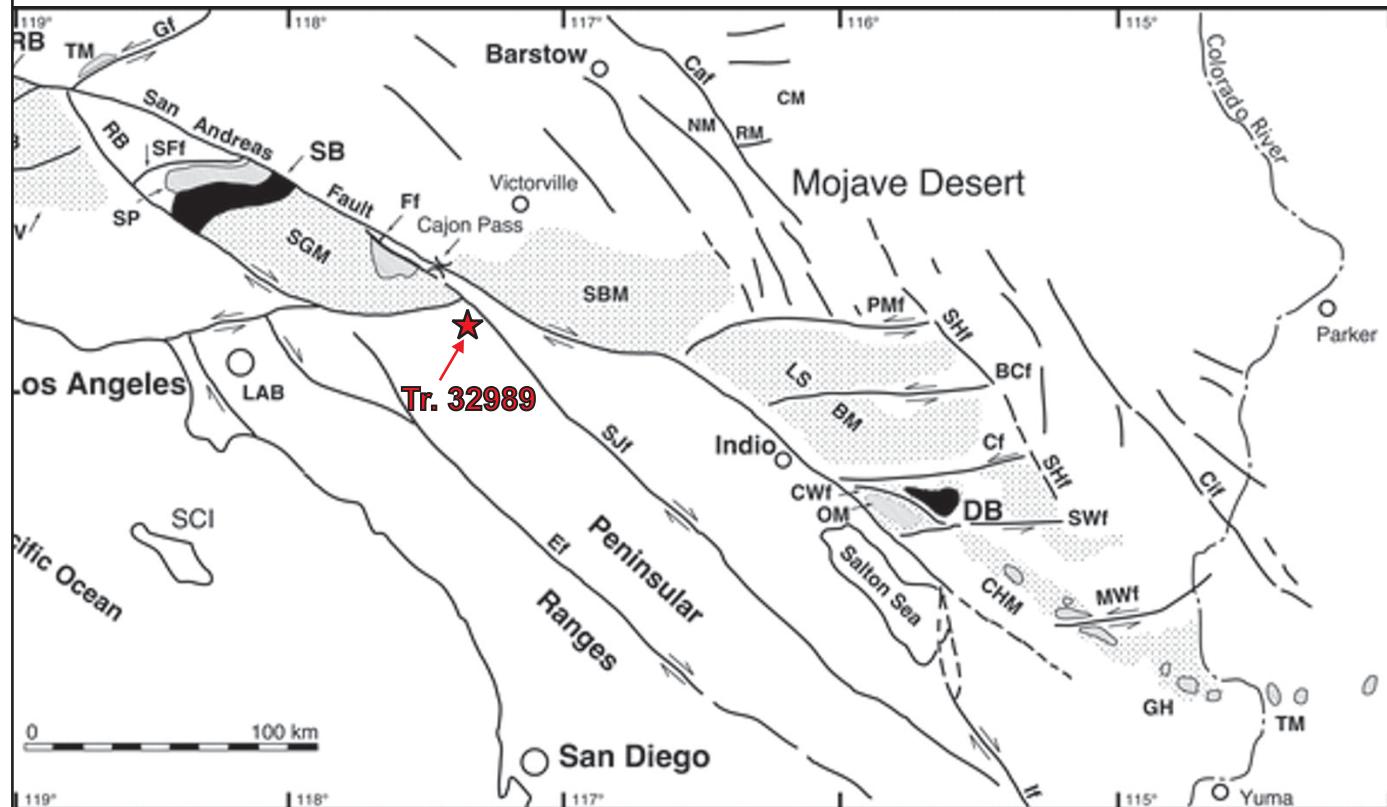
**FIGURE 3**

**FAULT MAP  
TRACT 32989  
HIGHGROVE AREA  
COUNTY OF RIVERSIDE, CALIFORNIA**

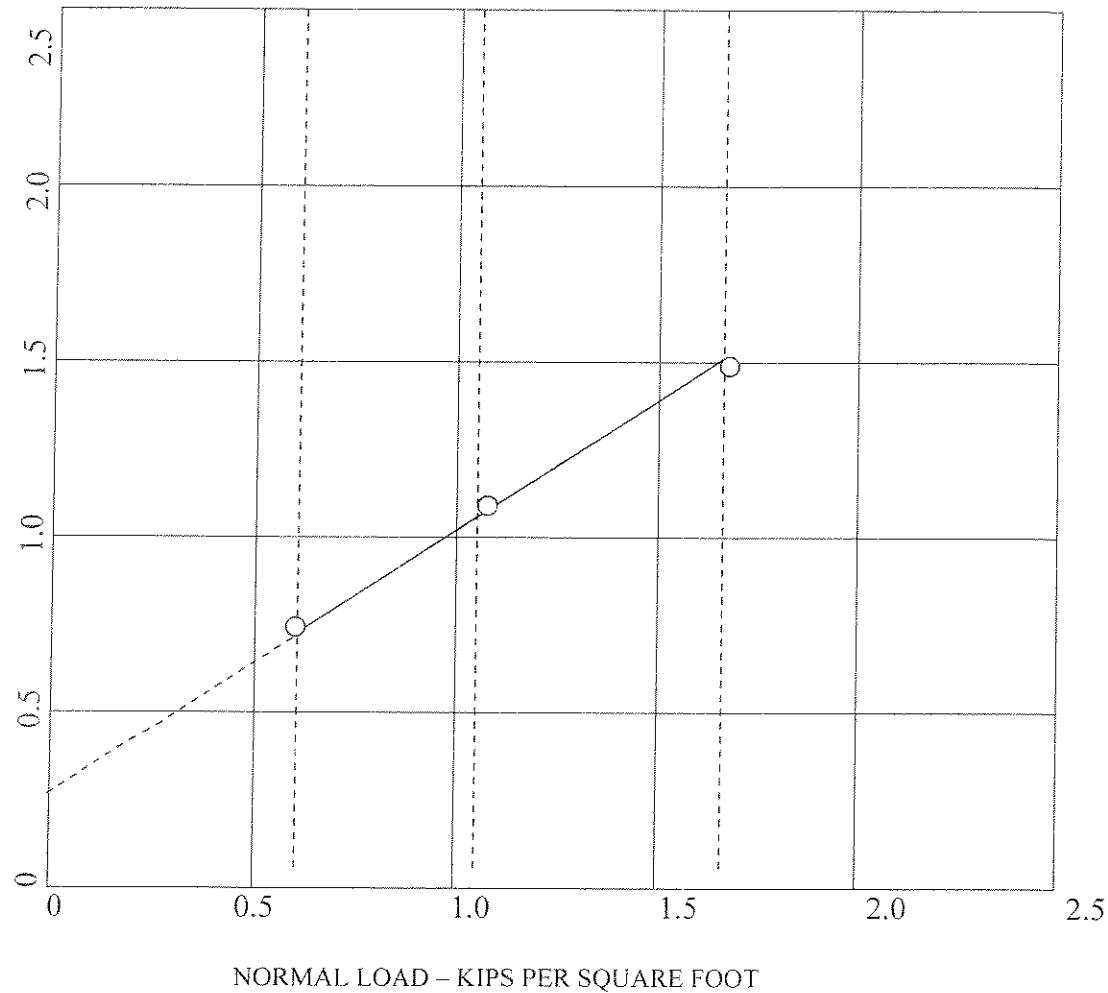
## DIRECT SHEAR TESTS

SYMBOL	LOCATION	DEPTH (ft)	TEST CONDITION	COHESION (psf)	FRICTION (degree)
○	B-1	0-3	Bulk-remolded to 90%	275	33

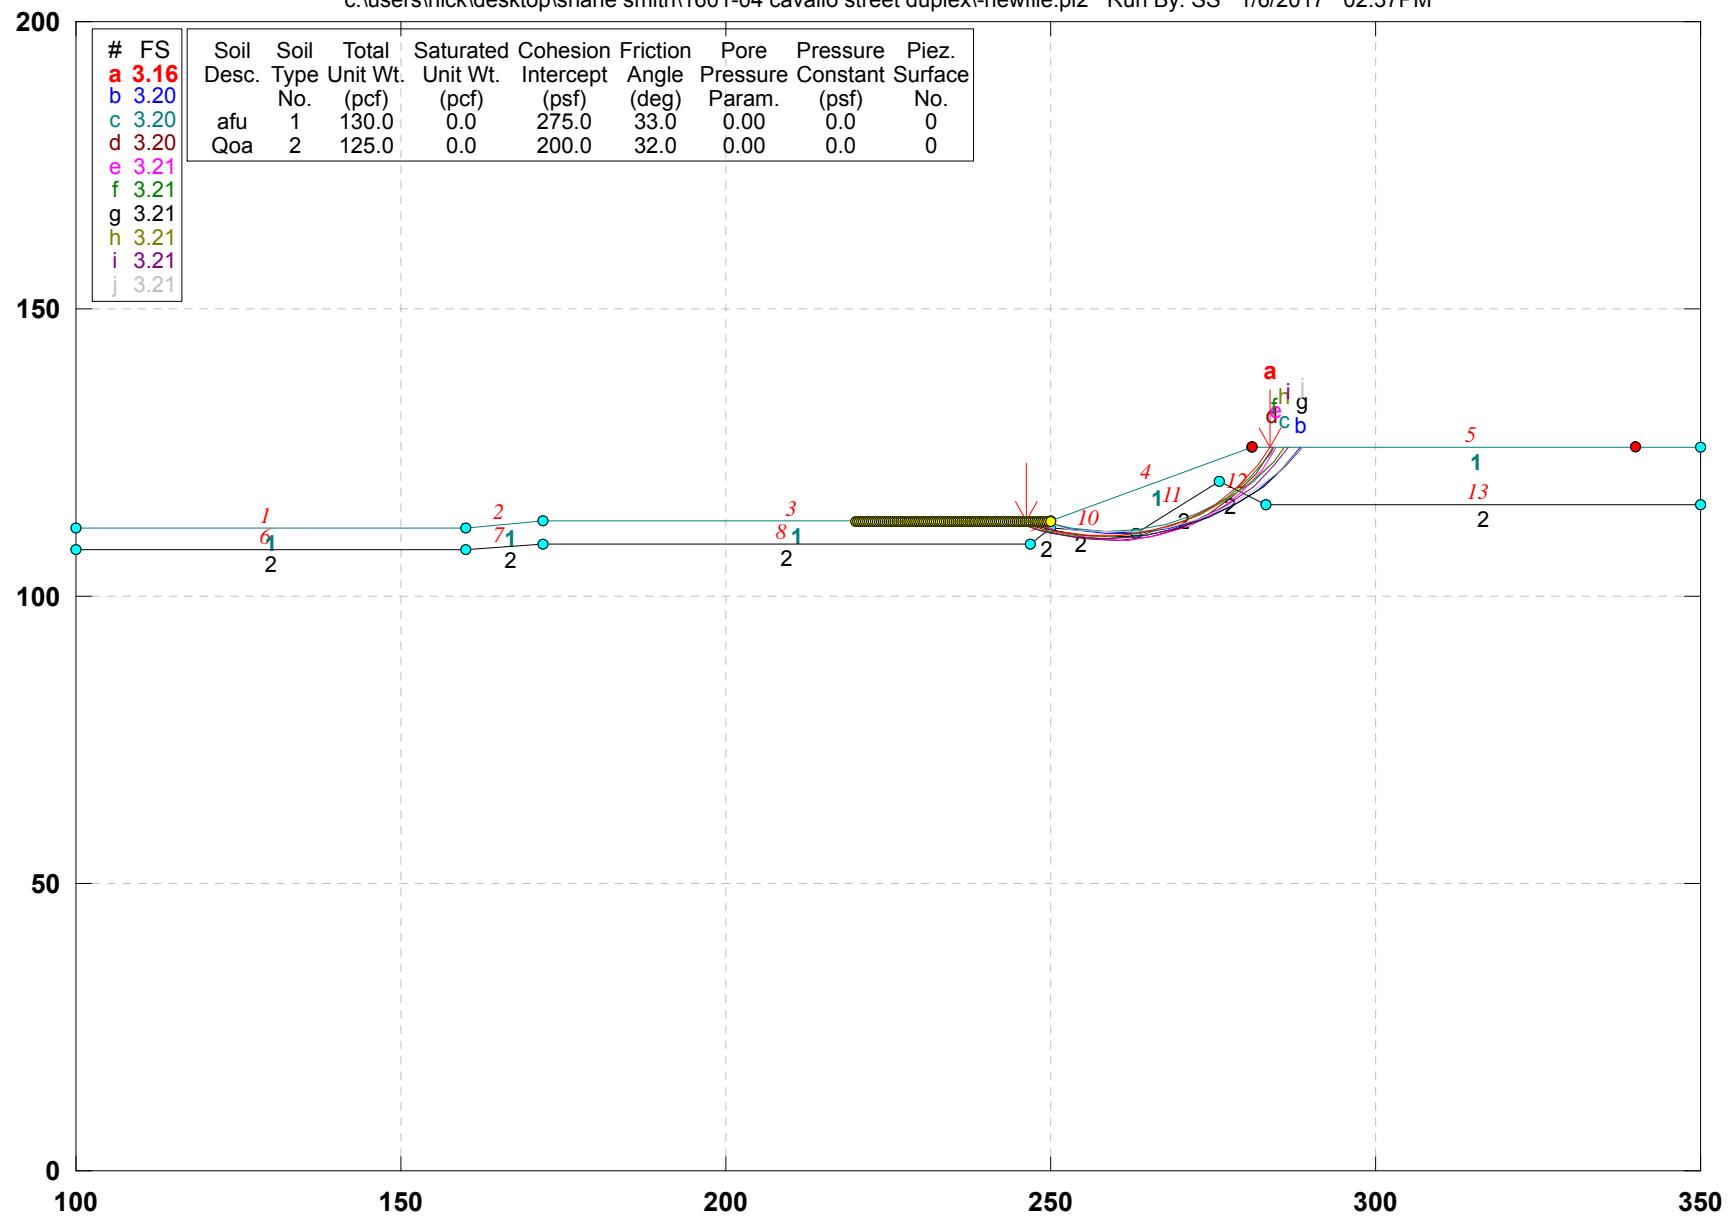
## 1612-03 15' Cut Slope Static

GSTABL7 v.2 FSmin=3.16

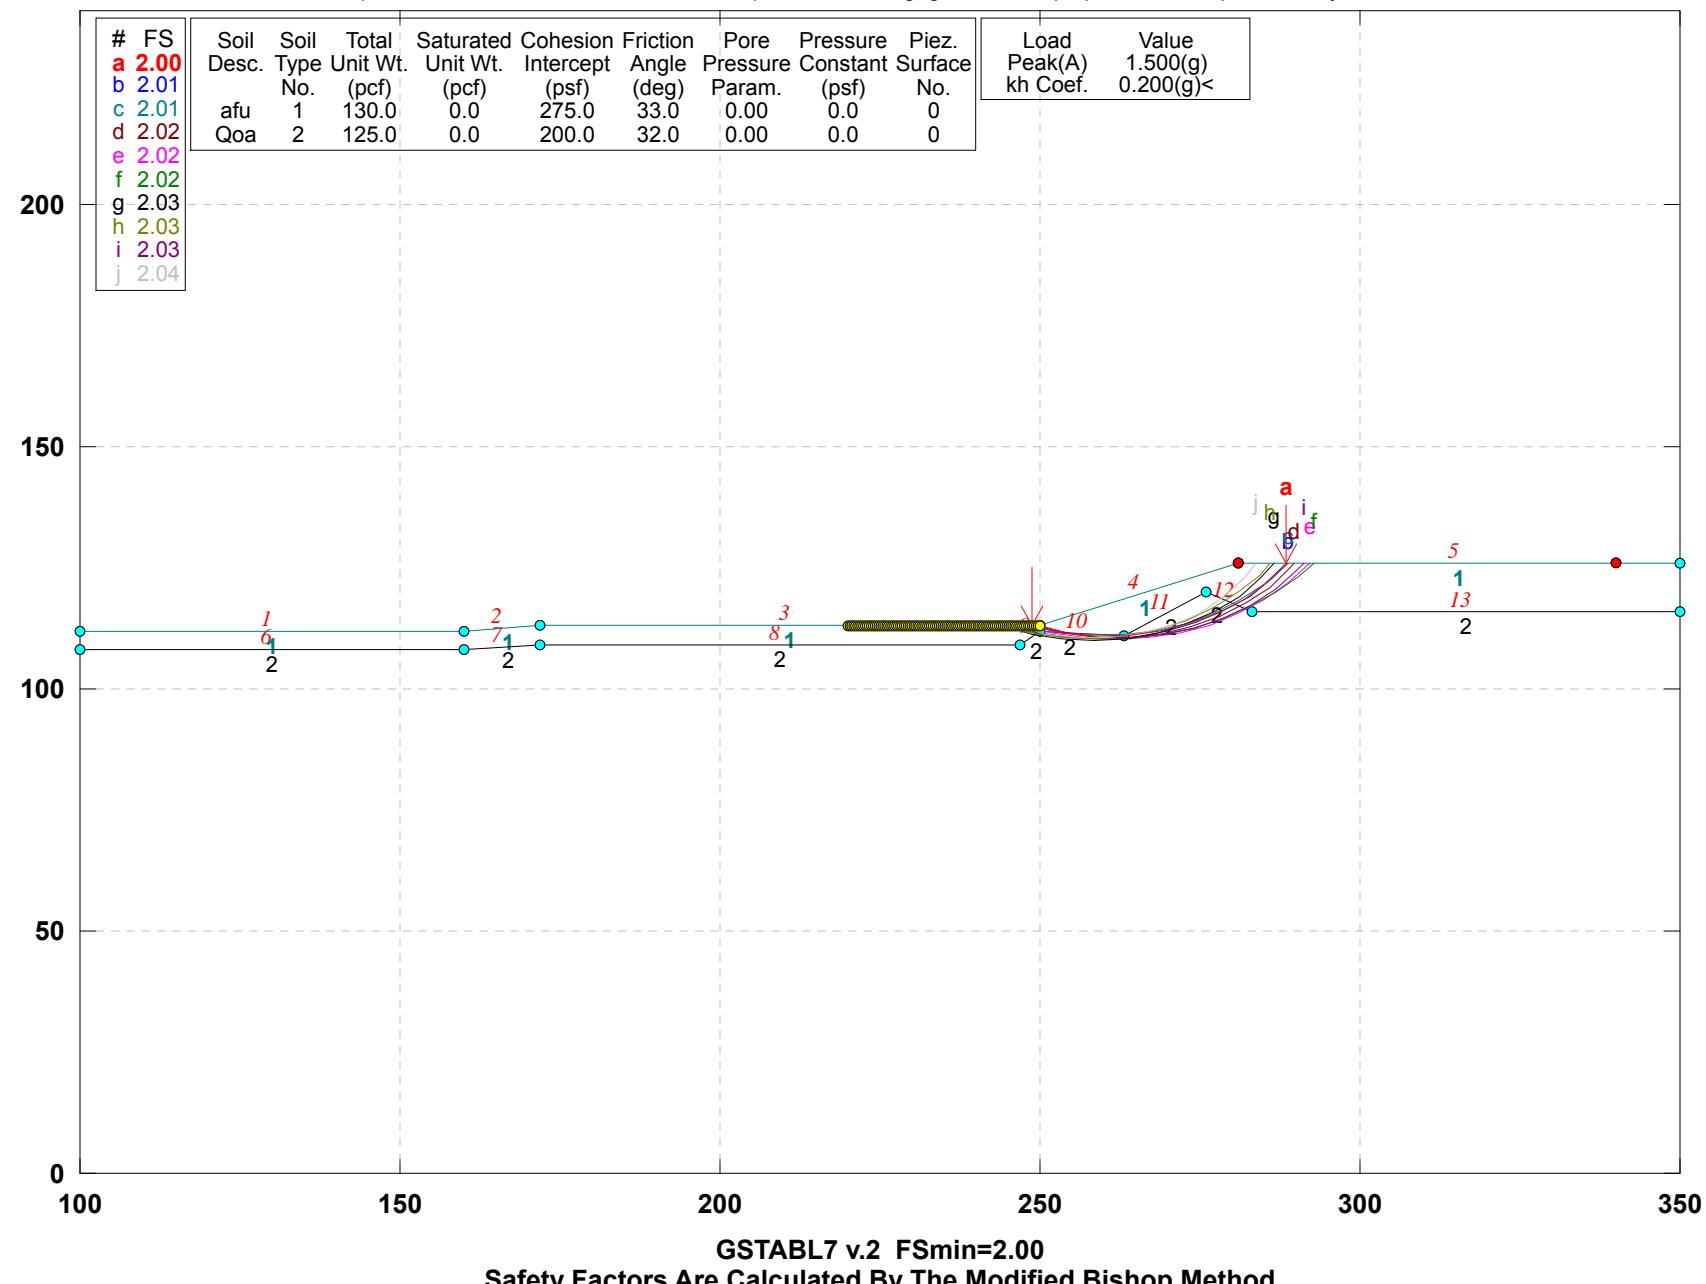
# 1612-03 15' Cut Slope Pseudo Static

c:\users\nick\desktop\shane smith\1601-04 cavallo street duplex\1612-03 highgrove cut slope psuedo static.pl2 Run By: SS 1/6/2017 02:45PM

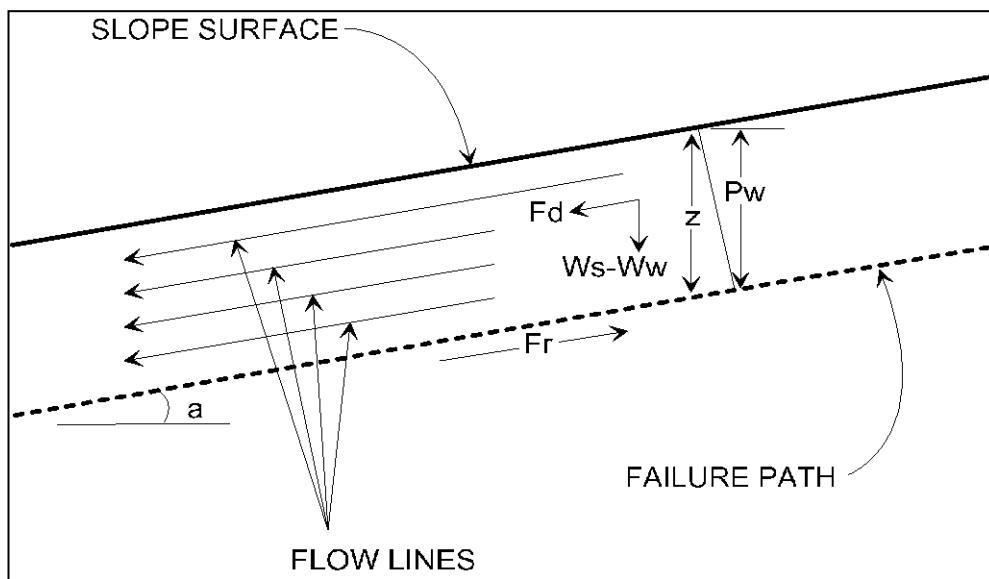
## SURFICIAL STABILITY ANALYSIS

Assume:

- (1) Saturation To Slope Surface
- (2) Sufficient Permeability To Establish Water Flow

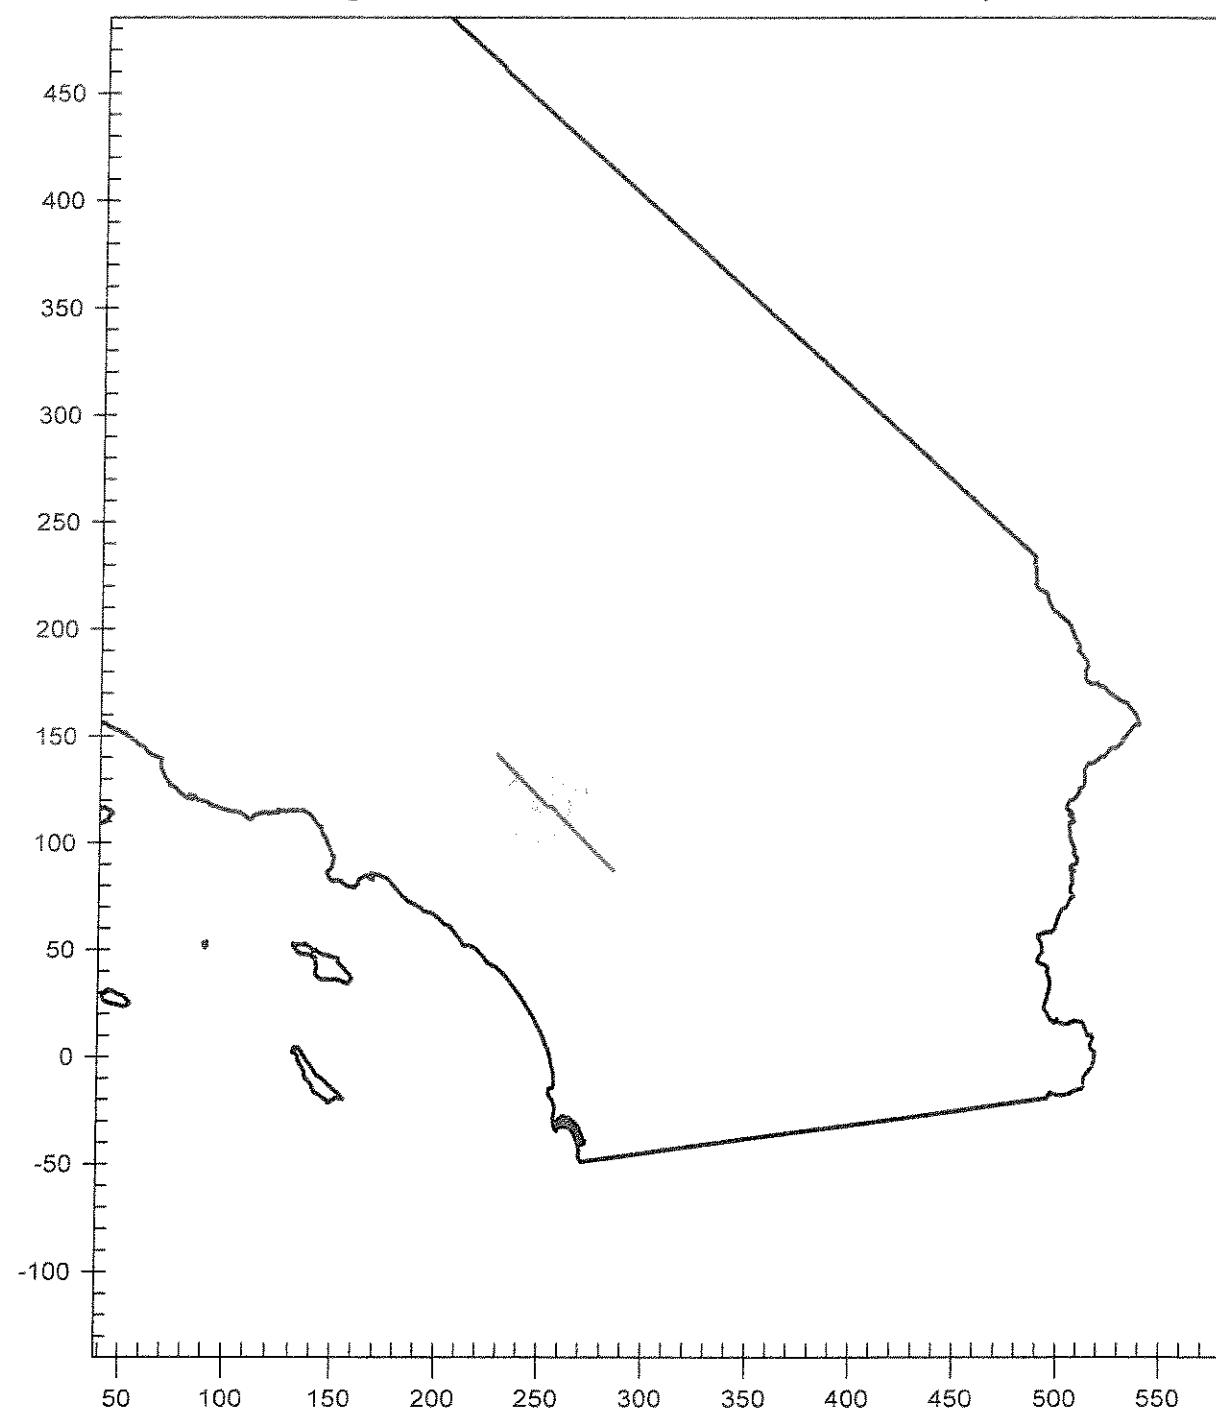
## EARTHQUAKE MAGNITUDES & DISTANCES

Paradigm, Co., LLC NEC Center & Mt Vernon Riverside Cnty
